Bmw DISA Valve Unit Rattle Repair Fix Kit Rattling Repair Instruction Guide

By x8rltd in Workshop > Cars 👁 2,795 ❤ 1

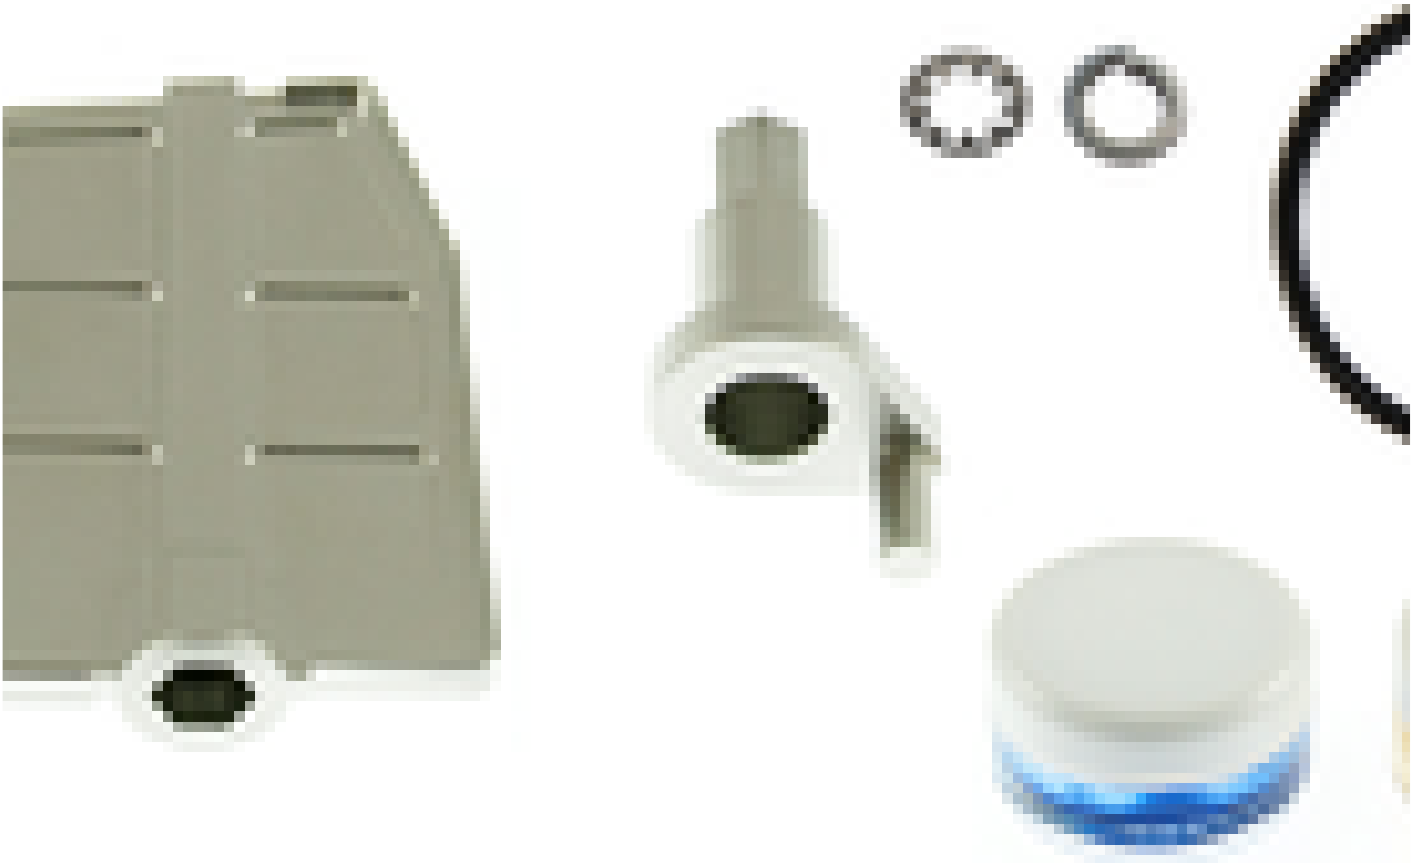
Rattling noise coming from the DISA valve? SES light lit and getting lean mixture faults. Rough running at idle. DTC codes and a loss in low end torque. Rattling, buzzing or clicking noise from the engine?

The original plastic Disa valve components wear and often snap causing the symptoms noted above. The pin retaining the flap can also pop out entering the engine!

The likely cause of the faults noted above and most common cause is the weak plastic components within the DISA valve unit vibrating together and wearing causing the flap to operate at the wrong times and eventually leading to destruction of the flap plate. The pieces of this flap can even enter the engine often causing severe engine damage; likewise the metal pin that holds the flap plate in position can vibrate loose and enter the engine.

Fit our improved design billet aluminium flap kit, designed to never fail, save the cost of a replacement DISA valve which will only fail again.

Using our kit the weak components of the DISA valve the flap and crank lever are replaced with our many times stronger billet aluminium parts, retained by our precision machined screw which tightly retains the two components together; eliminating wear and the need for the retaining pin which can enter the engine. Our part is completely redesigned to never fail- OEM clearances are reduced minimising vibrations in the part preventing any future failure.
