Toyota AYGO Peugeot 107 Citroen C1 Door Boot Tailgate Seal Leak Fix Seal Kit Seals Install Instruction Guide

by x8rltd

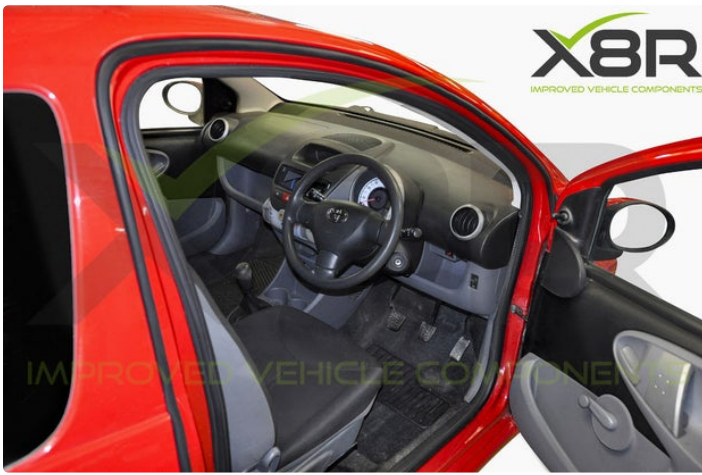
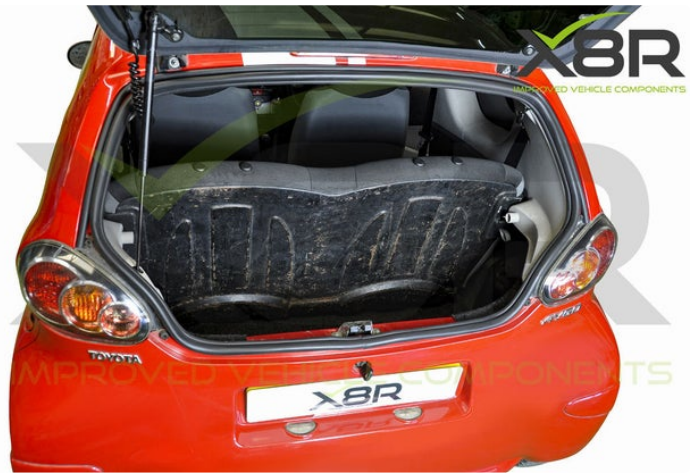
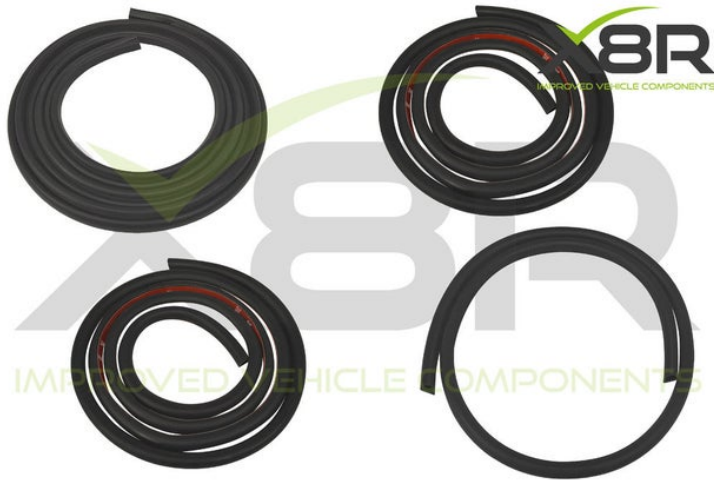
X2 External door seals

X1 Improved design tailgate seal

X1 External tailgate seal

X3 Alcohol wipes

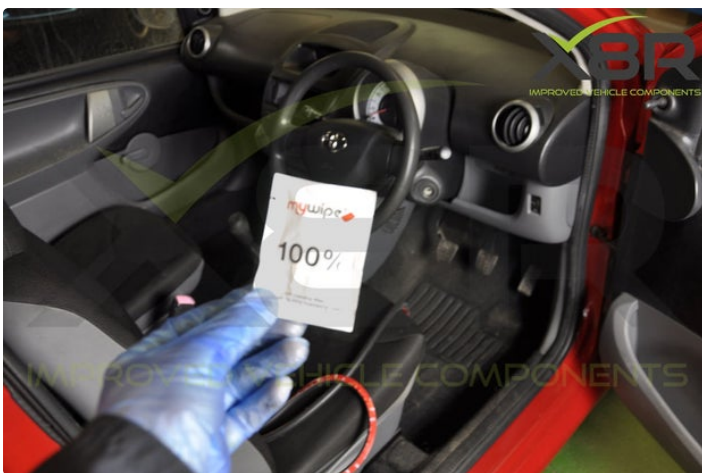
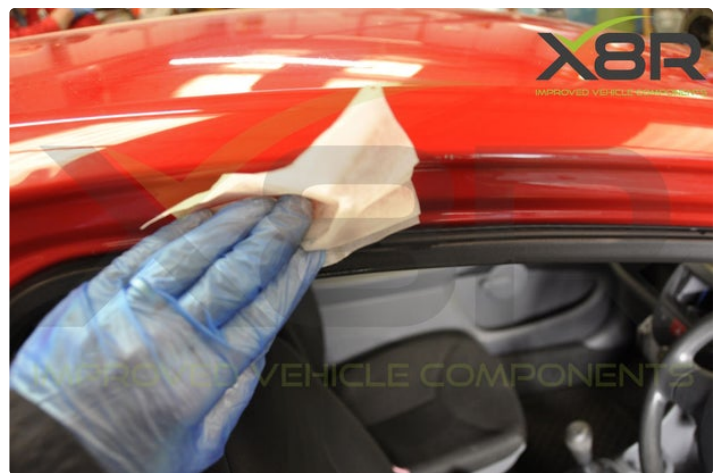
Step 1: Door Seals: Clean Up Surface

Using one of our alcohol wipes clean up the outside edge of the door recess, remove all grime / grease to ensure good adhesion of our seal.

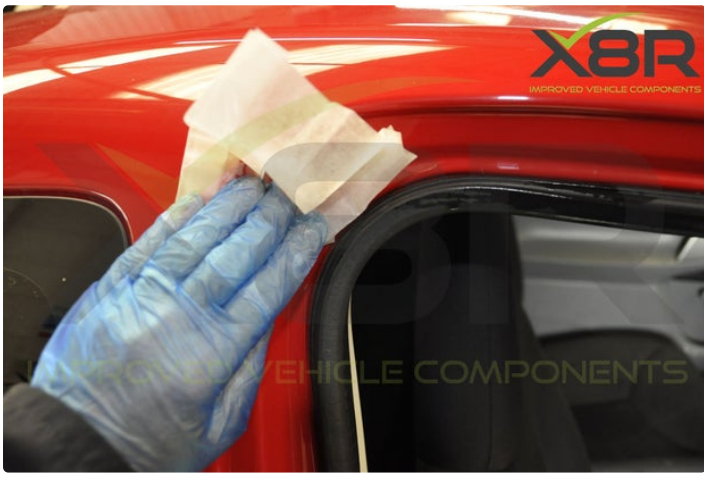
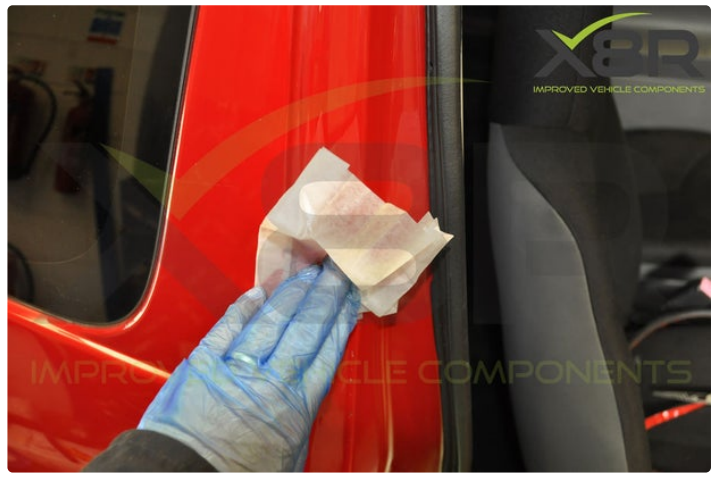
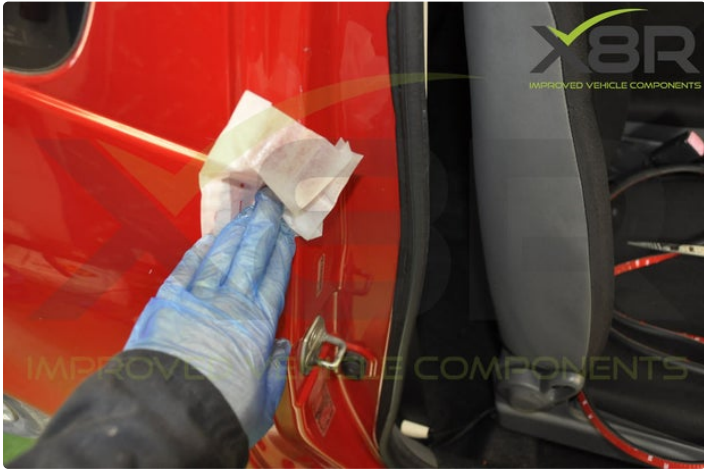
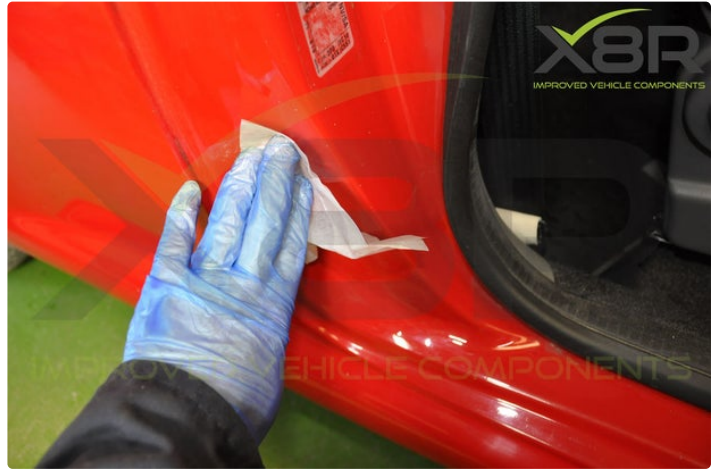
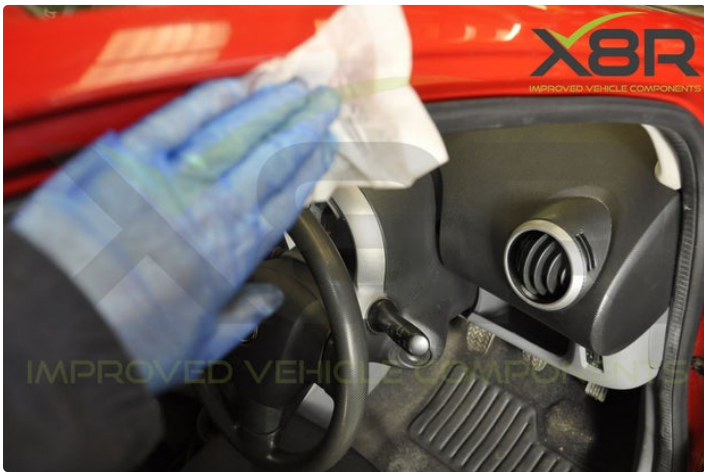
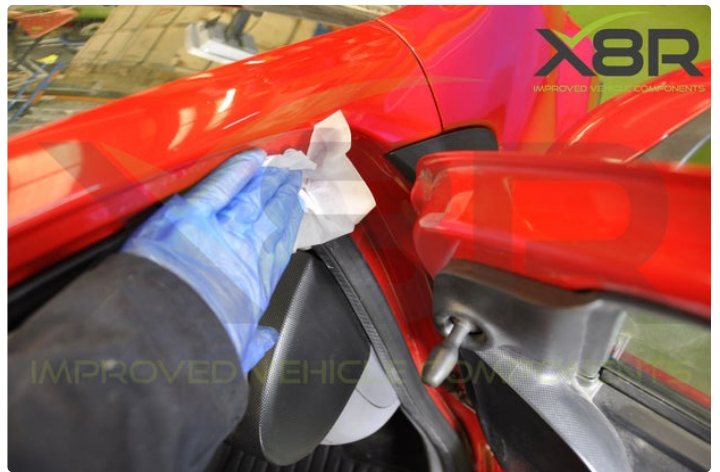
Step 2: Door Seals: Fit Door Seals

Peel back the adhesive backing paper and fit our seal in the position shown. As you work around the recess push the seal firmly in to position. If fitting in cold conditions a hot air gun can be used to make the seal more flexible.

If the seal provided is too long (doors vary slightly by model) cut down to length with a pair of scissors so that the seal finishes at the location shown.

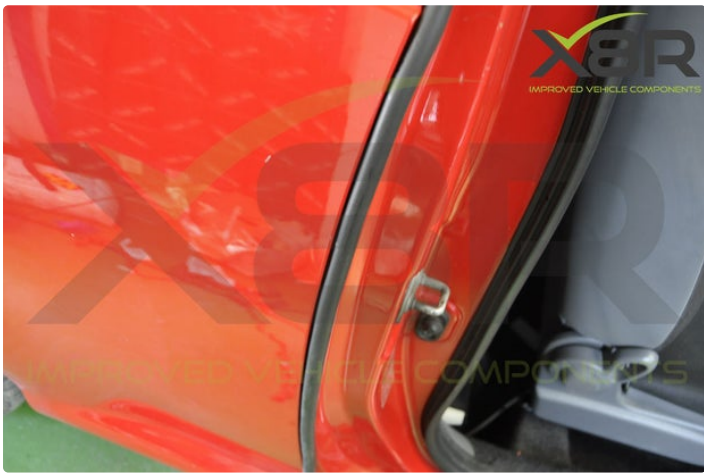
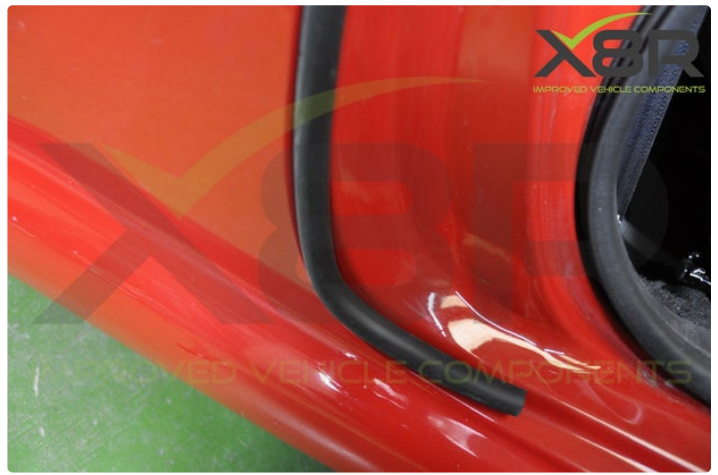
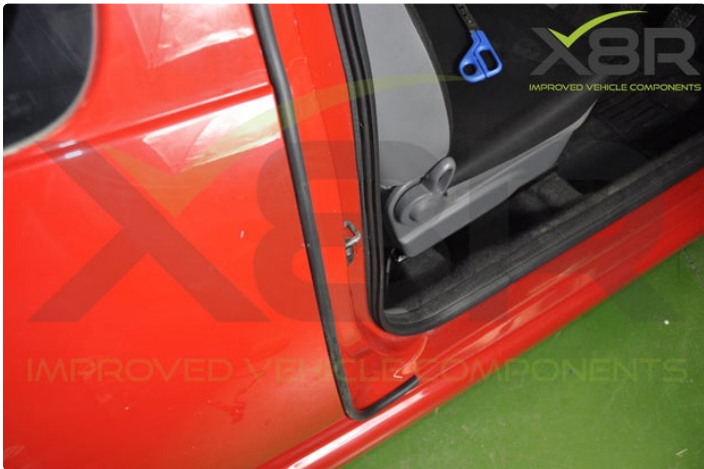
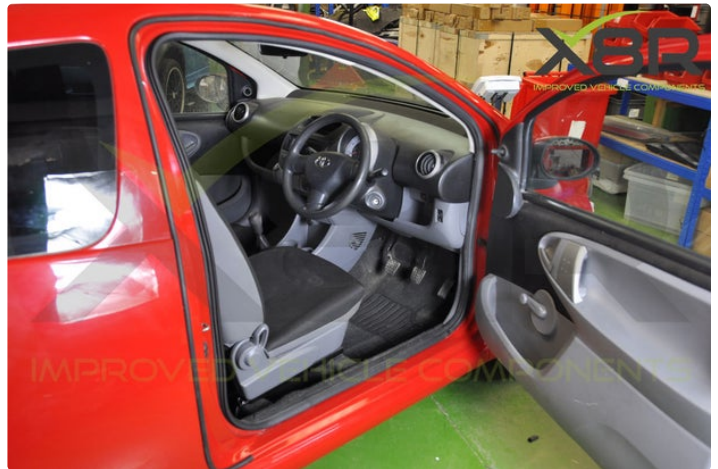
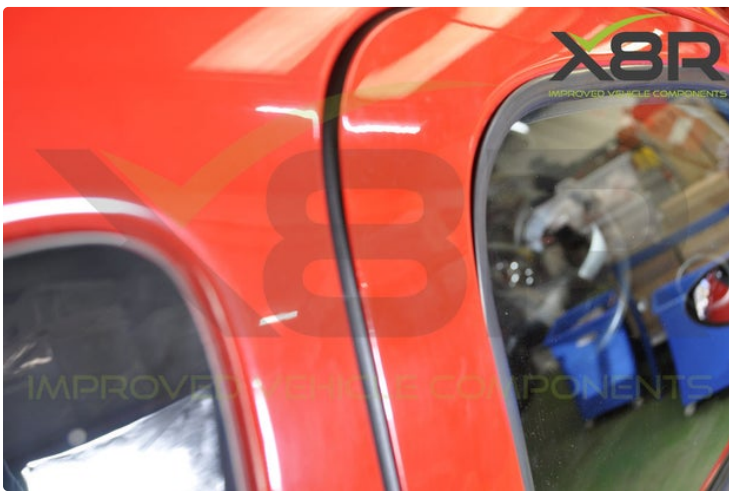
Step 3: Boot Seal Replacement: Remove OEM Seal

Cut the old seal at the location shown near the latch. Pull the OEM seal out of position and remove.

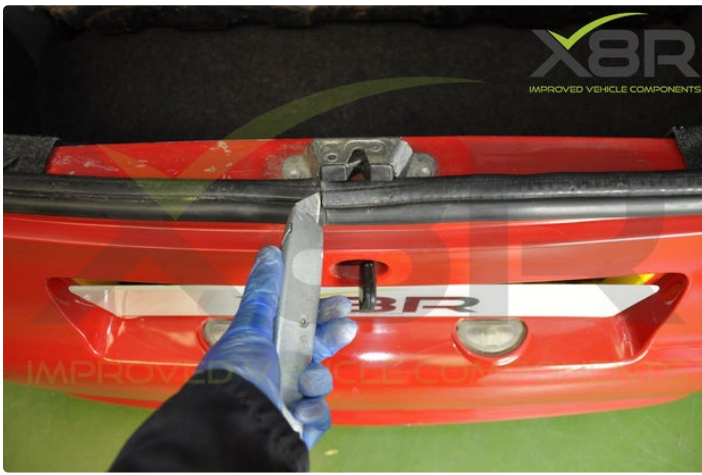
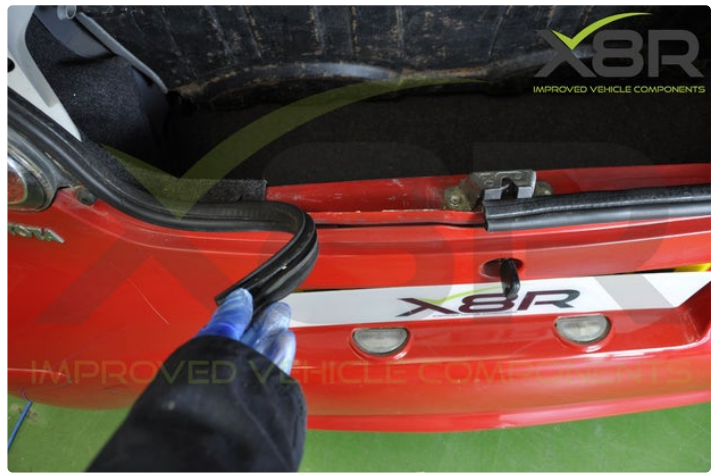
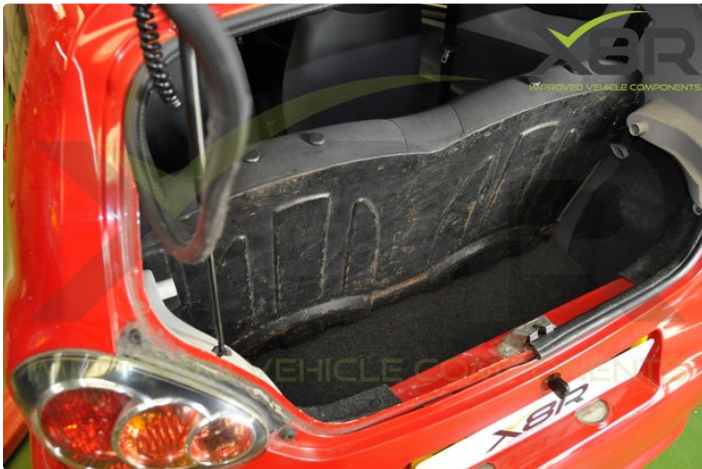
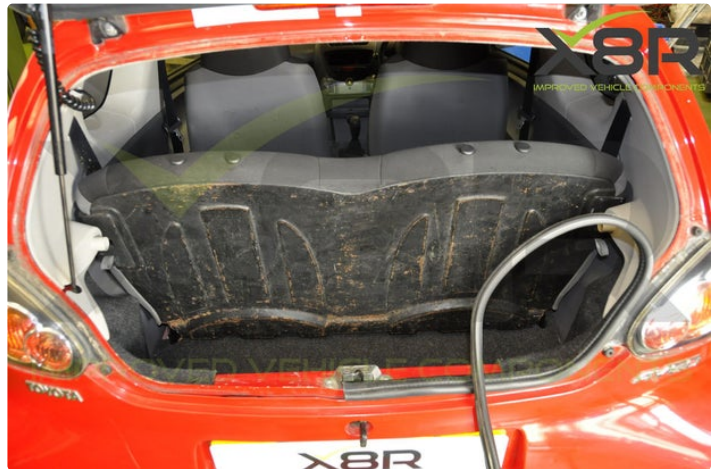
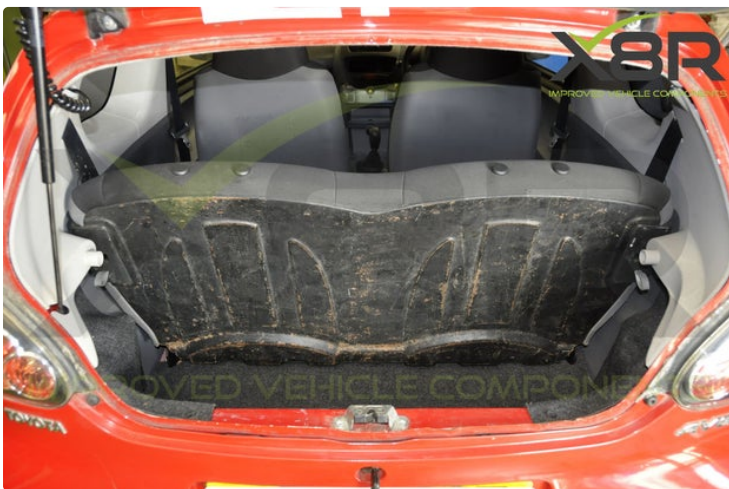
Step 4: Boot Seal Replacement: Fit Our New Seal

Push our seal in to position, our seal fits in exactly the same way as the OEM part. Start at the latch and work around, ensuring the seal is fully pushed in to the recess on the body as far as it will go.

At the end cut the seal down to length to marry up with the start of the seal.

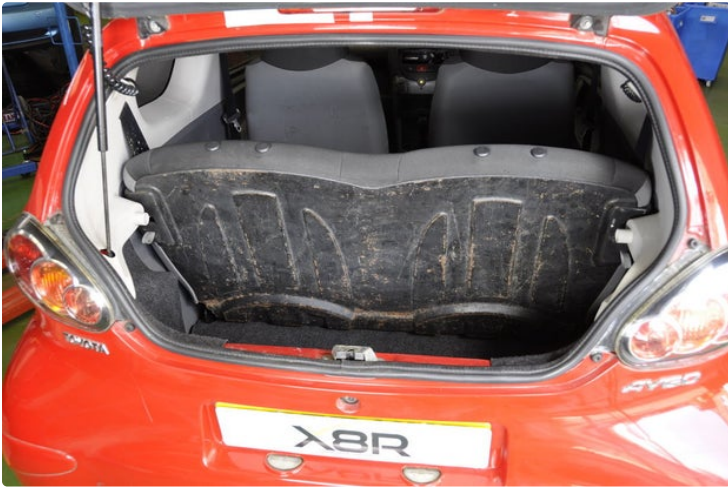
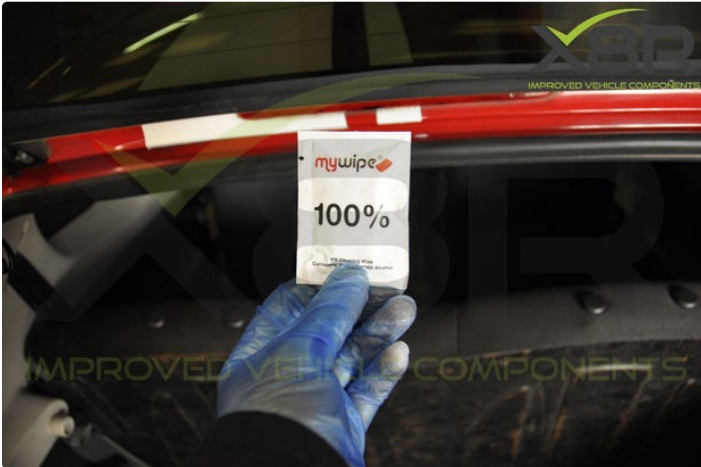
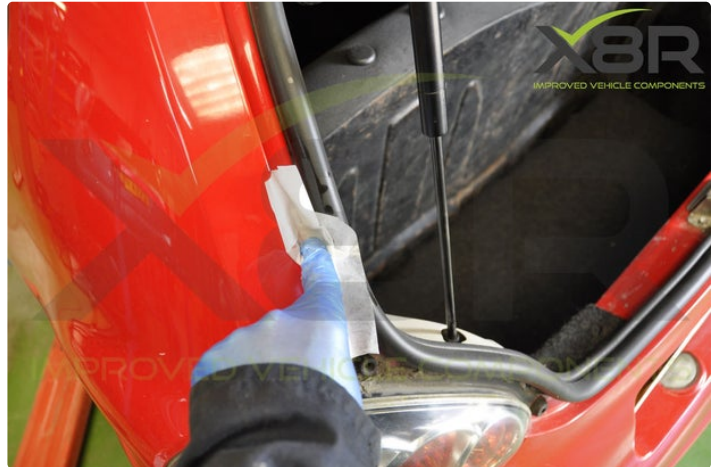
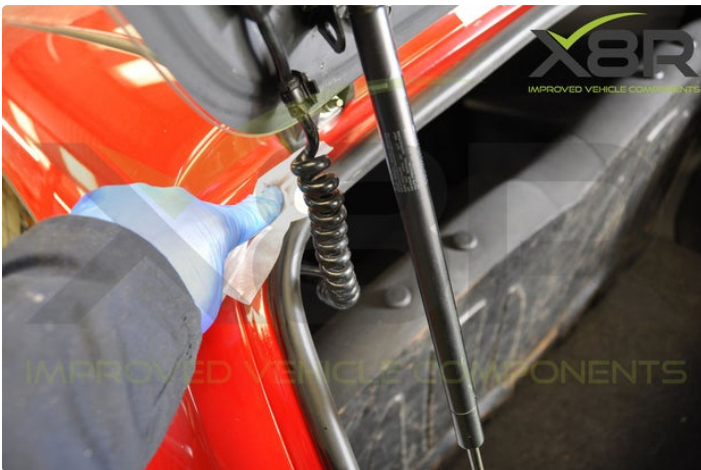
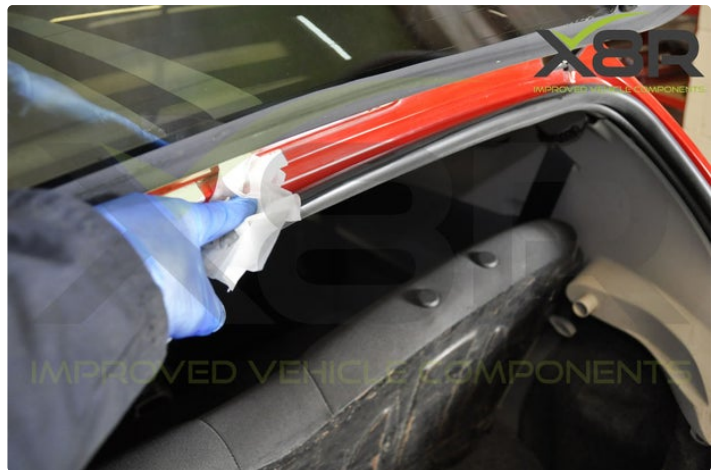
Step 5: Additional Boot Seal: Clean Up Surface

Using one of our alcohol wipes clean up the outside edge of the door recess, remove all grime / grease to ensure good adhesion of our seal.

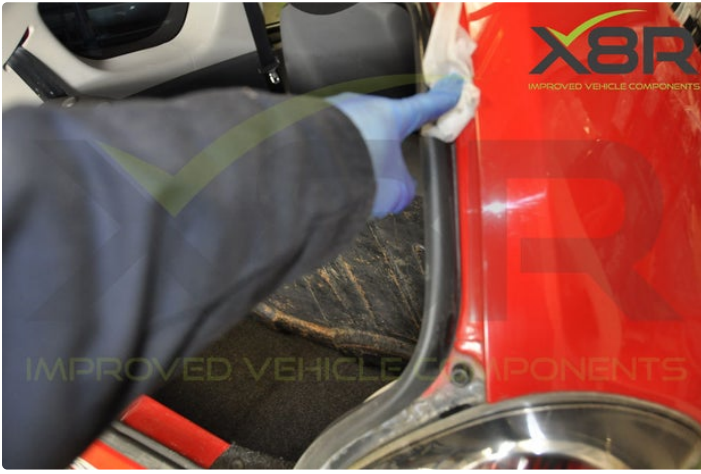
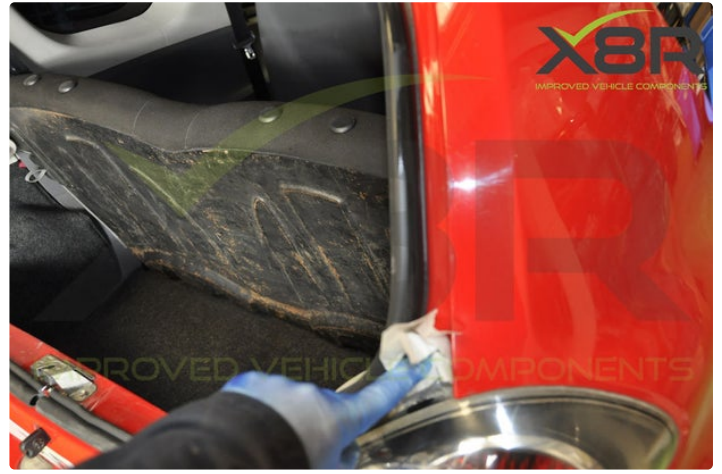
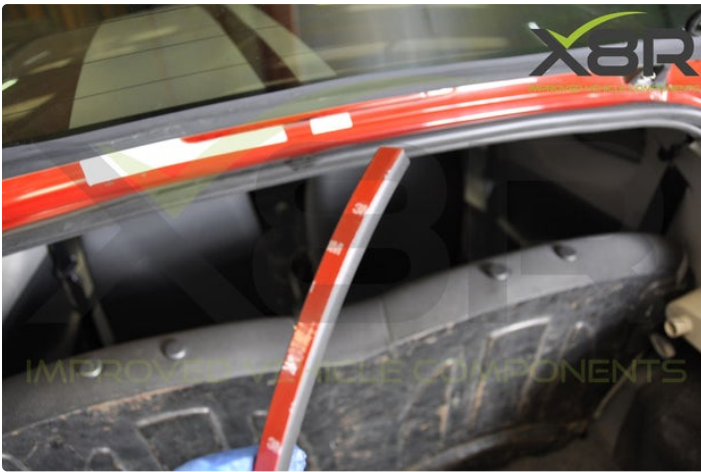
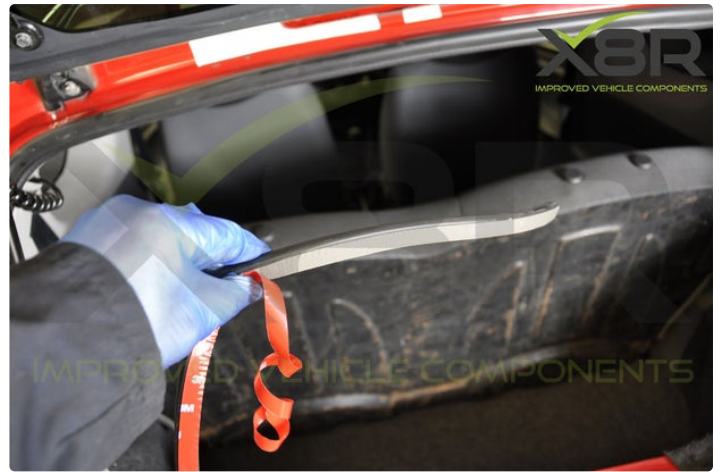
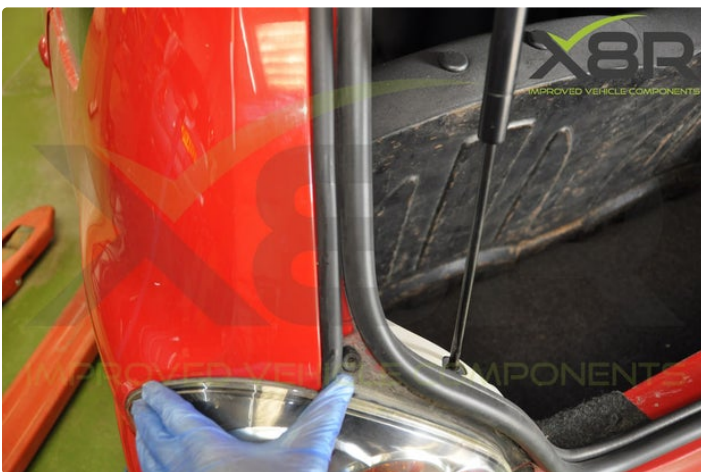
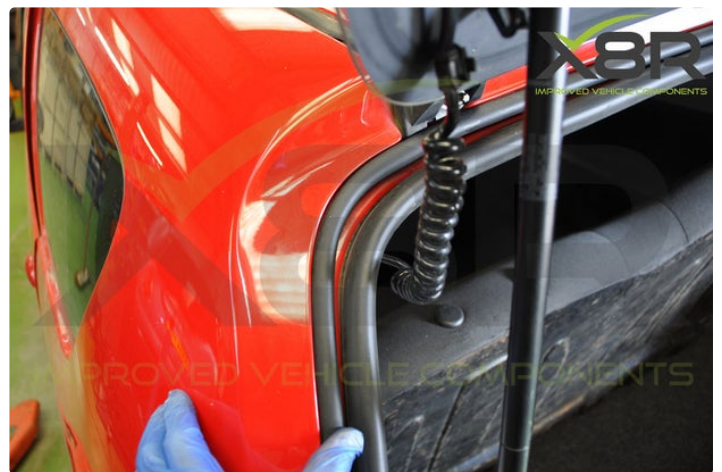
Step 6: Additional Boot Seal: Fit Seal

Peel back the adhesive backing paper and fit our seal in the position shown. As you work around the recess push the seal firmly in to position. If fitting in cold conditions a hot air gun can be used to make the seal more flexible. If the seal provided is too long (doors vary slightly by model) cut down to length with a pair of scissors so that the seal finishes at the location shown.
