## Toyota AYGO, Peugeot 107 & Citroen C1 High Level Brake Light Seal

by x8rltd

### The problem

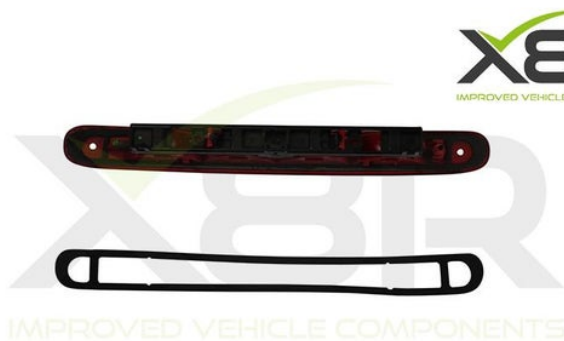
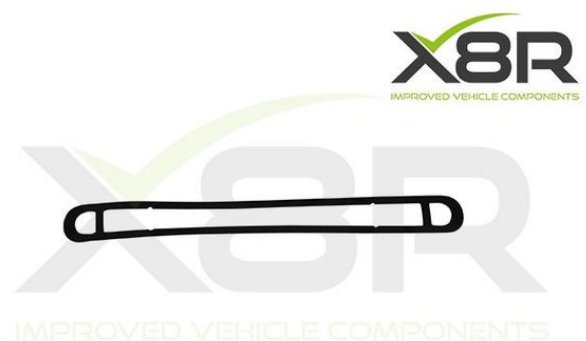
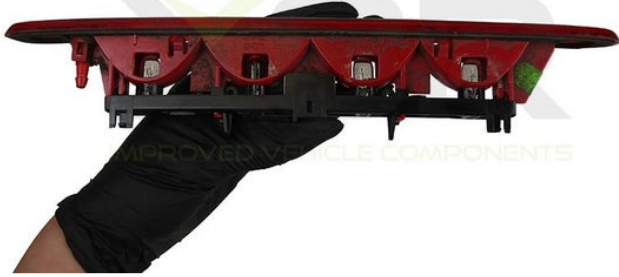
The foam gasket that the third brake light comes attached to from factory disintegrates over time due to its poor structure. This allows water to enter through the gasket and into the boot, causing puddles of water on the boot floor.

We have designed & created a new and improved high level brake light seal made of closed cell foam which is thicker than the OEM seal. It is also resistant to water to prevent leaks, and also reduces moisture & condensation entering the light unit and vehicle itself.

1 x closed cell foam high level brake light seal

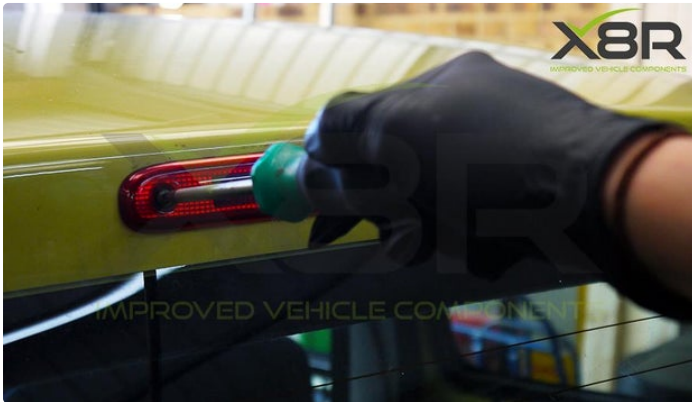
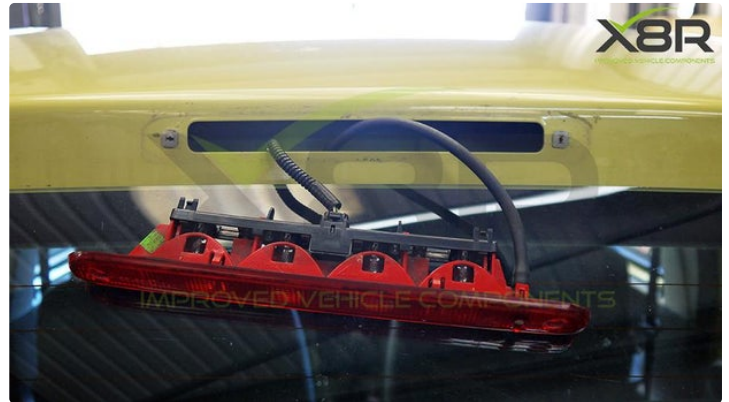
## Step 1: Remove the Brake Light From the Vehicle

Remove the high level brake light from the vehicle by using a Philip's screwdriver & removing the two screws either side of the light.

Pull the light out from the vehicle frame gently which will expose the electrical wire to the light & also the pipe to the rear windscreen washer jet. Gently remove the pipe, and disconnect the electrical connector to remove the light entirely.

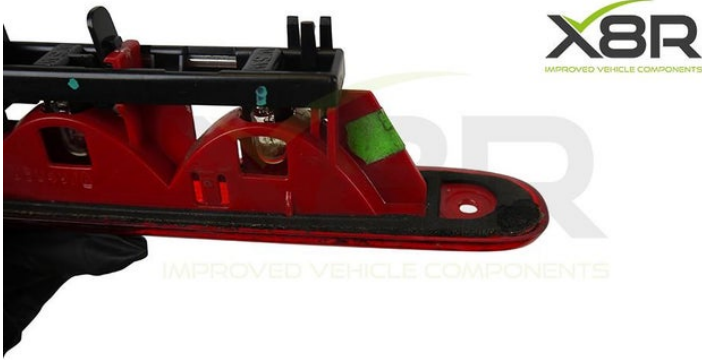
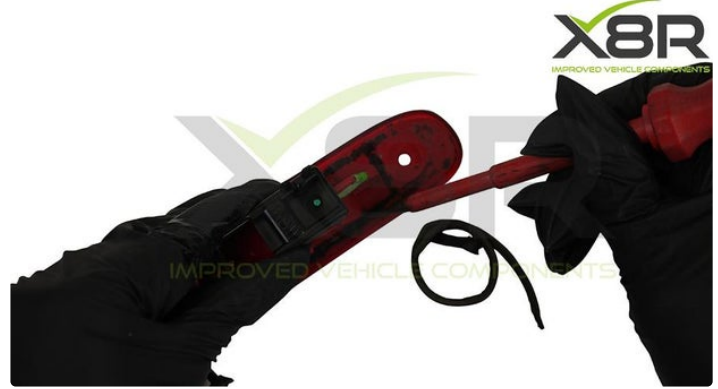
## Step 2: Remove the Old Seal

Using either a sharp flat head screwdriver or a Stanley blade, cut away at the old seal. This won't entirely remove the old seal, but should remove most of the old foam.

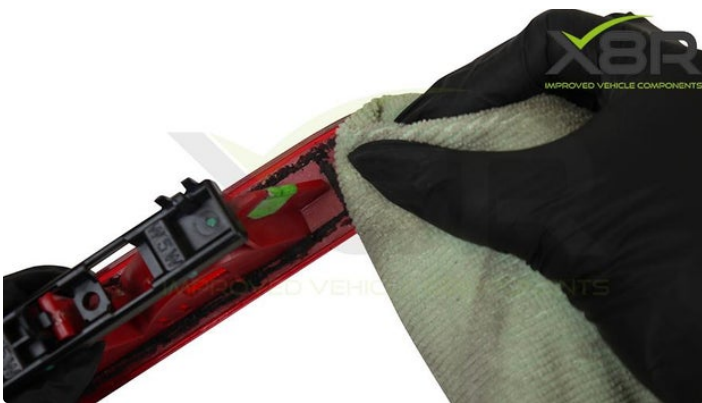
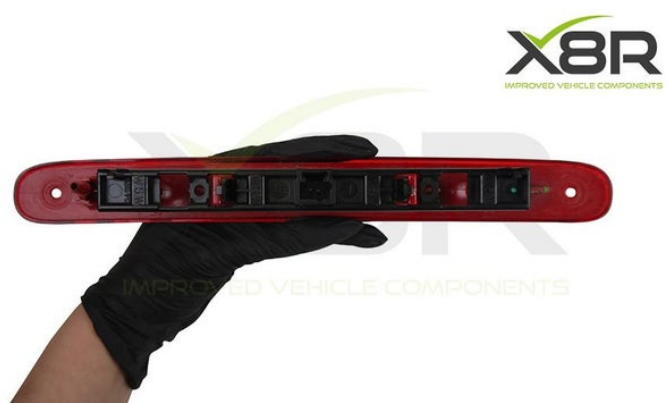
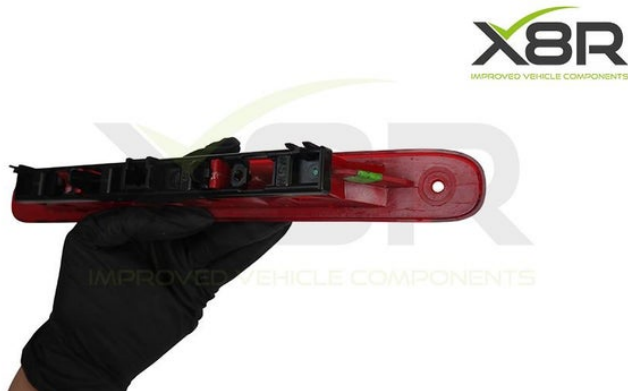
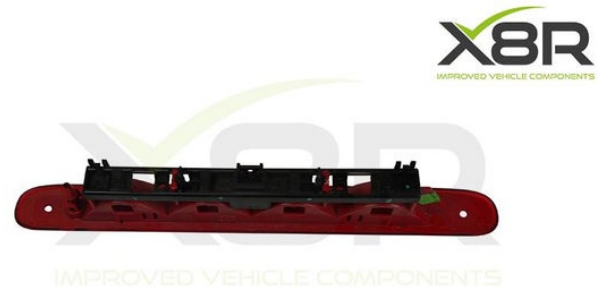
### Step 3: Clean Up the Light

Using tar and glue remover (either a spray can or liquid on a microfiber), start scrubbing at the remainder of the old foam and adhesive. This may take a few minutes & some elbow grease. Make sure the lighting unit is as clean as possible to ensure that the new seal sticks to it.

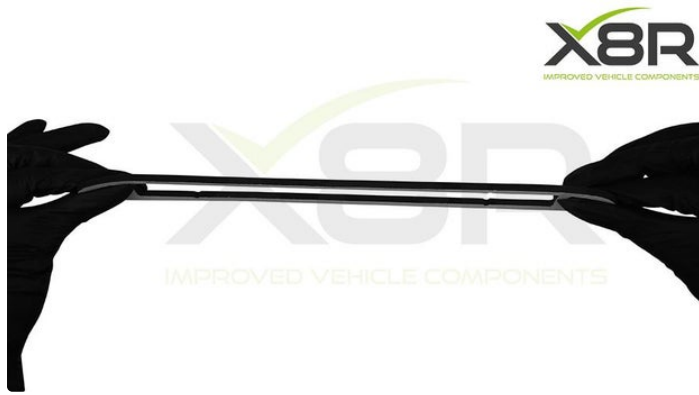
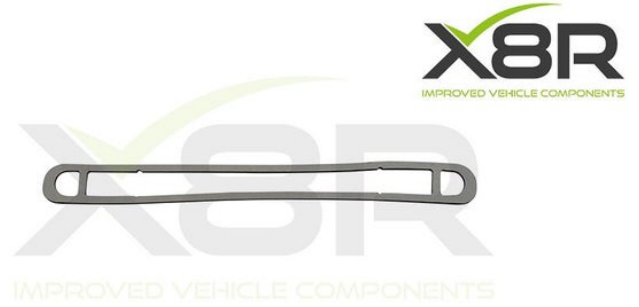
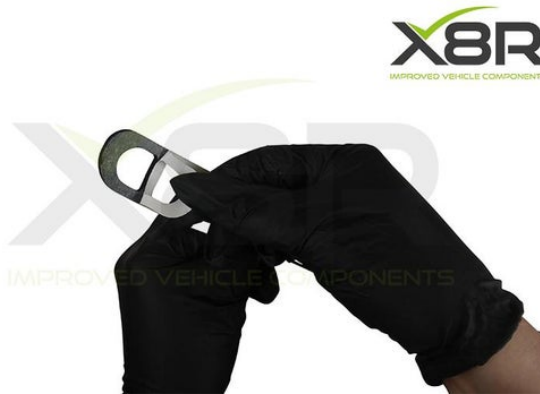
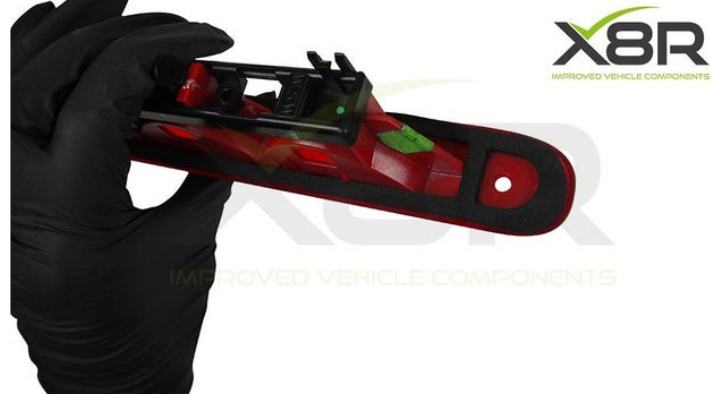
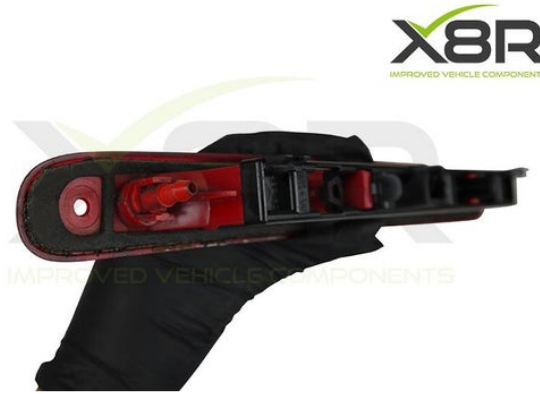
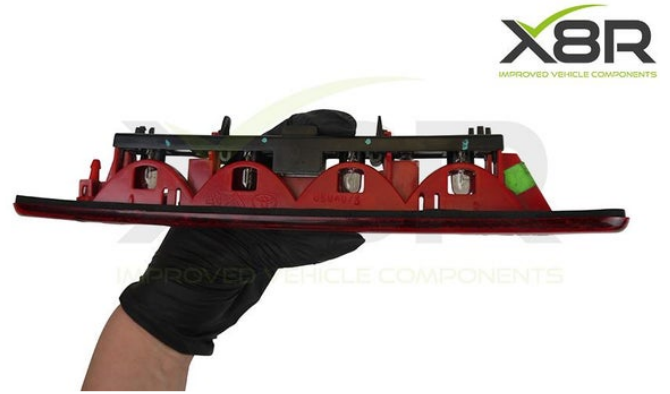
### Step 4: Bond the New Seal

Remove the self-adhesive backing from the new seal. Line it up carefully to the light (ensure it is the right way round, it is not perfectly symmetrical), once sure that it lines up then firmly attach it to the light. Press it down and hold for a few seconds.

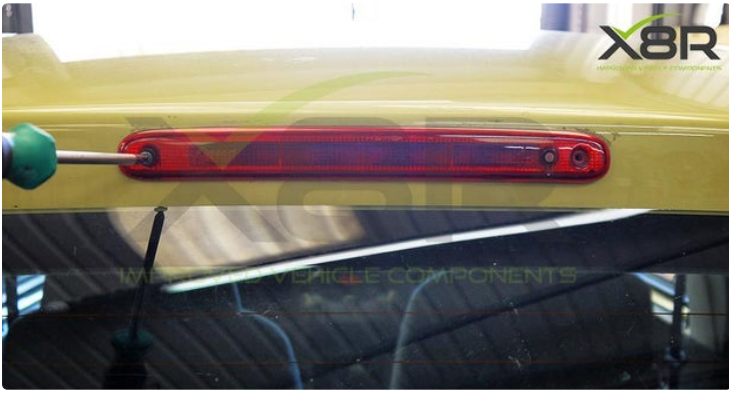
## Step 5: Fit Back on the Vehicle With New O-Ring

Remove the washer jet nipple from the lighting unit by prying a small flathead screwdriver in the joins it, this will cause it to pop off. Remove the original black O Ring and replace with our new Viton O ring.

Apply a small amount of RTV sealant to the foam seal and around the screws (as water can also enter through the screw holes). Attach the light back onto the vehicle with the screws and wipe away any extra sealant.

Attach the washer jet pipe & connect the electrical connector back onto the light.
