## Renault ABS Sensor Plate 40mm & 45mm

by x8rltd

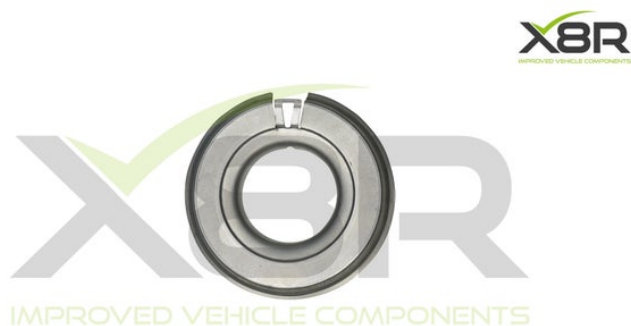
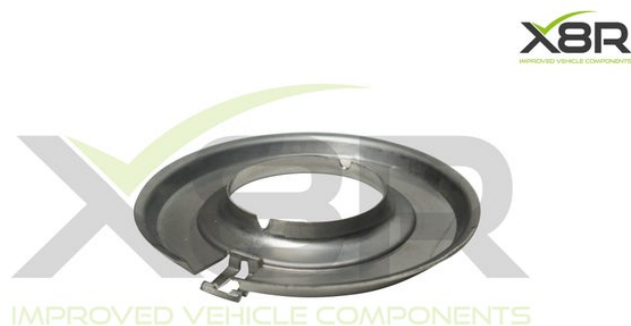
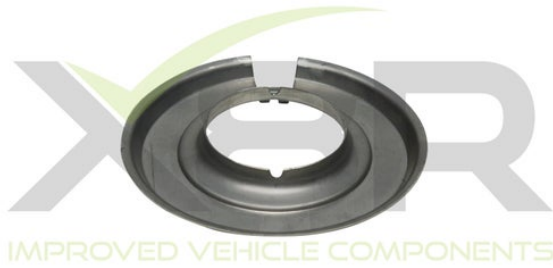
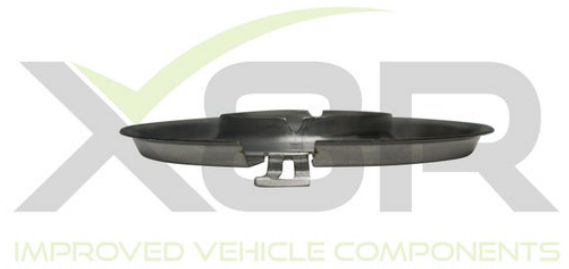
Our ABS plates are a much more cost-effective solution to this common and simple issue. We have designed & created our own plates out of marine grade stainless steel to prevent any corrosion like the original unit. They also have two indents for spot welds, this is because the knuckle itself may have surface corrosion, affecting a secure fit for the new ABS plate, if this is the case then you can spot weld it into place so the ABS sensor does not become lose.

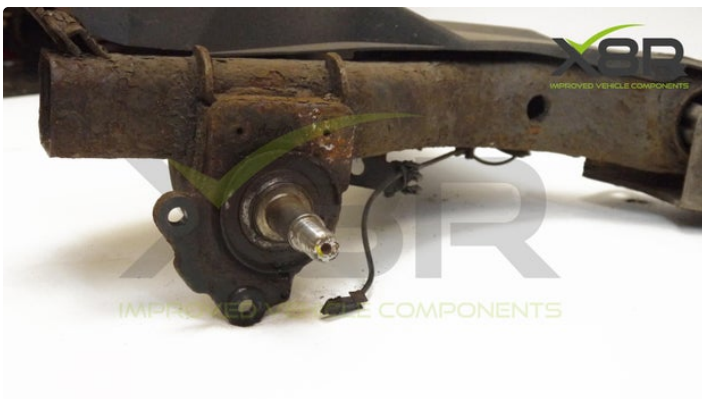
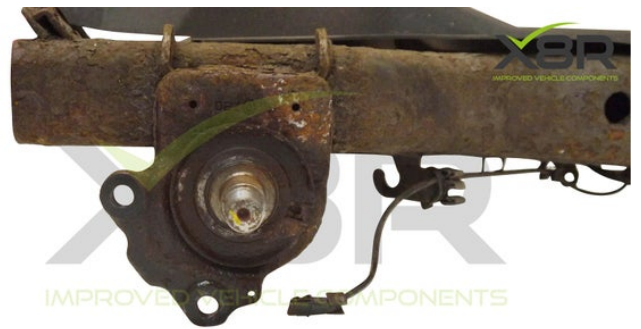
## Step 1: Get Prepared

Remove the wheels, brake caliper & disc from the vehicle to expose the steering knuckle & spindle where the original ABS plate is (or was, if the plate has disintegrated). Remove the ABS sensor from the plate if necessary.

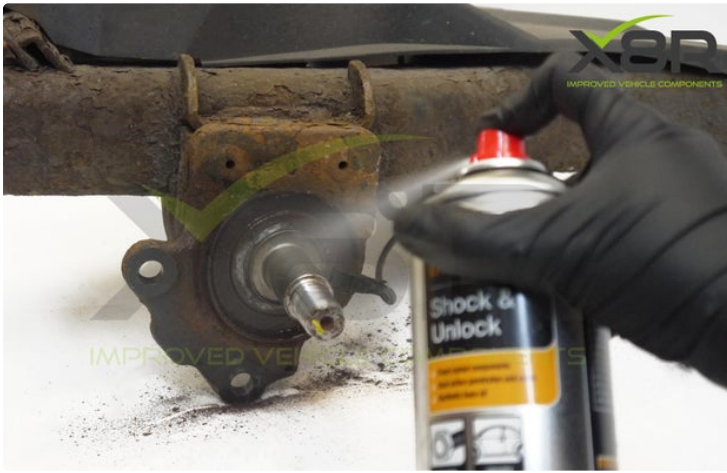
## Step 2: Apply the Penetrating Spray

Apply the penetrating spray generously to the plate and leave to soak for 1-2 hours. This will loosen the plate and make it easier to remove.

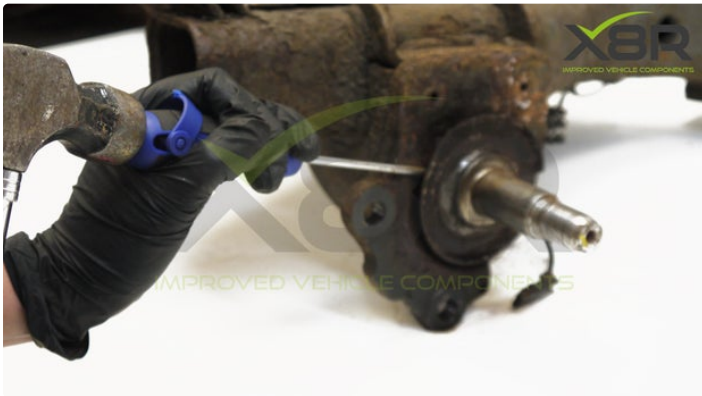
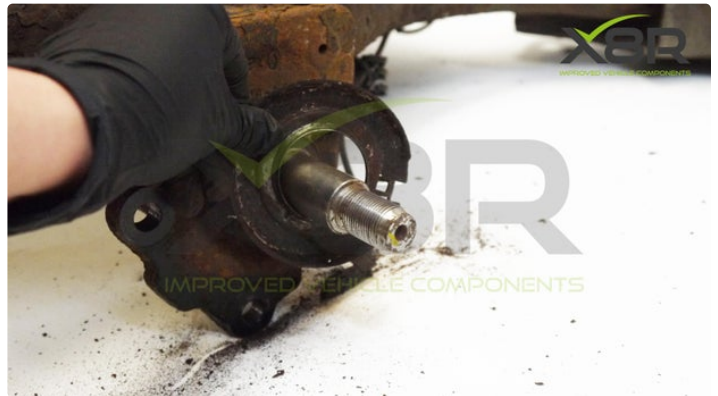
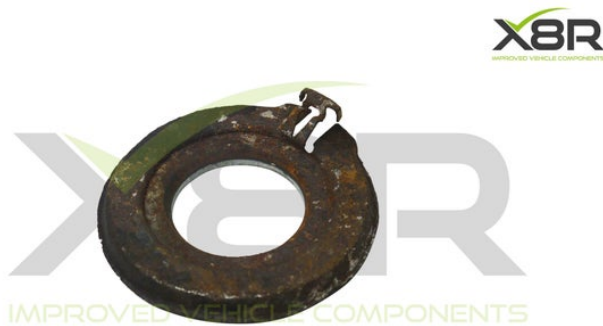
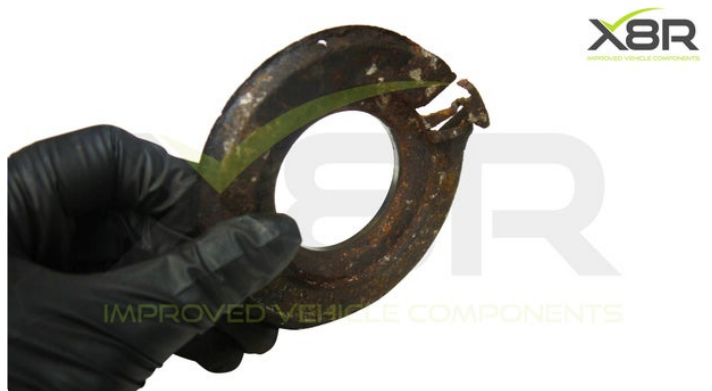
### Step 3: Remove the Original Plate

Using the flat head screwdrivers/chisel & hammer, start tapping around the outside of the plate. Be sure to go around the whole circumference. We found it easier to start with a larger screwdriver and then go in with a smaller screwdriver after.

Once the plate is completely loose, remove it from the

spindle.

If you are struggling to remove the original plate, you can use a blow torch or heat gun to aid the process. It may be stuck firmly due to the corrosion on the knuckle & plate.

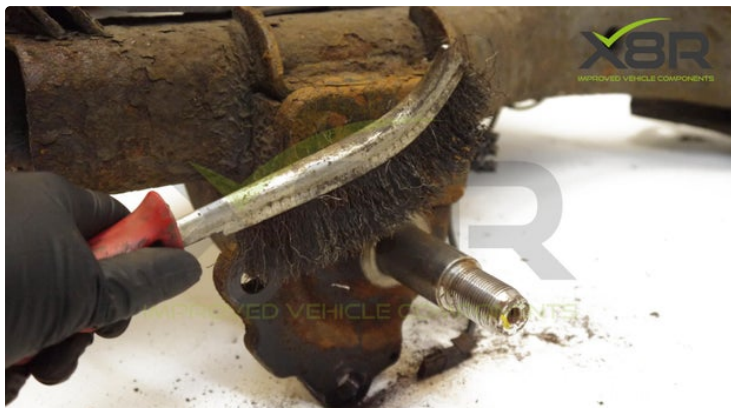
## Step 4: Wire Brush the Area

Using a wire brush, brush down the knuckle & spindle area of any surface corrosion. Try to be as thorough as possible so the new plate can fit flush to the knuckle.

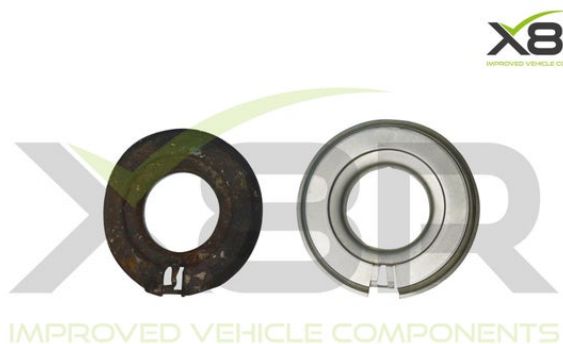
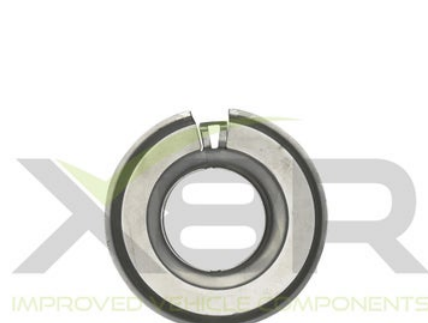
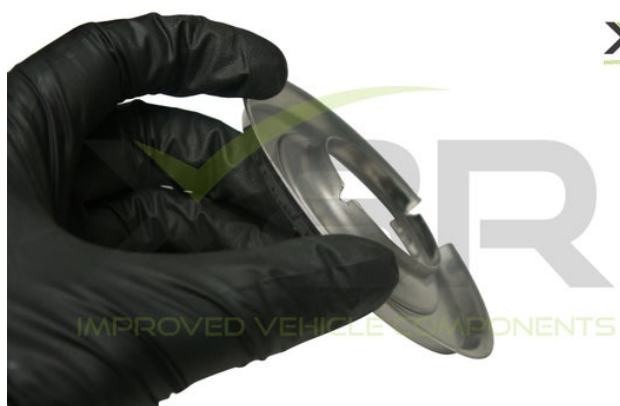
## Step 5: Apply the New ABS Plate

Place the new ABS plate over the spindle, ensuring the connector for the sensor is in the correct position. The new plate should fit flush & firmly to the knuckle. If it doesn't, we recommend using a spot welder to join it to the spindle. There are two cut outs on the centre of the new plate specifically for spot welding (if necessary).

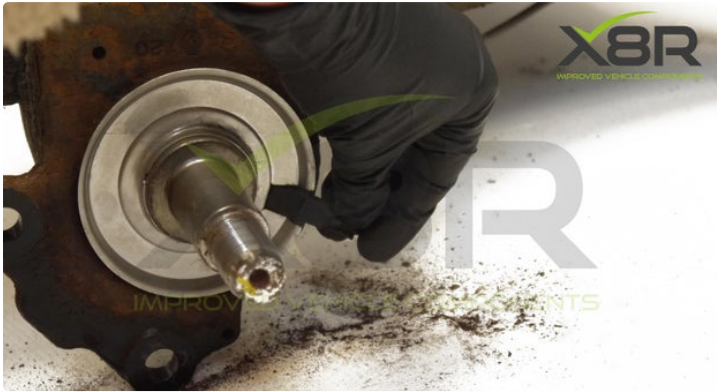
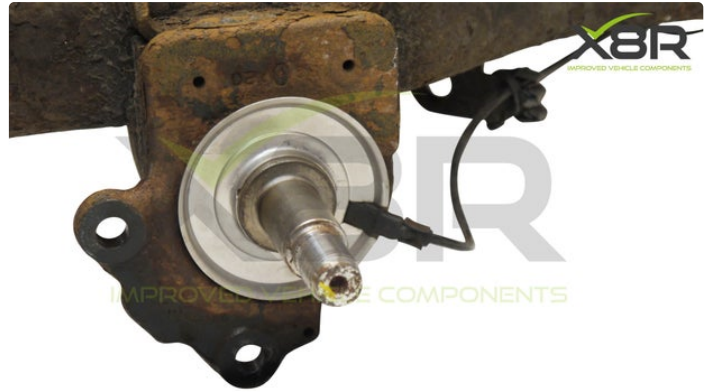
## Step 6: Connect the ABS Sensor

Connect the ABS sensor to the connector on the new plate and rebuild the vehicle. The car may need to be plugged into a diagnostic machine to clear the ABS fault on the dashboard.
