# Pierburg Intake Inlet Manifold Swirl Flap Blank Blanking Removal Repair Kit De-flap Kit Caps Delete Bungs

## The Problem

**Our solution**

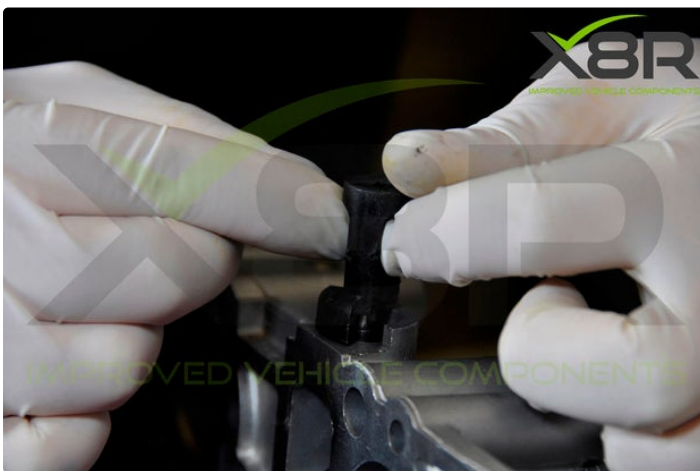
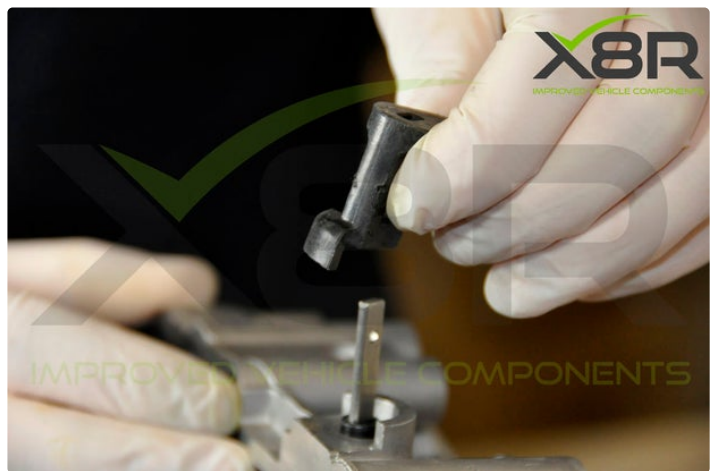
## Step 1: Remove the Swirl Flap Actuator Arm

- On the the underside of the intake manifold pry back the two tabs as shown and lift off the plastic part.

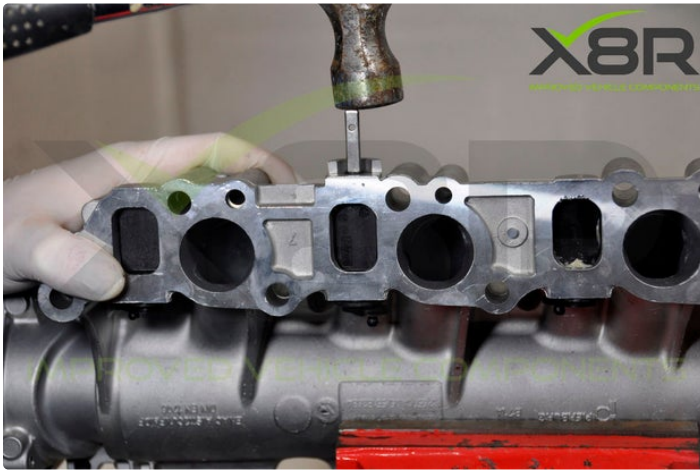
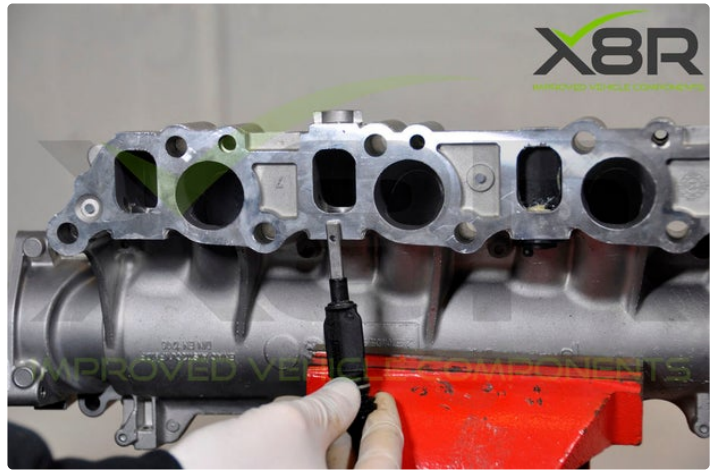
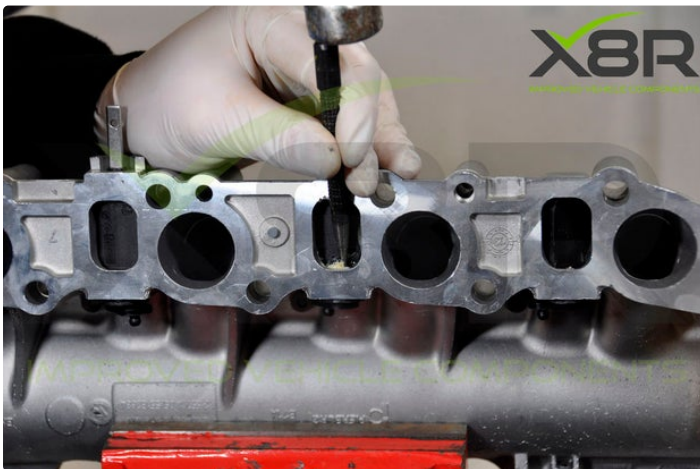
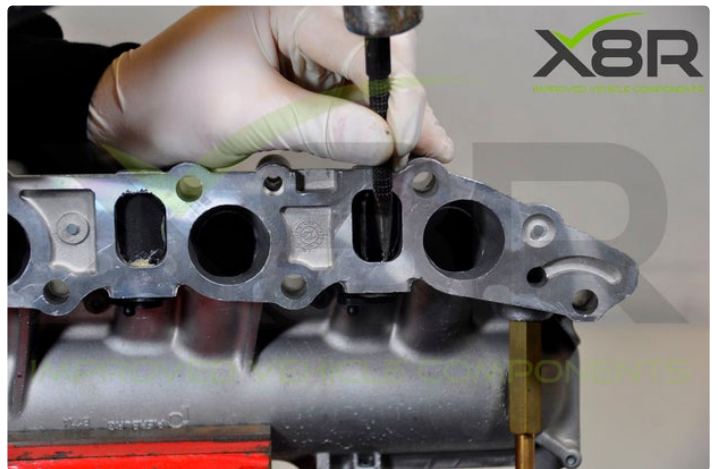
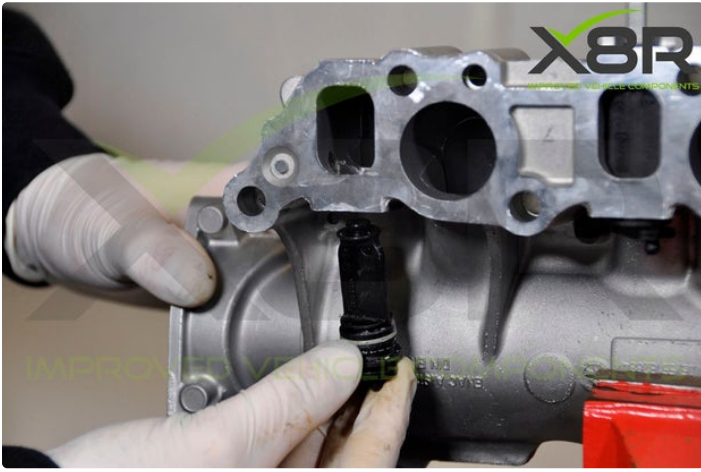
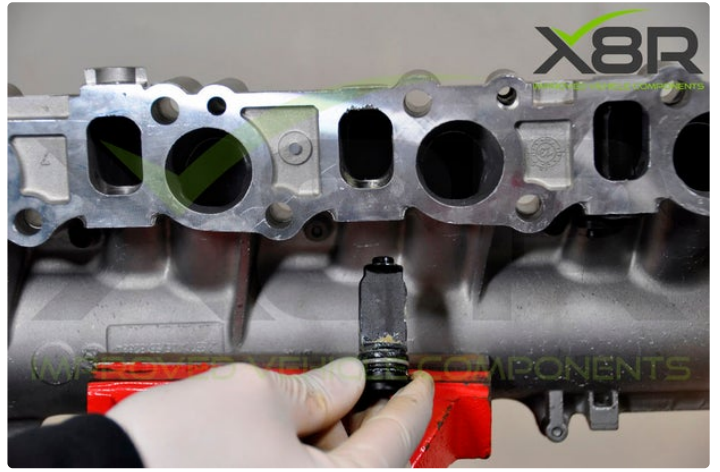
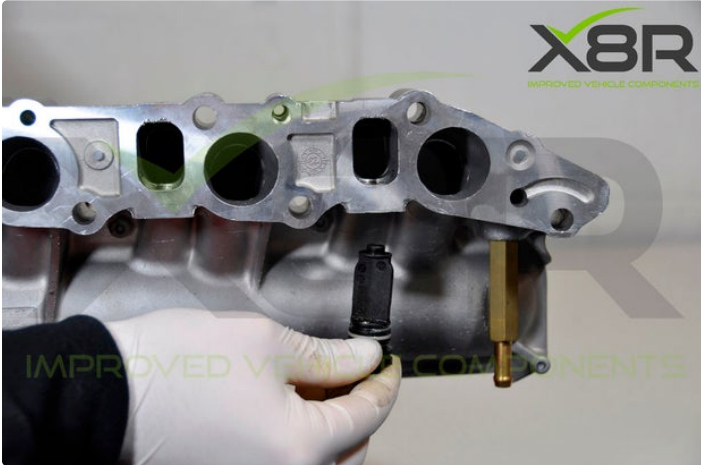
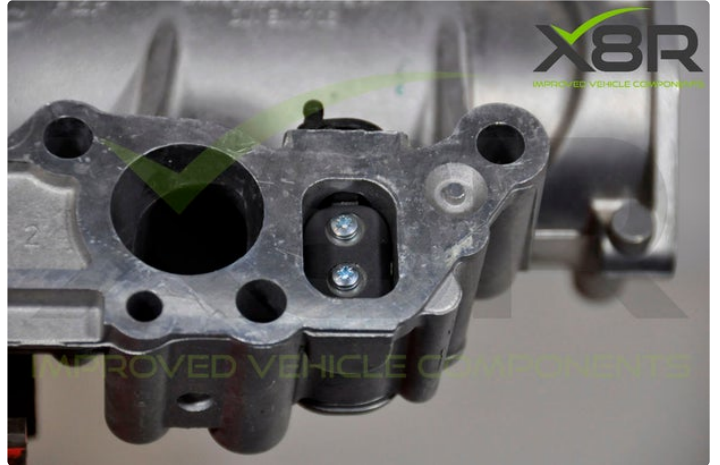
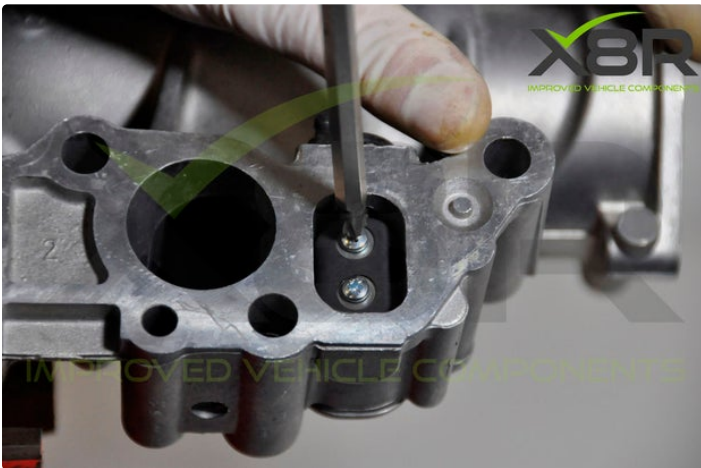
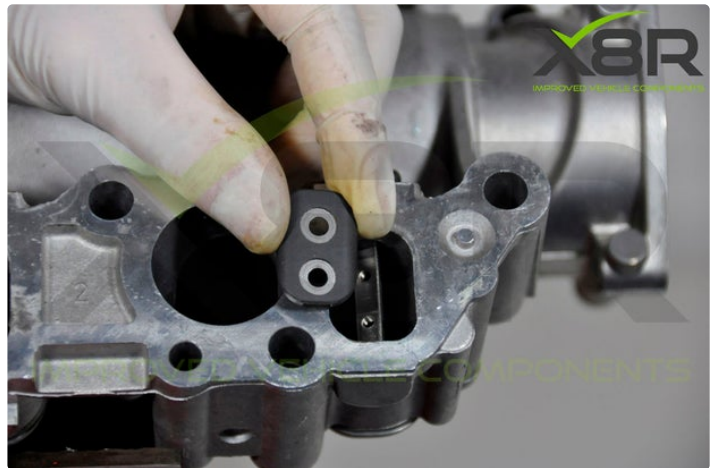
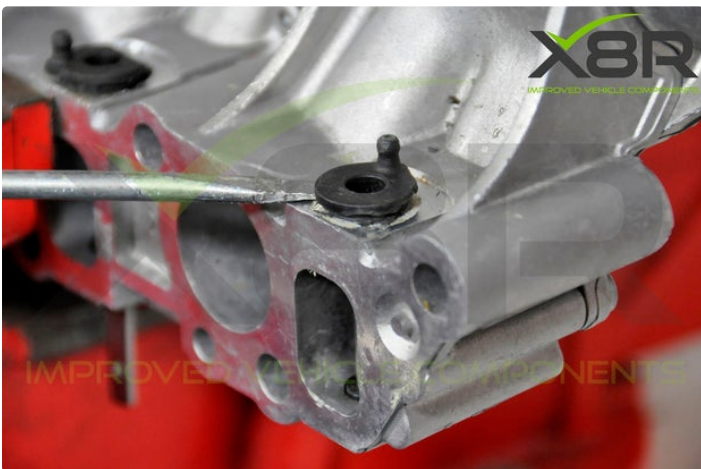
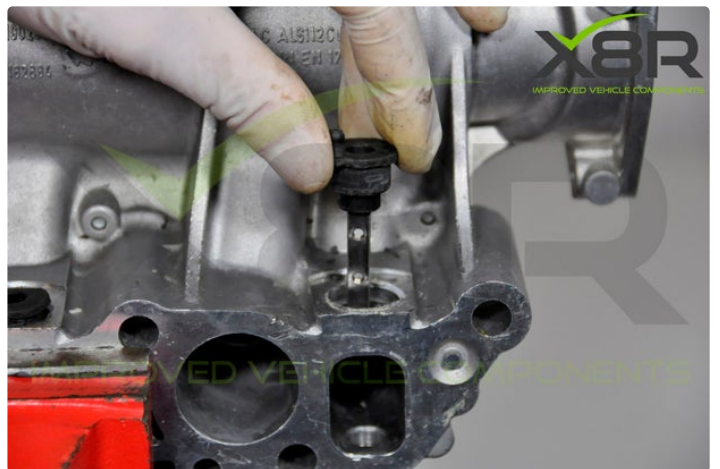
## Step 2: Remove the Swirl Flaps

**Newer design intake manifolds with part numbers: 55210202, 55210201, 2.03462.03, 2.03462.02:**

- Using a small punch, tap out the old swirls - you may have to tap out the swirls in different positions to allow the swirls to be removed from the manifold.

**Older design intake manifolds with part numbers: 55206459, 55190238, 55194739, 55206460, 2.03462.01, 2.03462.00:**

- Unscrew the two screws on the flap and remove the flap.
- To remove the remnants of the swirl flap insert a pry tool or flat headed screwdriver under the outer part of the swirl flap and lift up.
- If the swirl doesn't want to lift out; twist the swirl and try again.
- Repeat process for all swirl flaps.
- **Clean the inlet manifold of all soot/oil making sure the 5 holes are clean and free of grease.**

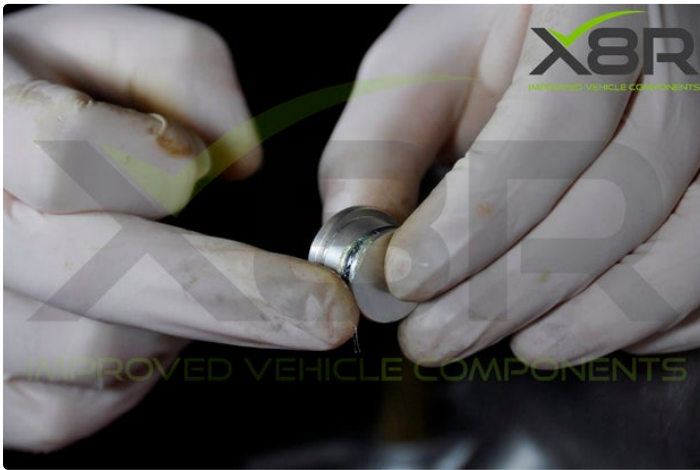
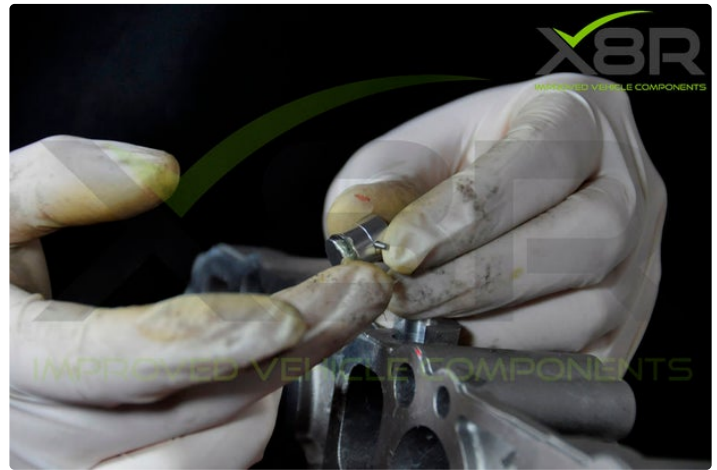
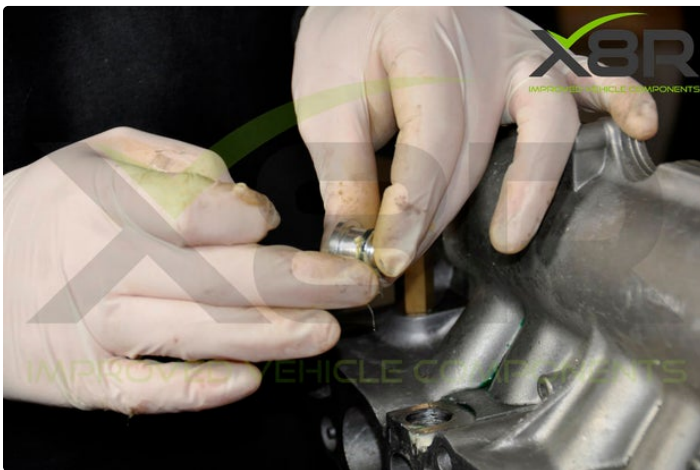
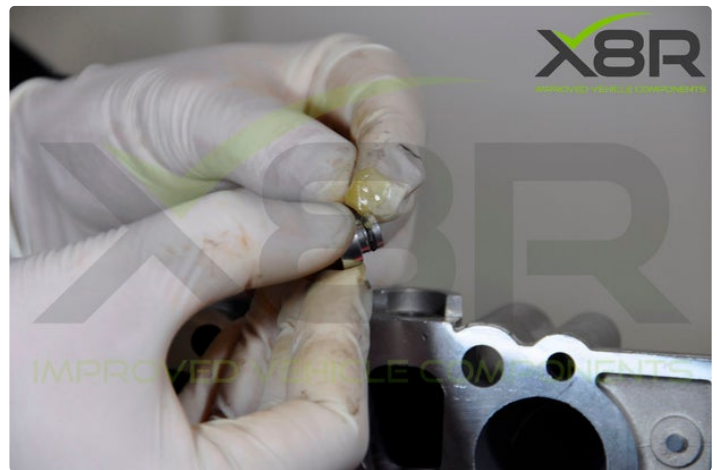
### Step 3: Test Fit Swirl Fap Blanks Before Fitting

- Before gluing the swirl blanks; apply a small amount of grease to the o-ring on the blanks and test fit. The O-rings are designed to be a tight fit (based on normal wear) take care not to damage the o-ring seals. Do not force in but ease in a little at a time, varying the angle to ensure the o-ring seals and doesn't bind.

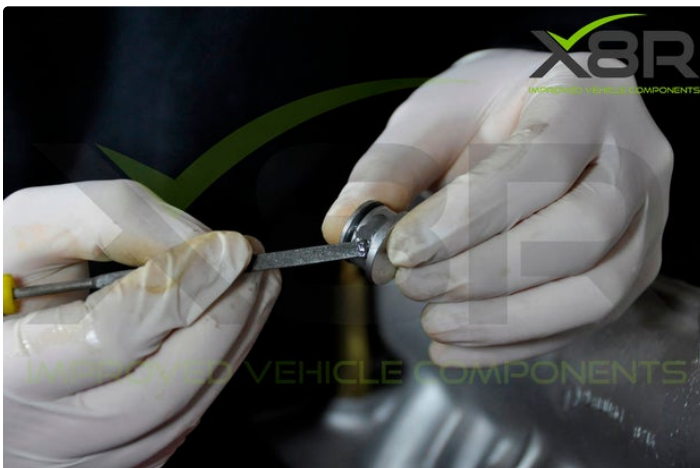
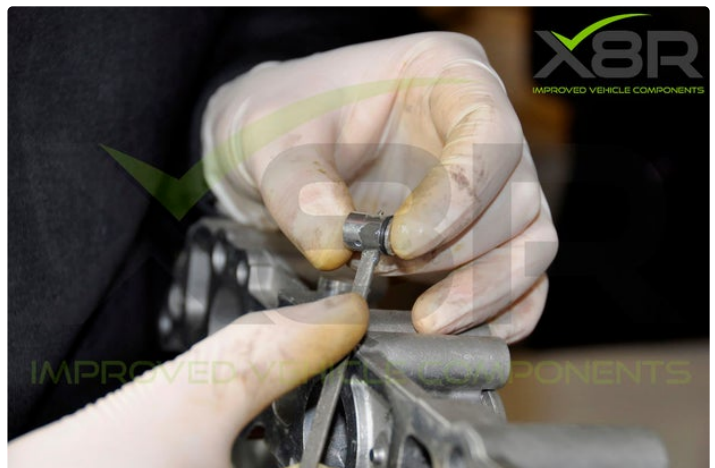
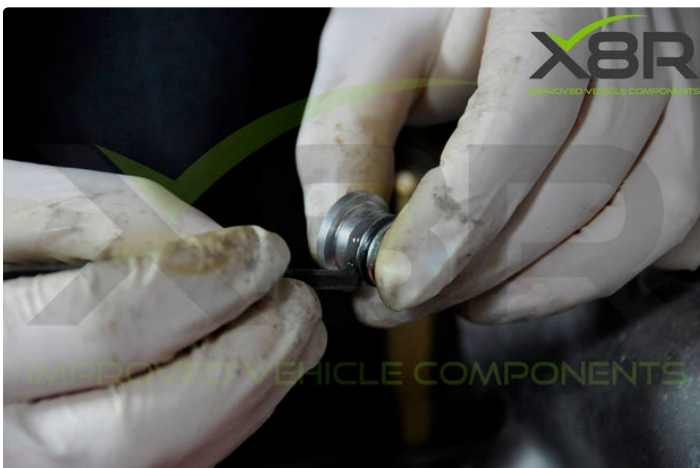
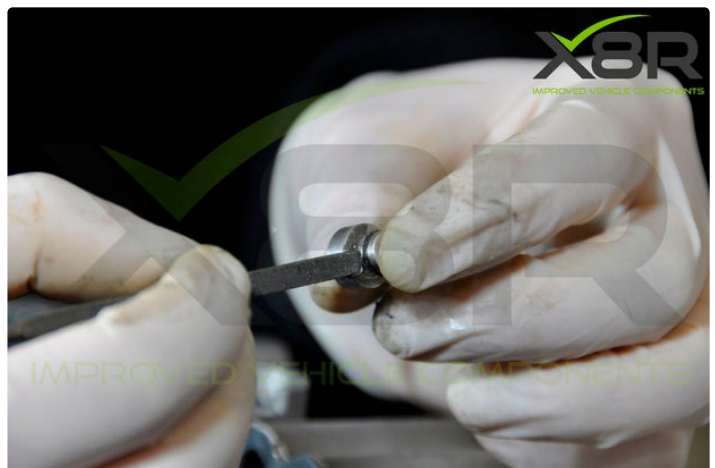
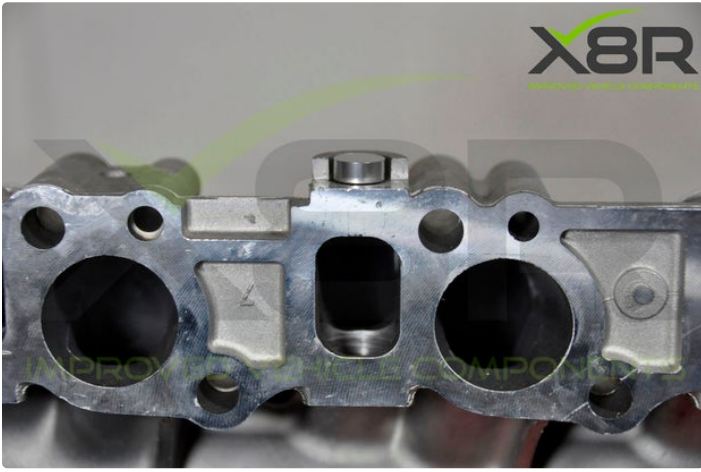
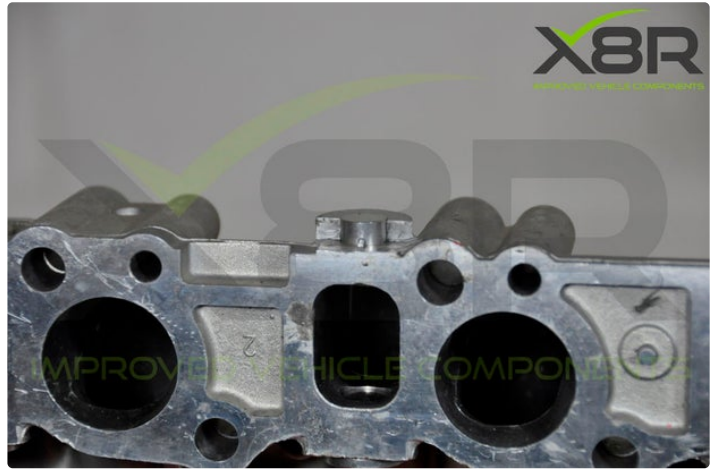
### Step 4: Glue the Blanks in Position

- Once you are satisfied the o-rings have been shaped and are sealing correctly. Using the adhesive supplied apply evenly around the blanks, keeping to the metal surface area of the blanks and avoiding the o-ring seal.

- Press the blanks into the holes.
- Please follow the adhesive instructions included with our product for mixing and curing times.
- When refitting the intake manifold the flap actuator motor should remain fitted as well as the electrical connection but the lever arm should be disconnected. This enables the ECU to identify that the motor is functioning correctly and should not cause any error lights to show up on the vehicles dashboard.
