BMW Steering Rack Tool Kit

by x8rltd

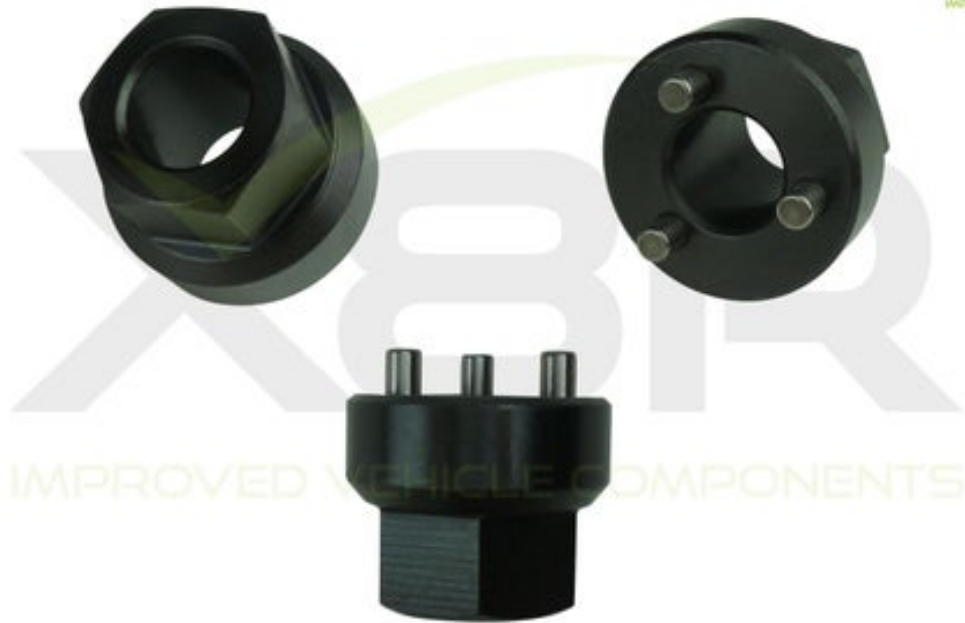
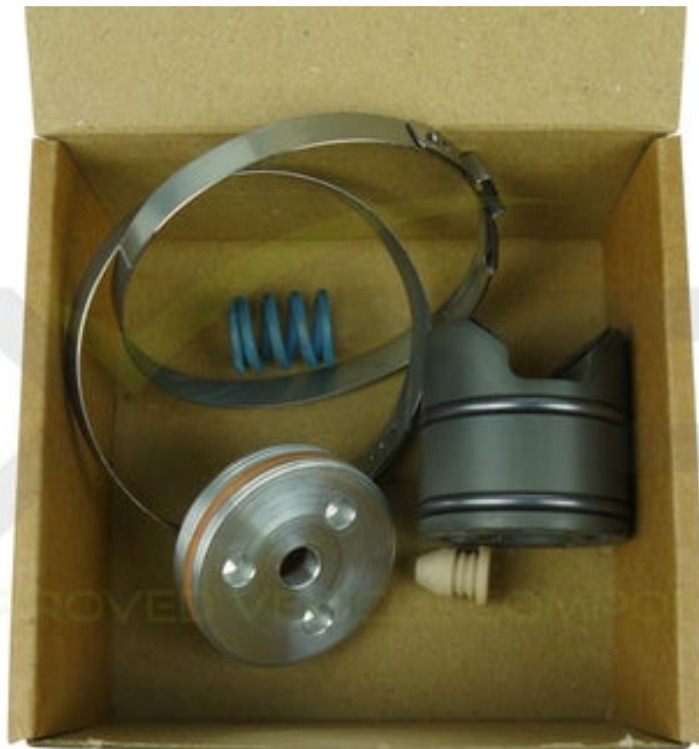
You will receive

1 x BMW & Mercedes Steering Rack Socket

1 x BMW OEM bush repair kit equivalent to 32106891974

1 x Tube of OEM BMW steering grease equivalent to 83232208093

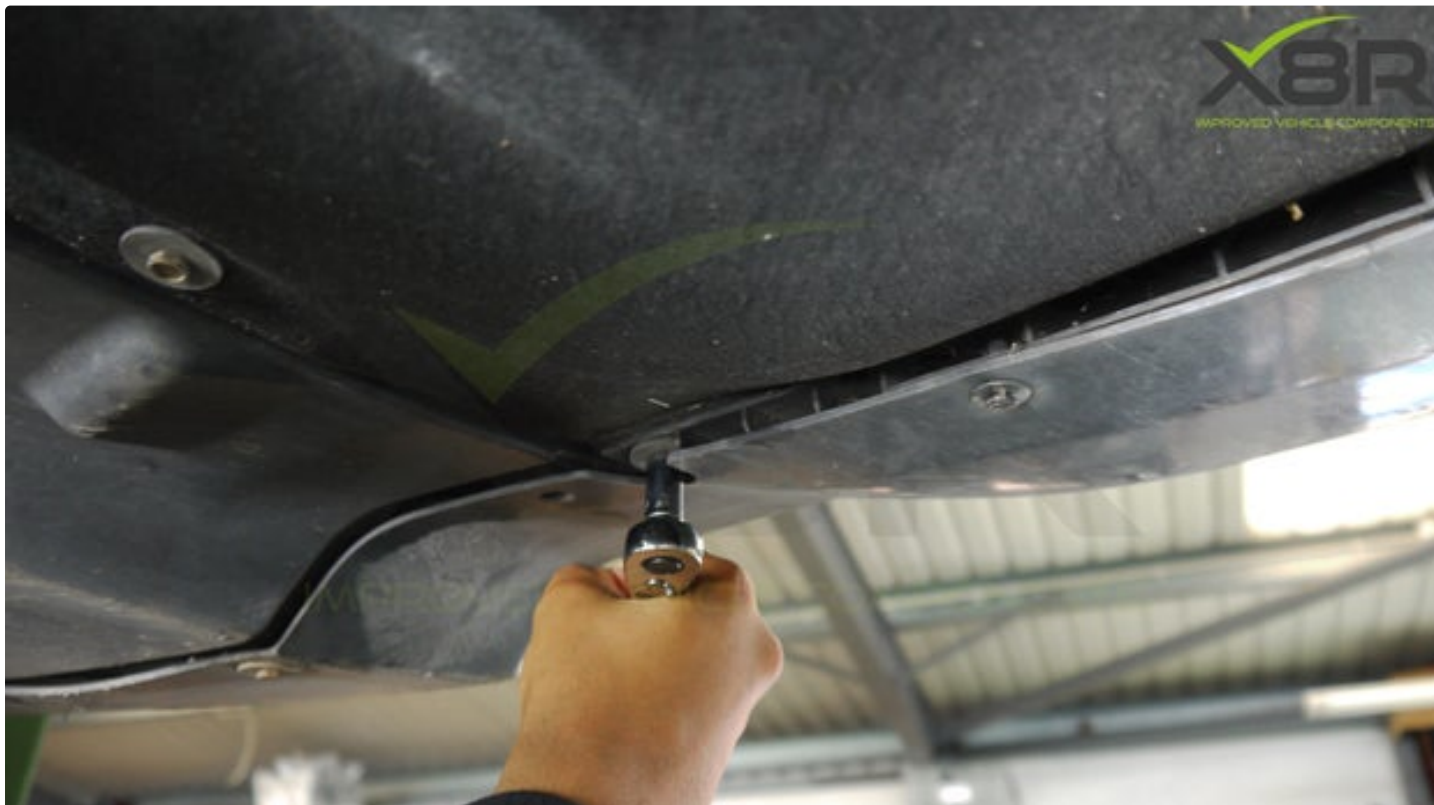
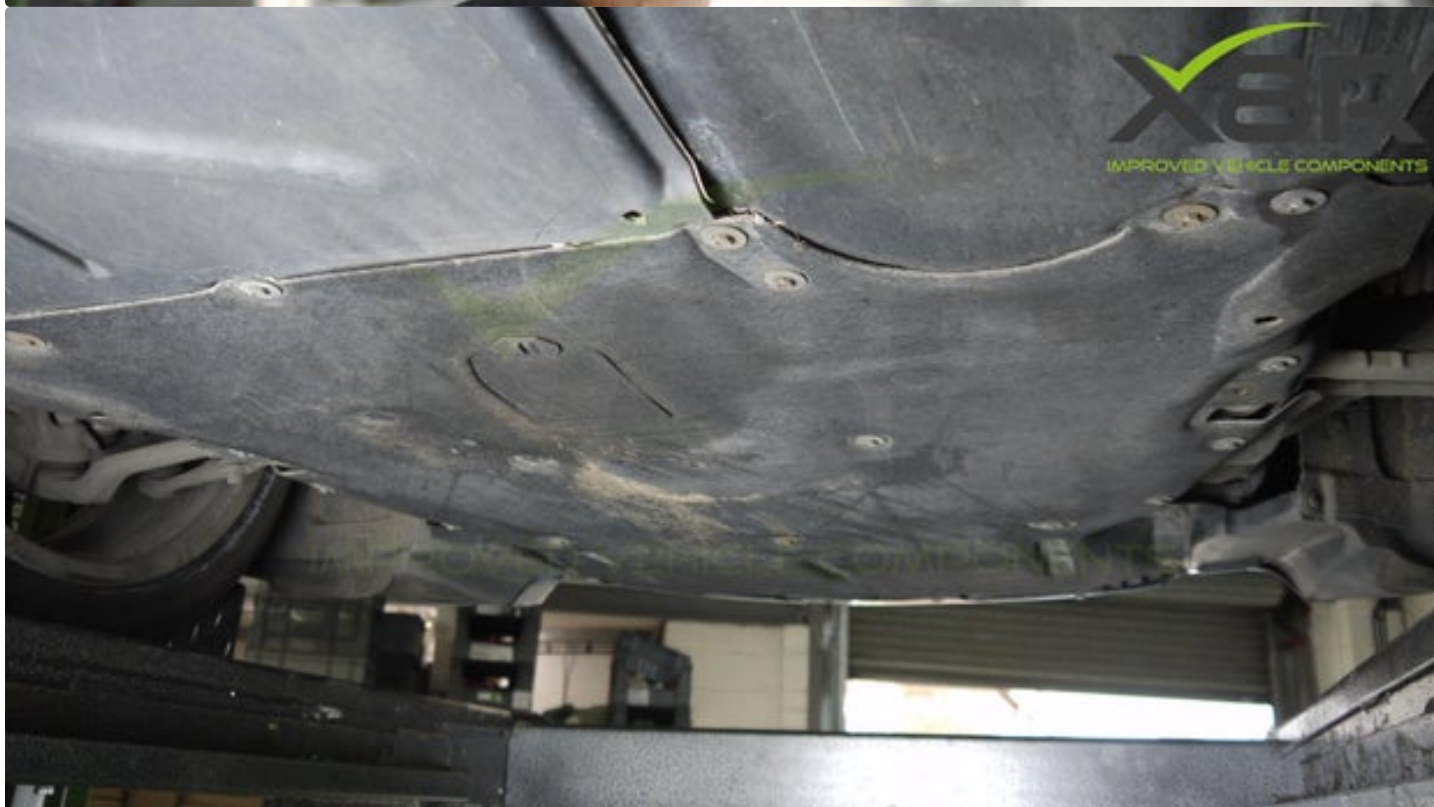
Step 1: Remove the First Undertray

Firstly either jack the front of the vehicle up or put it on a ramp.

Remove all 25 bolts on the undertray using an 8mm socket & ratchet, remember to also remove the 4 at the front of the vehicle under the bumper.

Carefully remove the undertray.

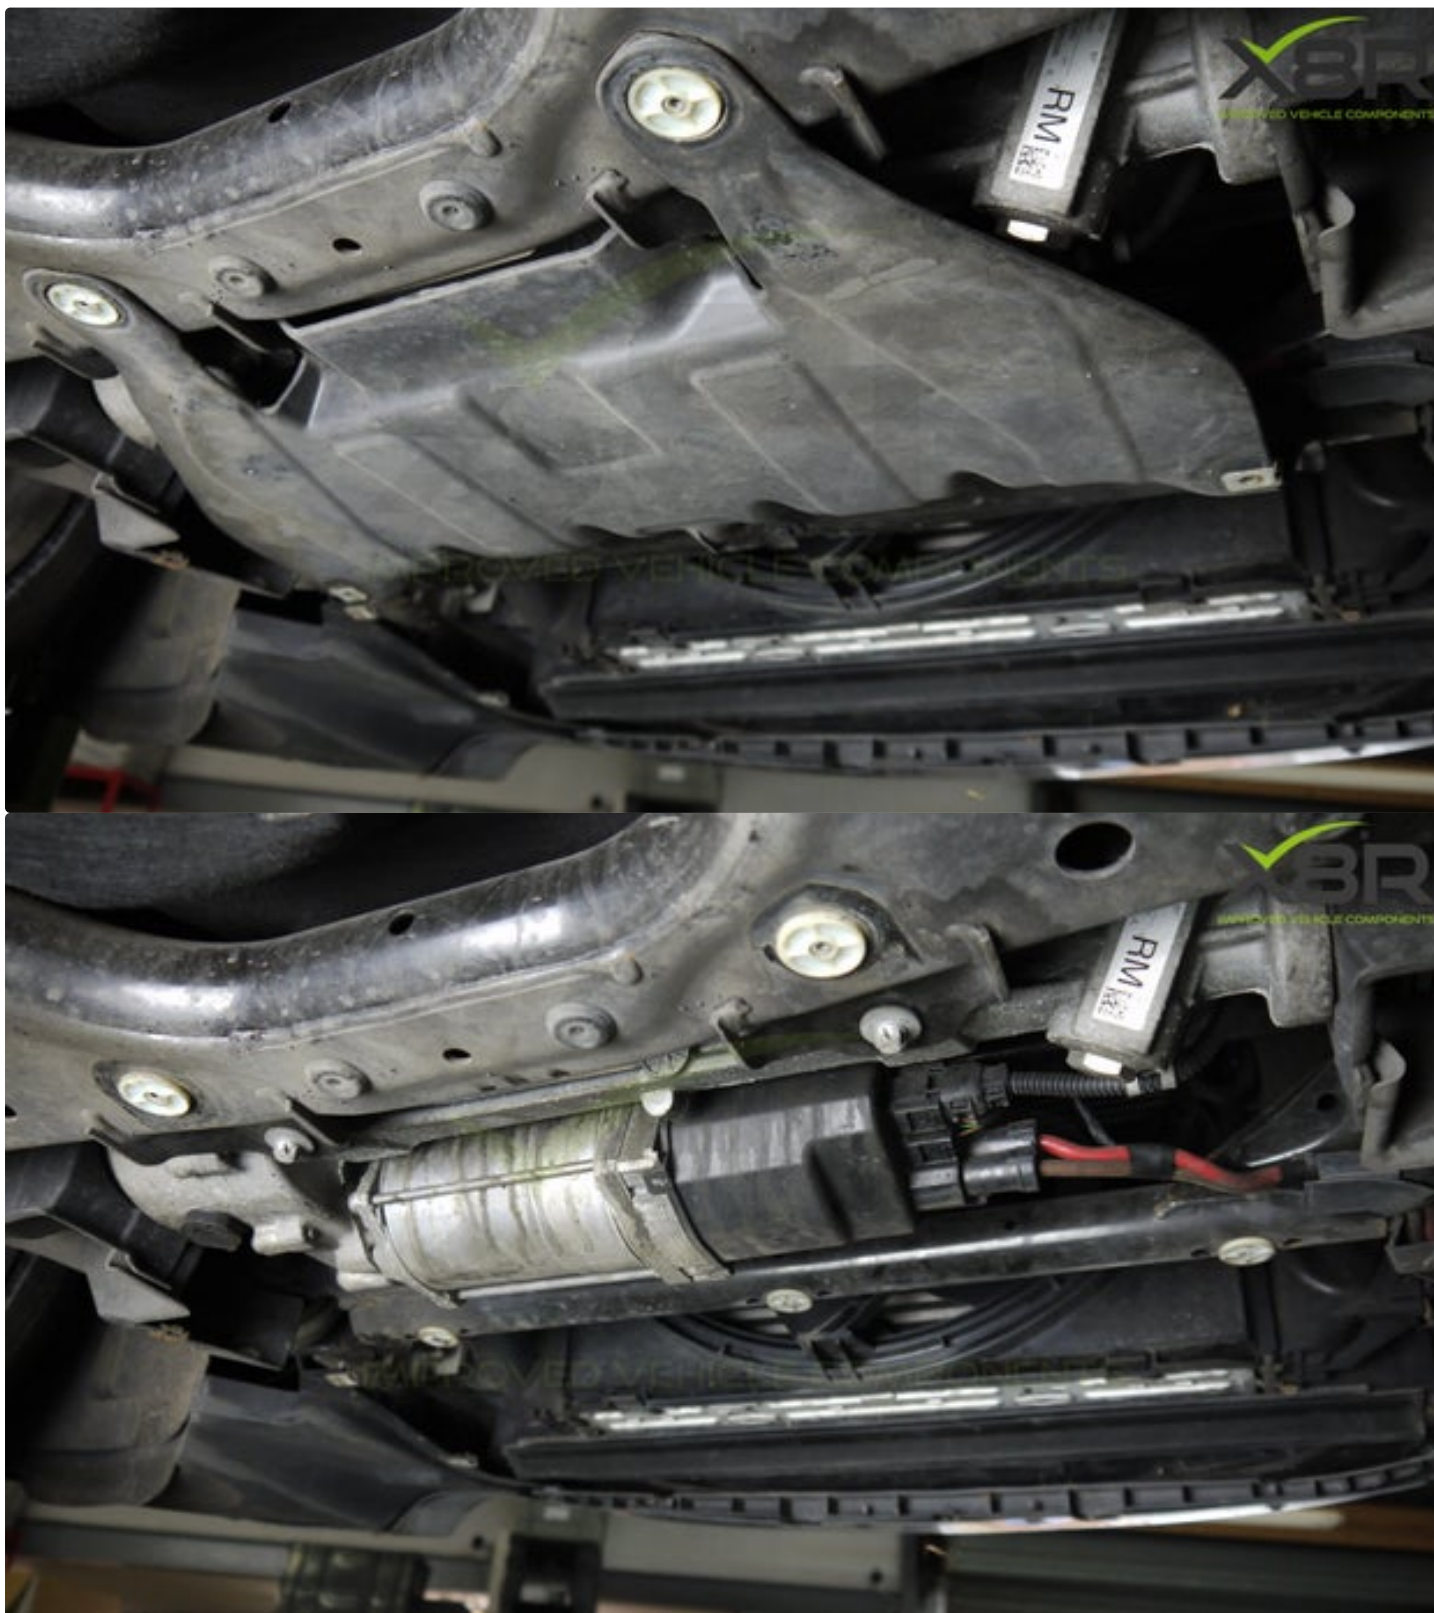
Step 2: Remove the Second Undertray

There is a second undertray protecting the steering rack, remove a further 3 bolts to remove this undertray. They also require a 8mm socket.

This exposes the steering rack and the three pin locking cap (where our tool fits onto).

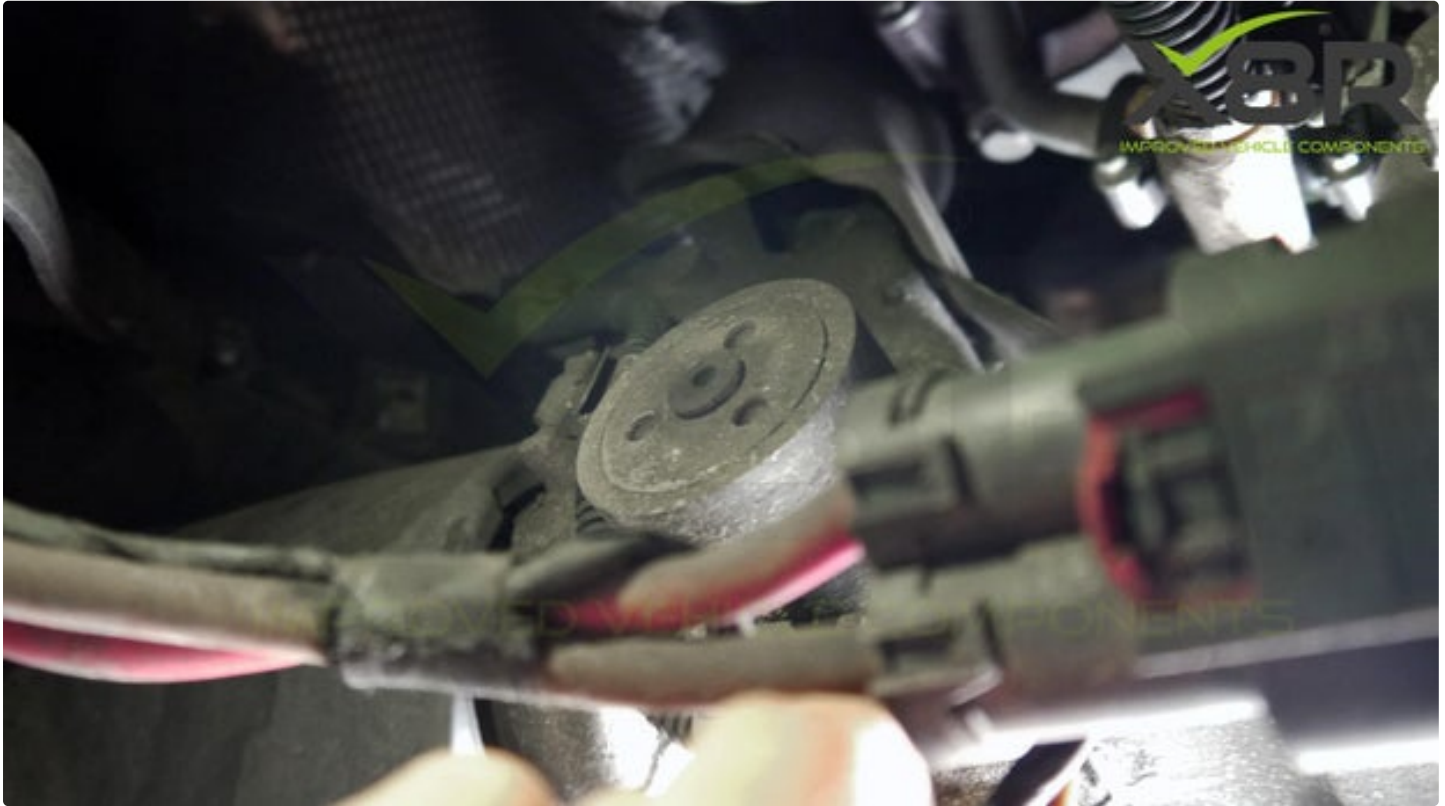
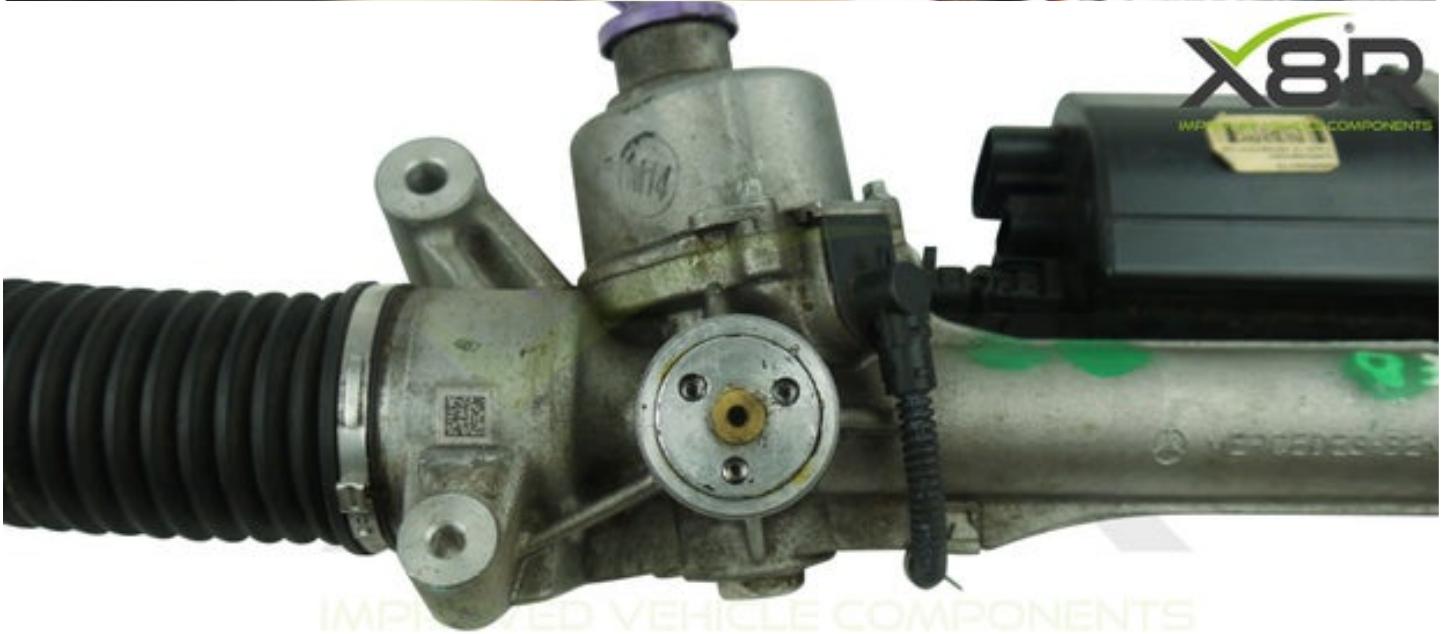
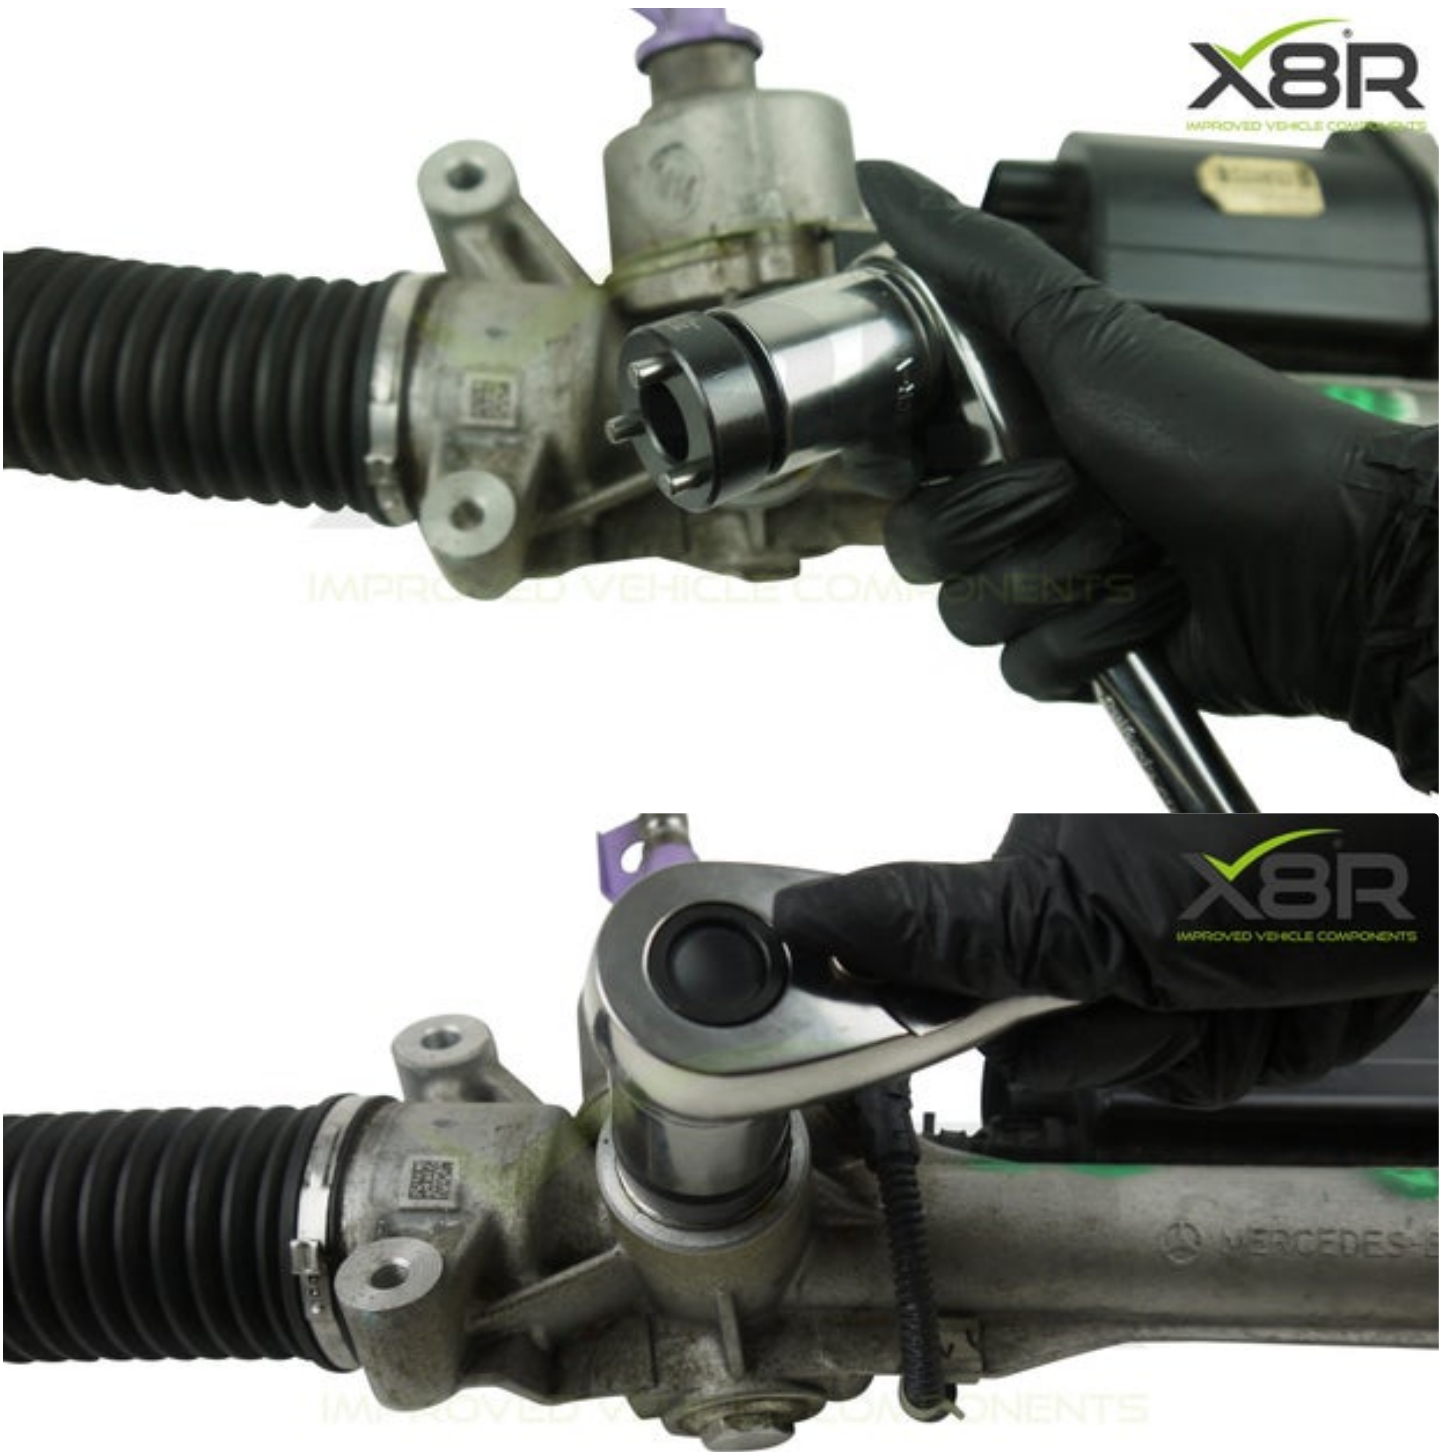
Step 3: Use the Steering Rack Tool

Place the Steering Rack Tool onto a flexi joint socket and ratchet, this is due to the lack of space around the steering rack in order to carry out the repair. (if you are carrying out the work on a bench, you can do this with just a ratchet).

Spray some WD40 onto the locking cap (if required) and leave for a few minutes to penetrate.

Lock the tool into place on the cap with the three pins, and twist until the cap is completely loose.

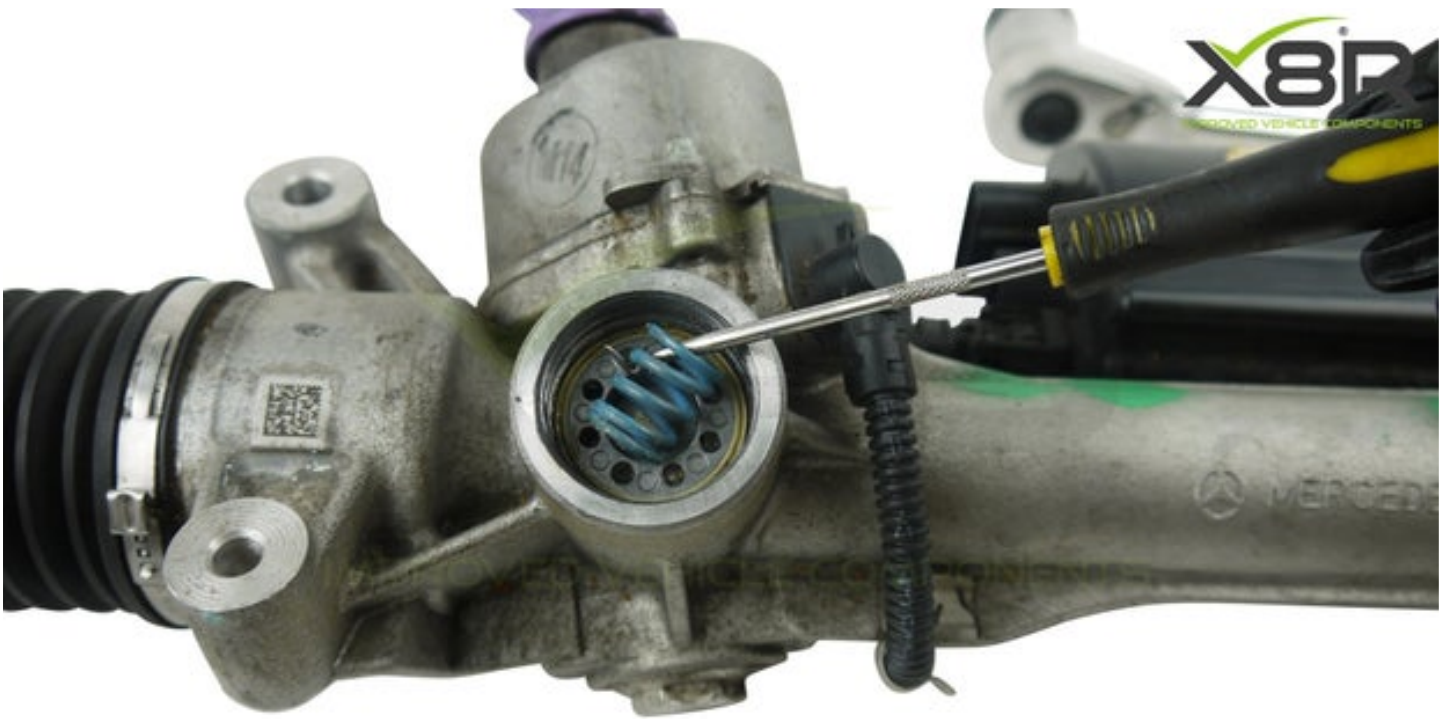
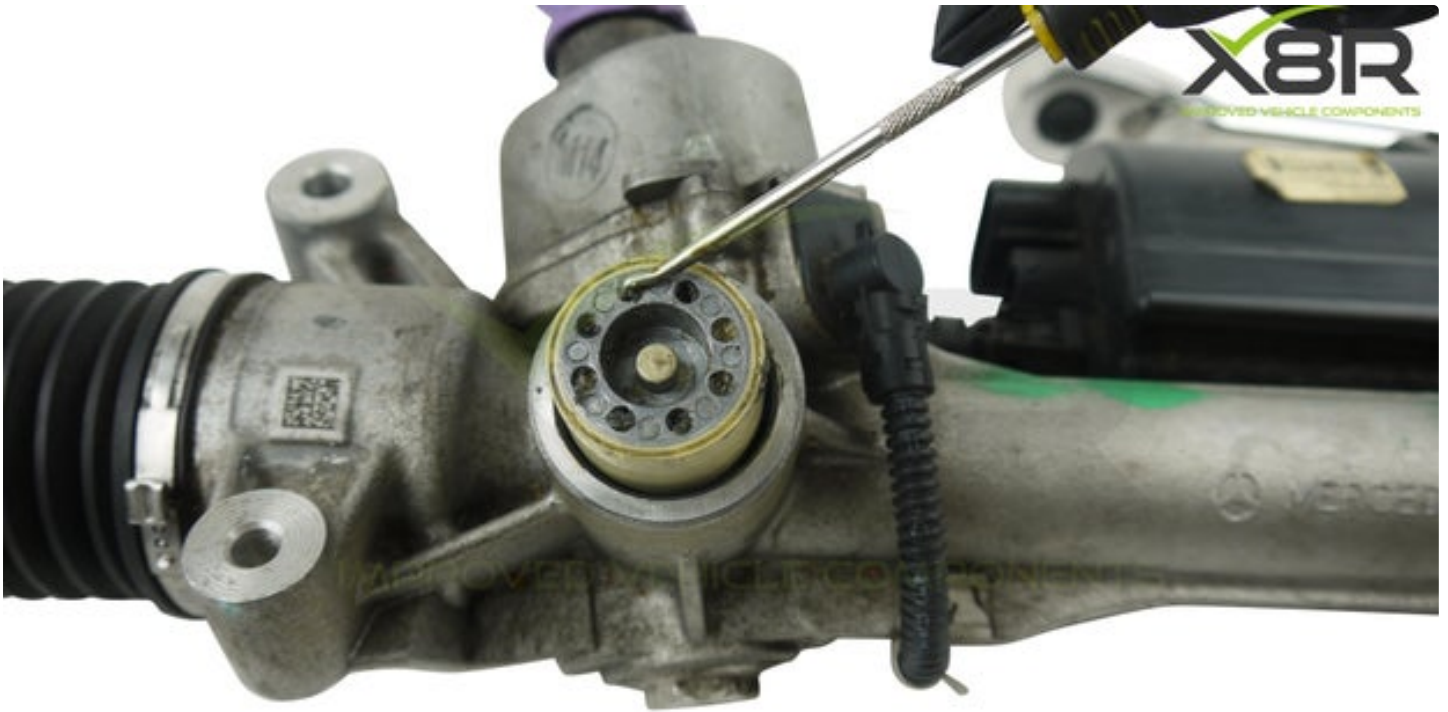
Step 4: Remove Old Components

Remove the locking plate followed by the spring and then the bush.

We found the easiest way to get the old bush out (as it will be stuck in place) is with a pick or prying tool. If your steering rack has been making noise or vibrations as per the symptoms of the fault, you will notice some wear marks on the bush.

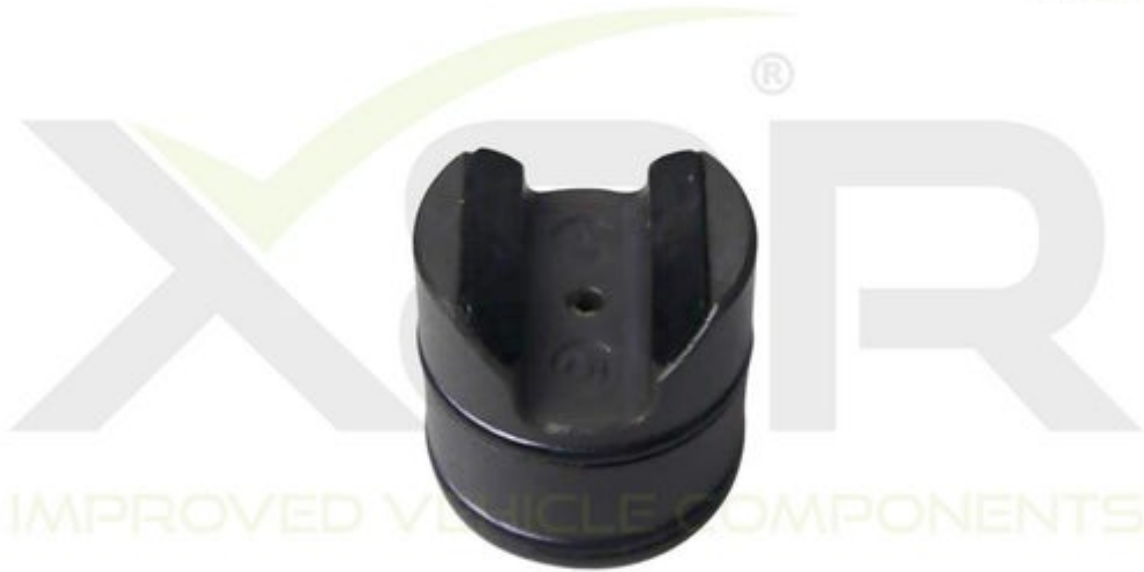
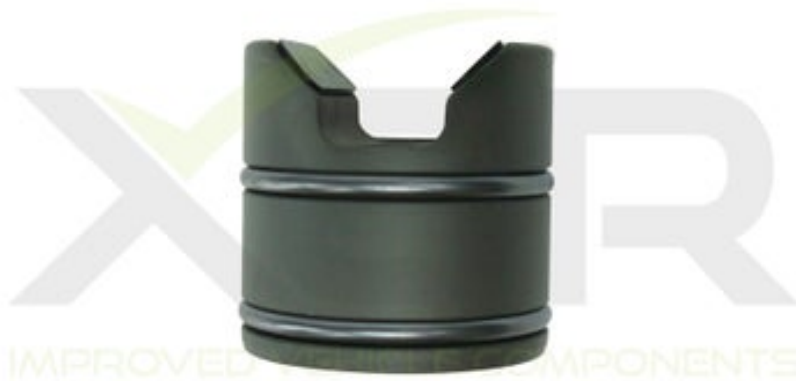
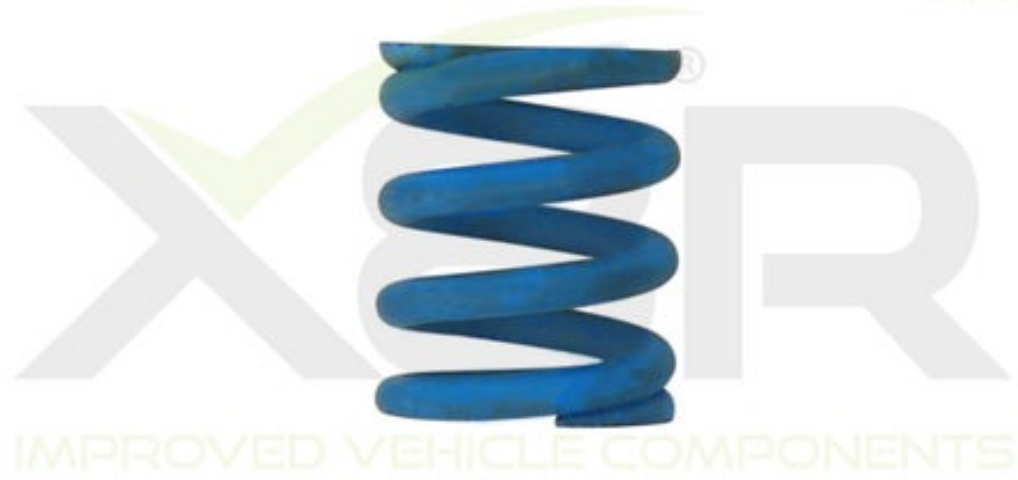
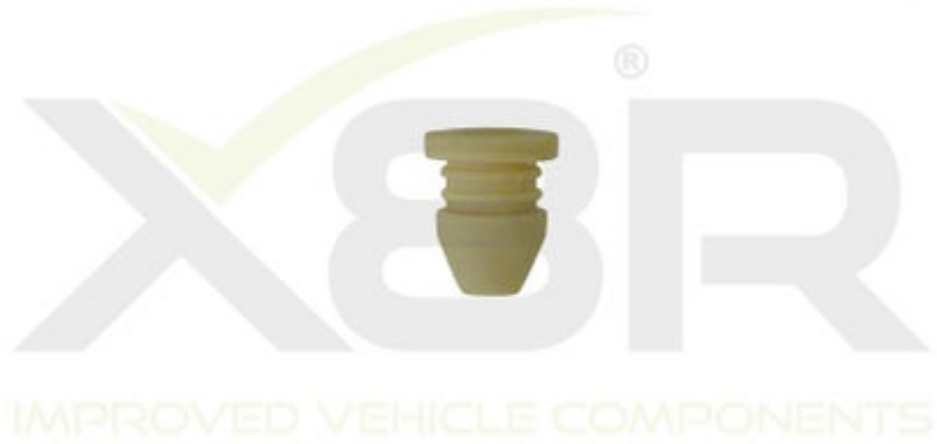
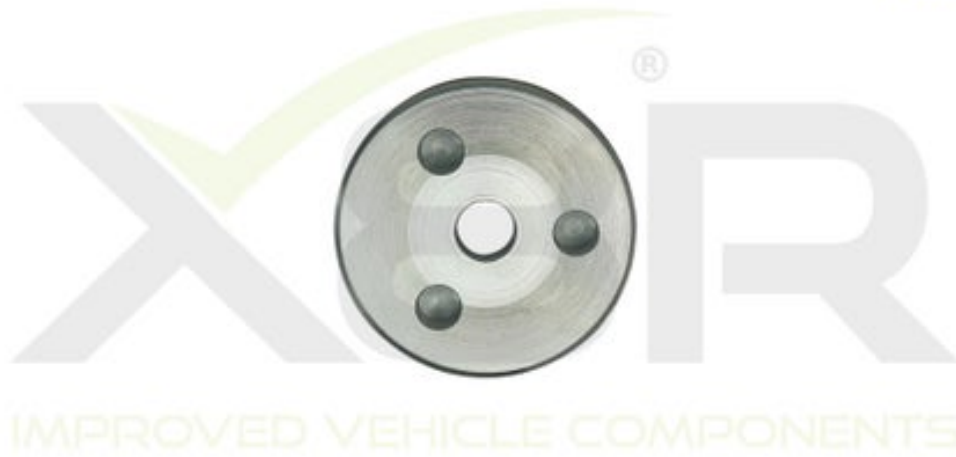
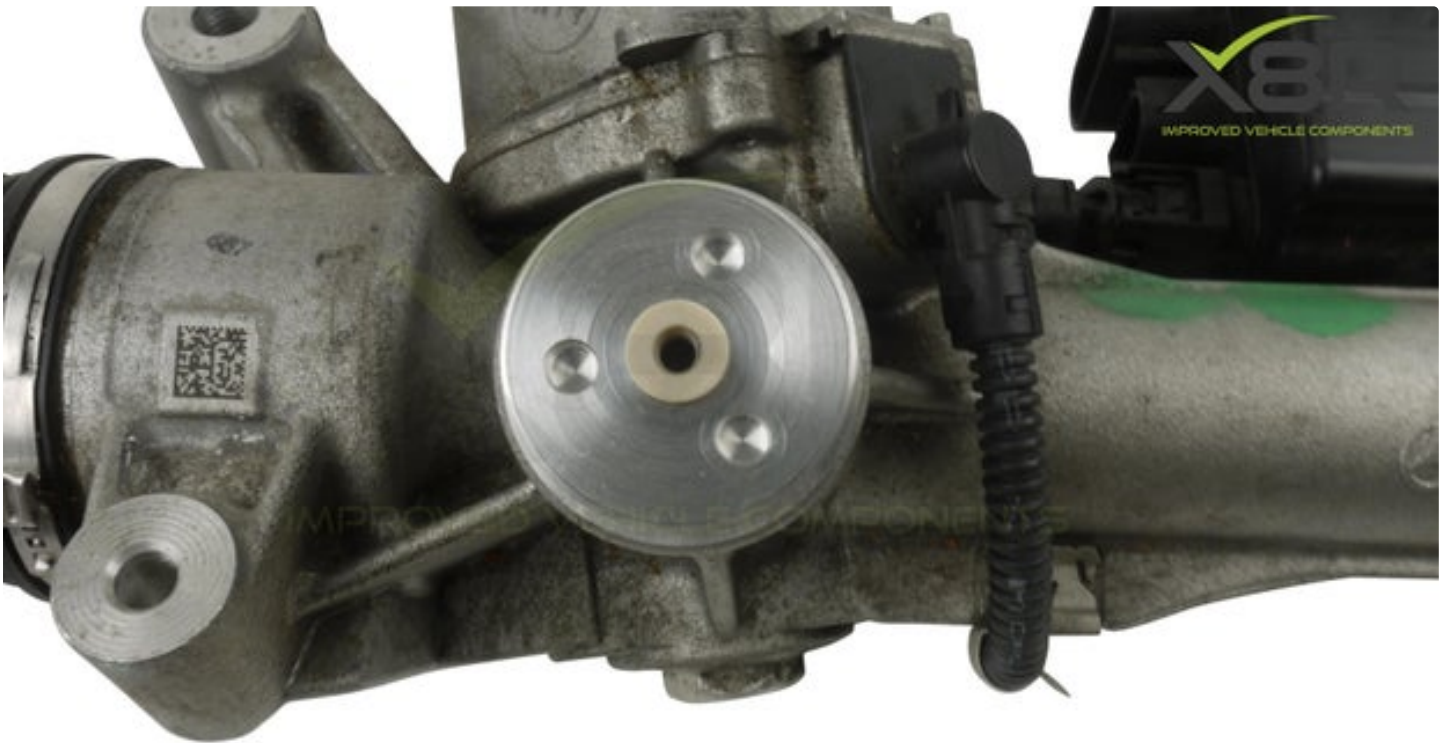
Step 5: Replace With New Components

Replace the old bush with the new & improved bush. Firstly cover it with the steering rack grease provided (be generous) and push into the steering rack.

You can see that the new bush is an improved design made with integrated o rings and made from improved materials, it also has two rubber pads on the top to prevent excessive wear and has a wider gap where the internals of the steering rack sit.

Fit the new spring.

Fit the new bung into the center of the new locking cap (may require a bit of force) and then loosely fit the locking cap by hand.

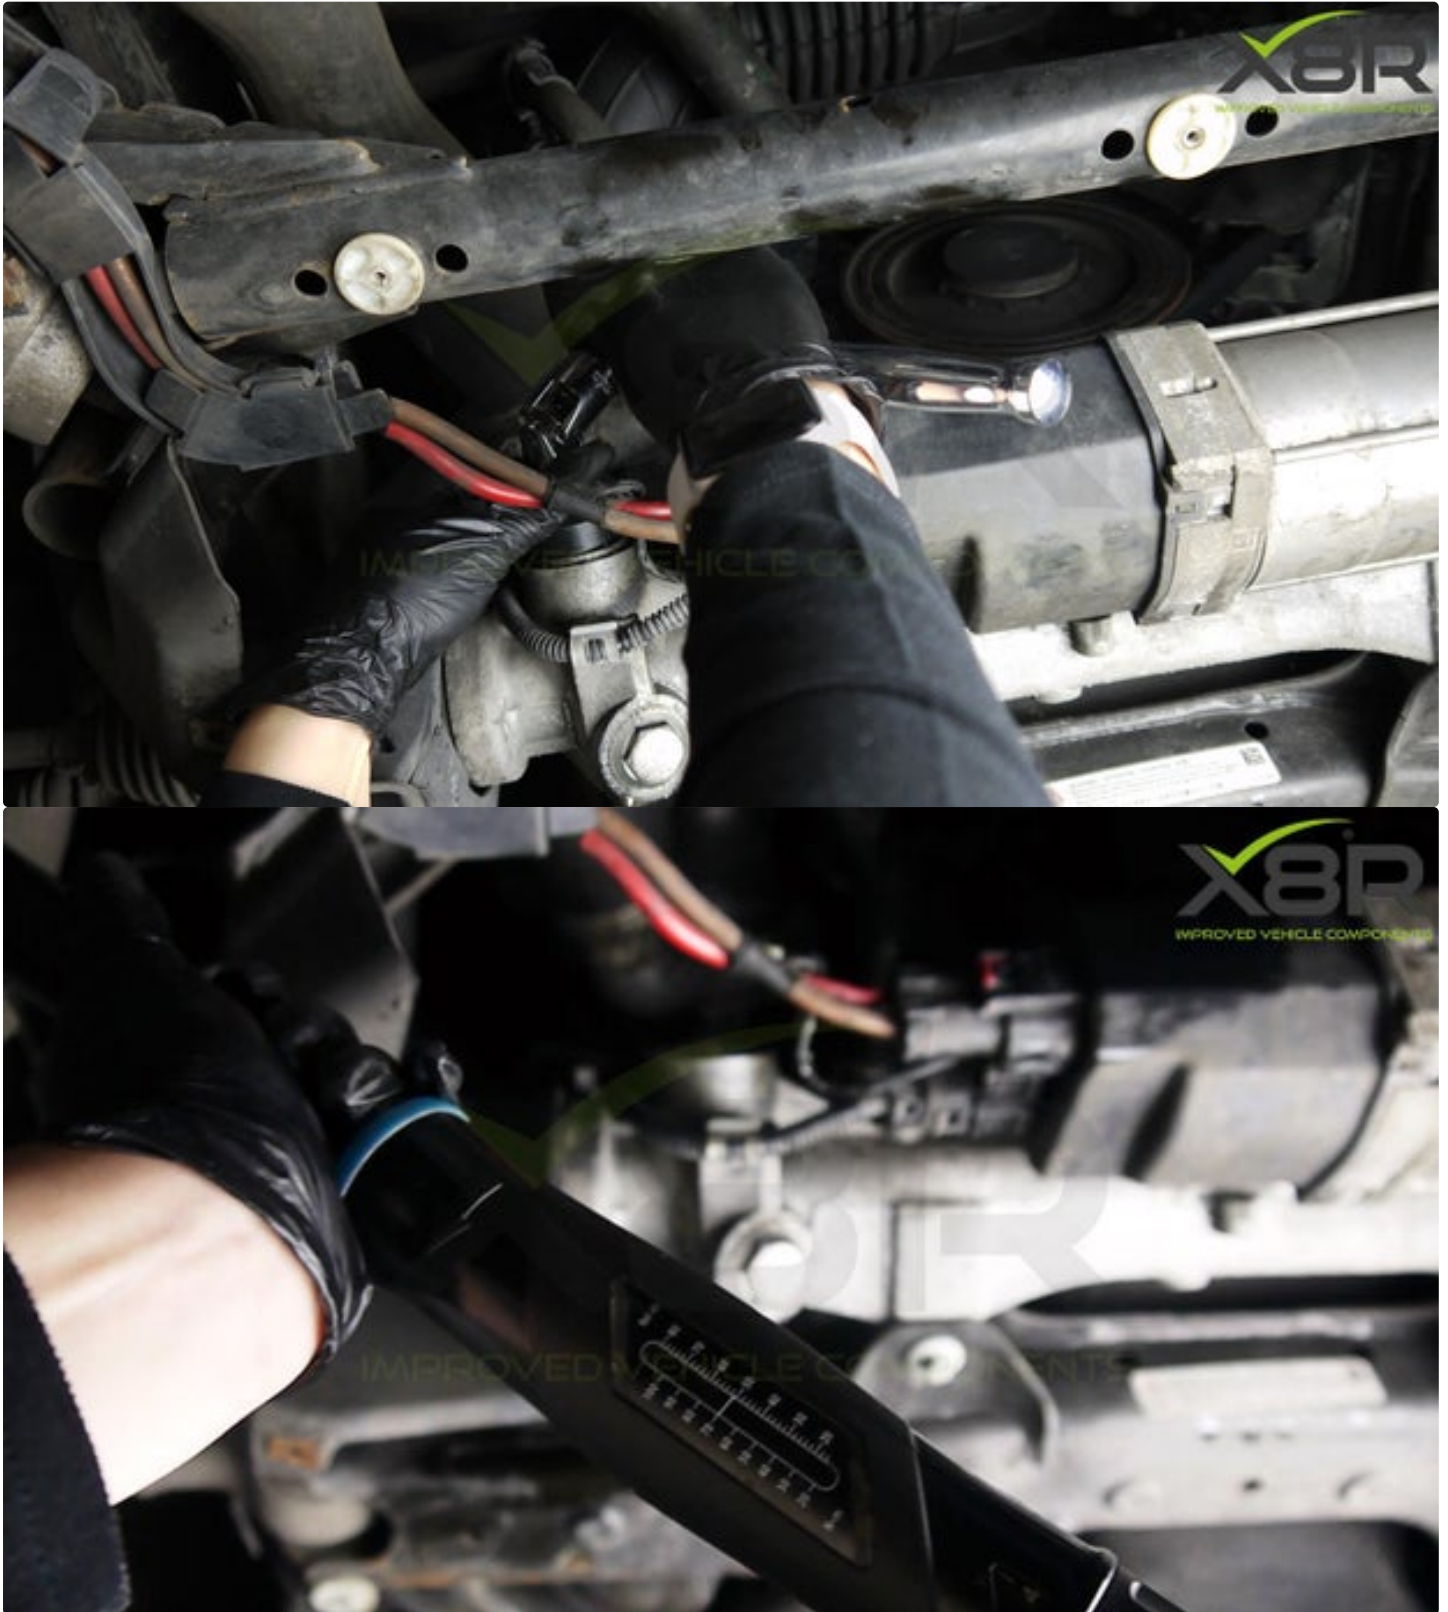
Step 6: Tighten the New Locking Cap

Please be aware that torque settings will vary between vehicles, make sure to check your vehicles specific torque setting before you tighten the bush.

Tighten the cap up using the tool kit. Then tighten it up to 70nm of torque which is the recommended measurement from BMW. We recommend trying out the steering at this stage, as if the steering feels considerably tighter than loosen it by a quarter turn at a time until it feels right (we had to loosen ours by two quarter turns as the steering felt very tight at first).
