Vauxhall Astra J Mk6 GTC VXR Insignia Zafira Improved Clutch Pedal Pivot Pin

Symptoms of Fault

The Fault

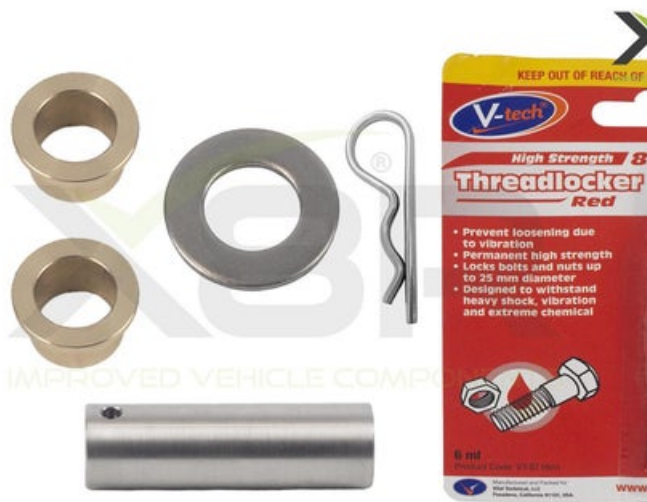
1 x stainless steel clutch pivot pin

2 x self-lubricating brass bushes

1 x stainless steel washer

1 x R pin

1 x threadlock

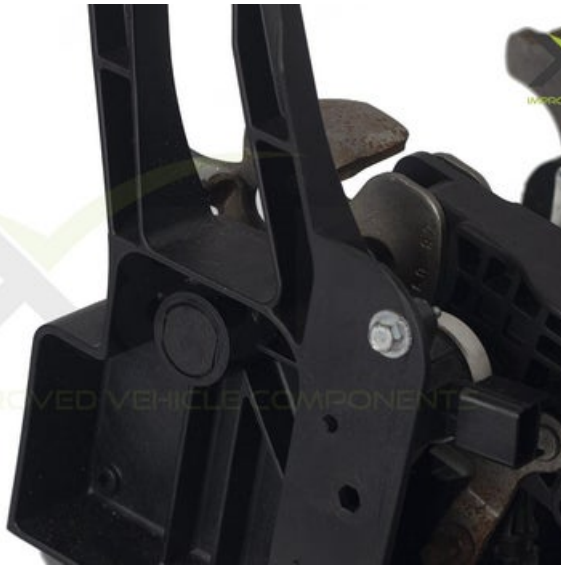
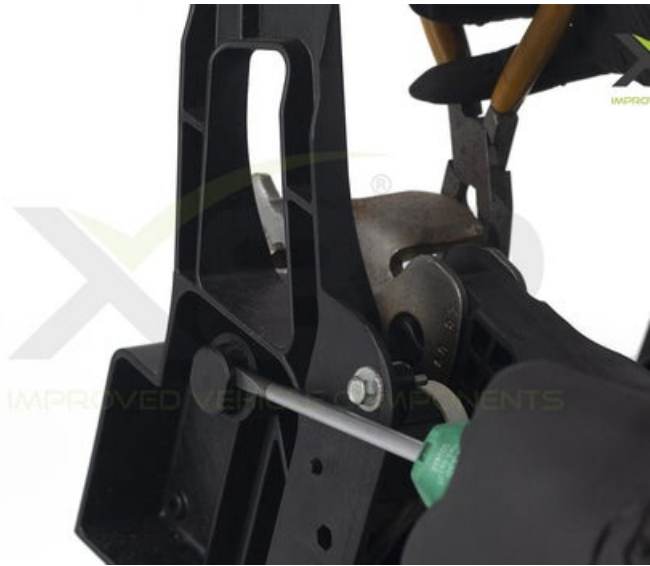
Step 1:

Remove the original clutch pedal pin by using a flathead screwdriver under the main head of the pin, and pushing the other end with a pair of grips.

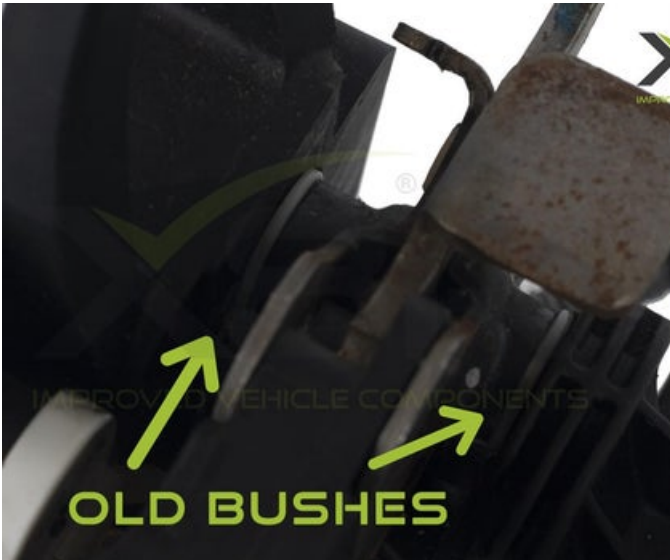
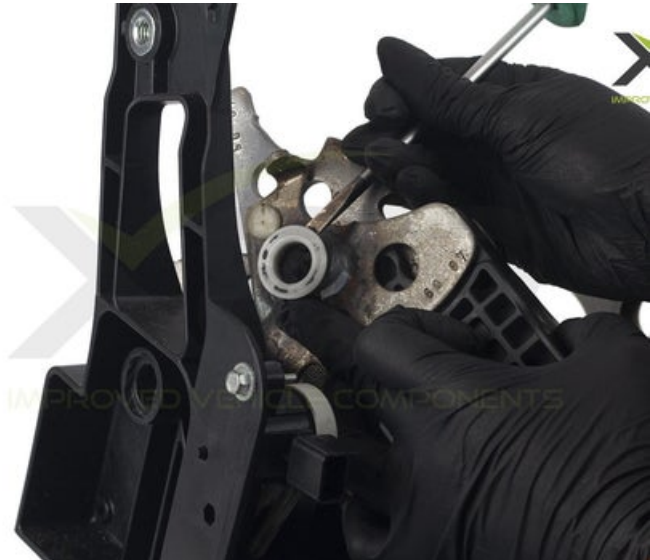
Step 2:

Lift the clutch pedal out of place. Remove the old bushes, again using a flathead screwdriver.

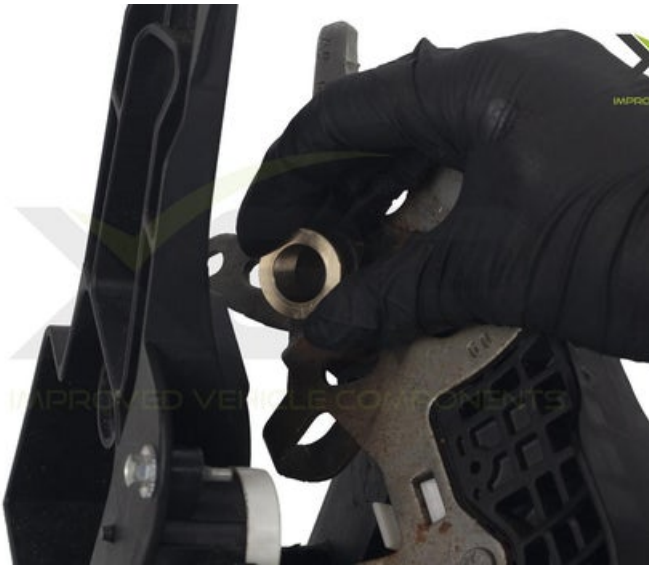
Step 3:

Insert the new X8R bushes either side of the clutch pedal and push the pedal back into the mechanism.

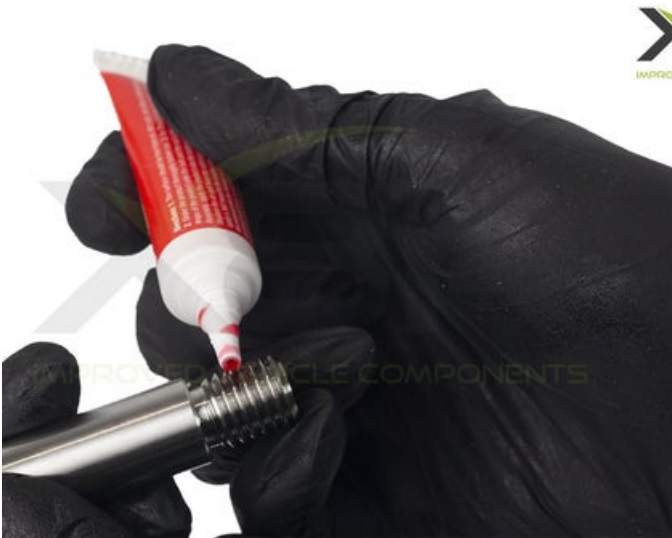
Step 4:

Generously apply the threadlock to the thread of the new X8R pivot pin.

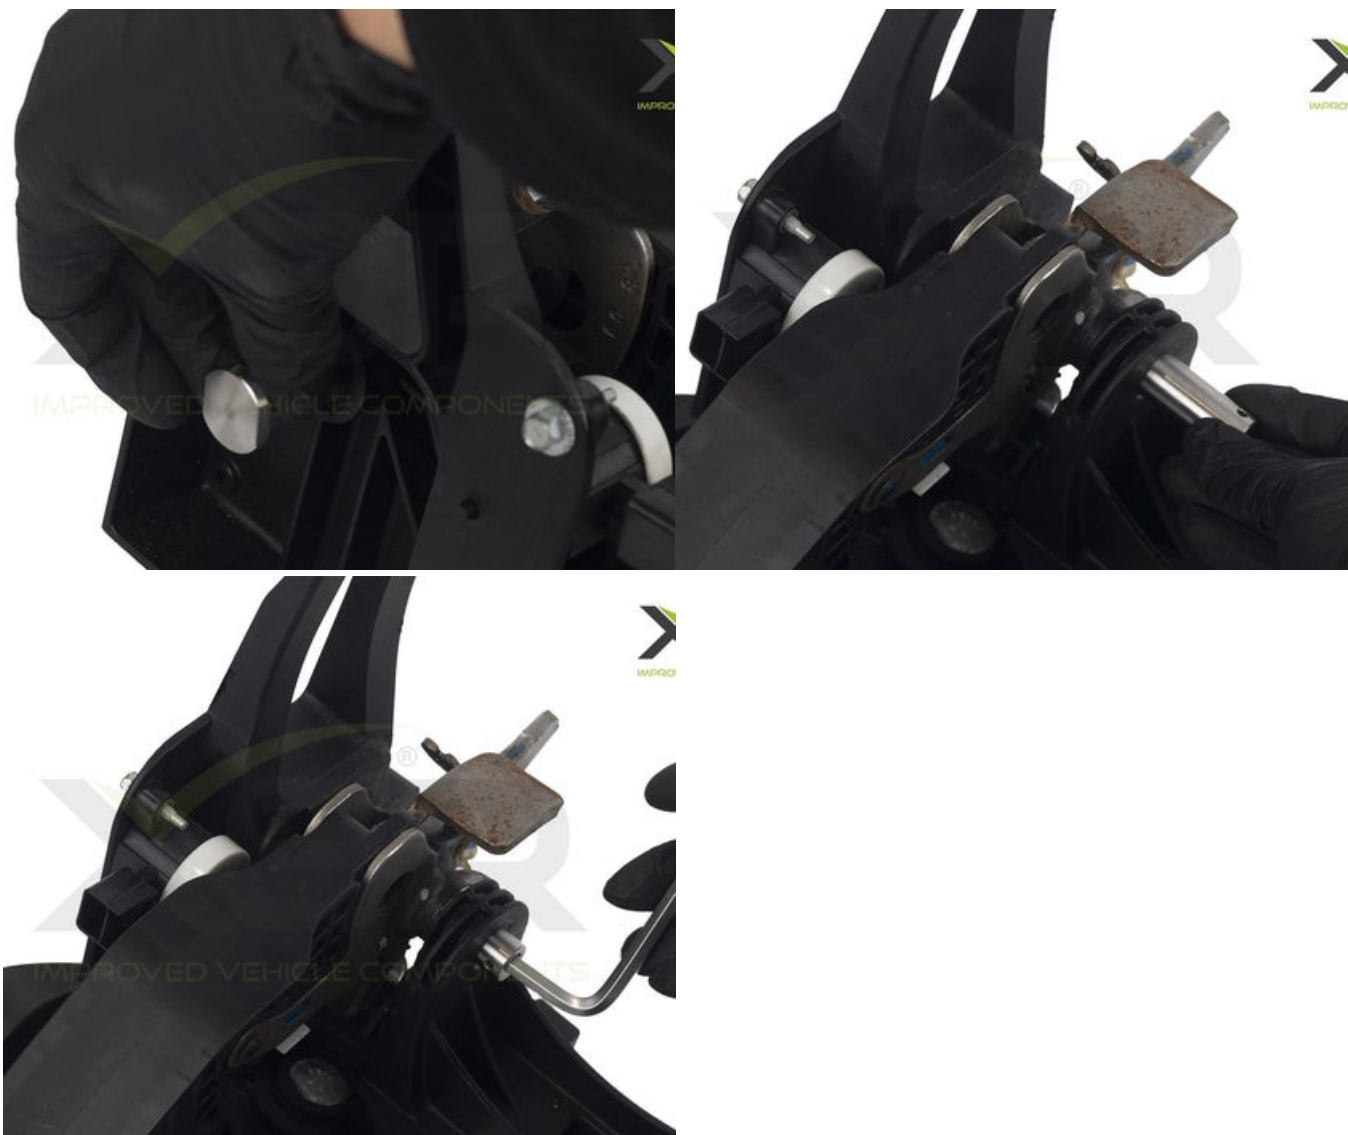
Step 5:

Push the new pivot pin into place just as the old one was. Screw the back half on by hand and tighten it with a 6mm allen key.

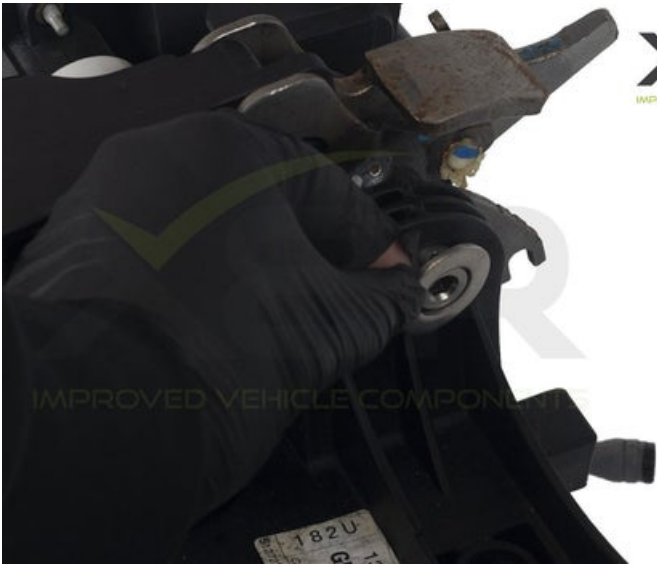
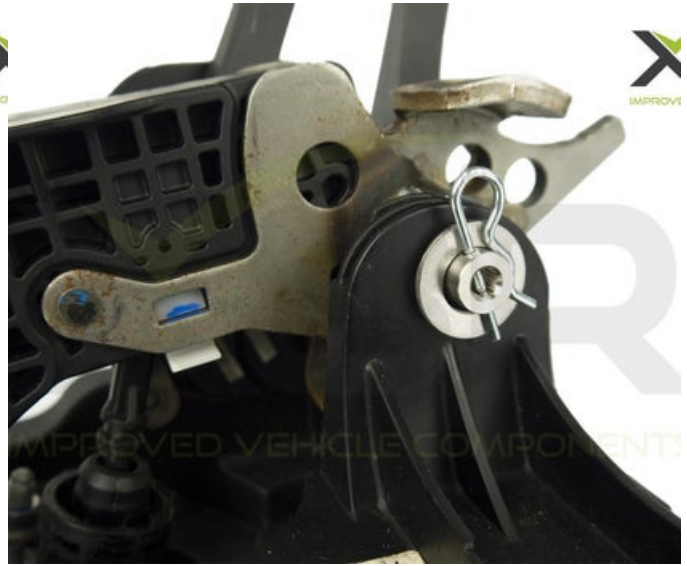
Step 6:

Press on the stainless steel washer and push in the R pin.

Please note that some movement left to right is absolutely necessary for a pedal to function, but you will find the X8R kit has drastically reduced the excessive movement.
