Toyota AYGO Peugeot 107 Citroen C1 Tail Light Seals

Introduction: Toyota AYGO Peugeot 107 Citroen C1 Tail Light Seals

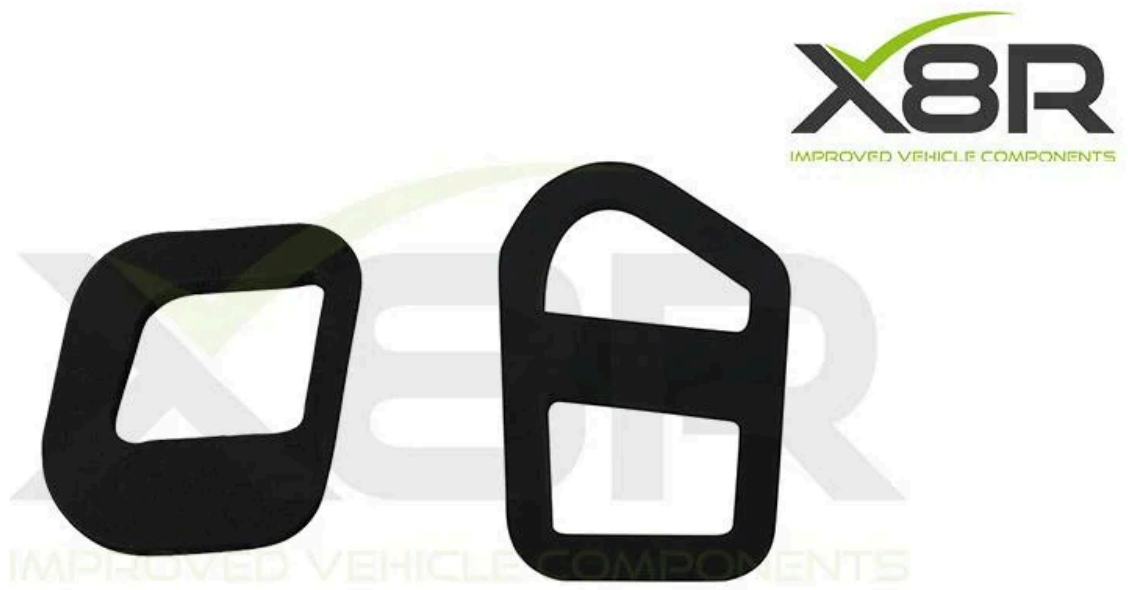
It is very common for the original foam seal to fail and cause leaks

The foam gasket that the tail light comes attached to from factory disintegrates over time due to its poor structure. This allows water to enter through the gasket and into the boot, causing puddles of water on the boot floor

Fit our improved design / material seals and cure these leaks.

Our improved design seals are precision die cut (for the best finish) from the best quality closed cell foam, a far superior material to the original. Remove the old worn seals, fit our seals and stop water entering the light unit and vehicle itself.

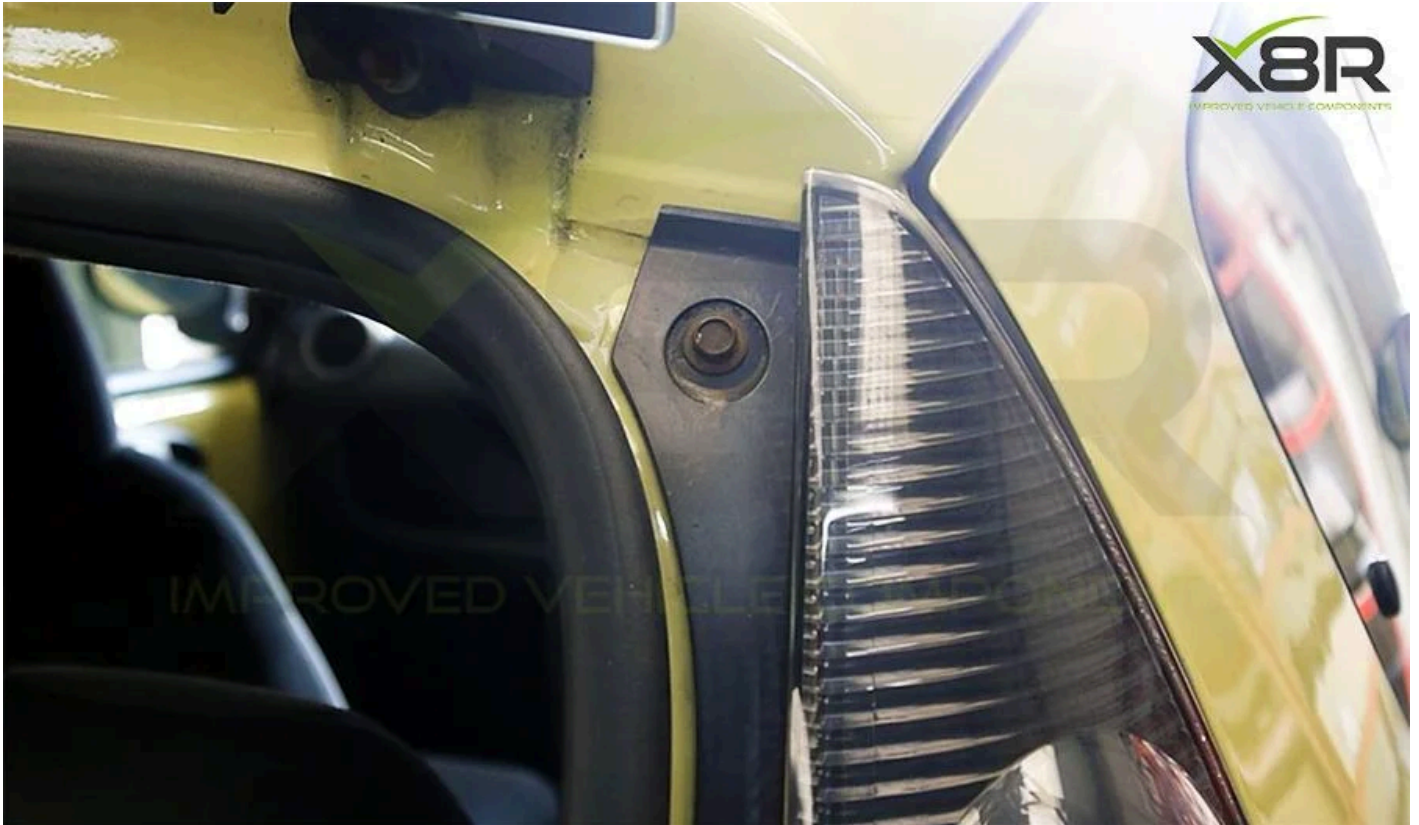
Step 1: Remove the Tail Lights From the Vehicle

Citroen C1 & Peugeot 107:

Open the boot and remove the two bolts with a 10mm socket & ratchet. The lighting unit will become loose and can be pulled away from the body. Disconnect the electrical plug and remove from the car.

Toyota Aygo:

Open the boot & using a Philip's screw driver, remove the bolt on the boot trim on the back of the light. Move the trim away from the body to expose the two bolts holding the light to the car. Undo the nuts with a 10mm spanner to loosen the light, disconnect the electrical plug and remove the light from the car.

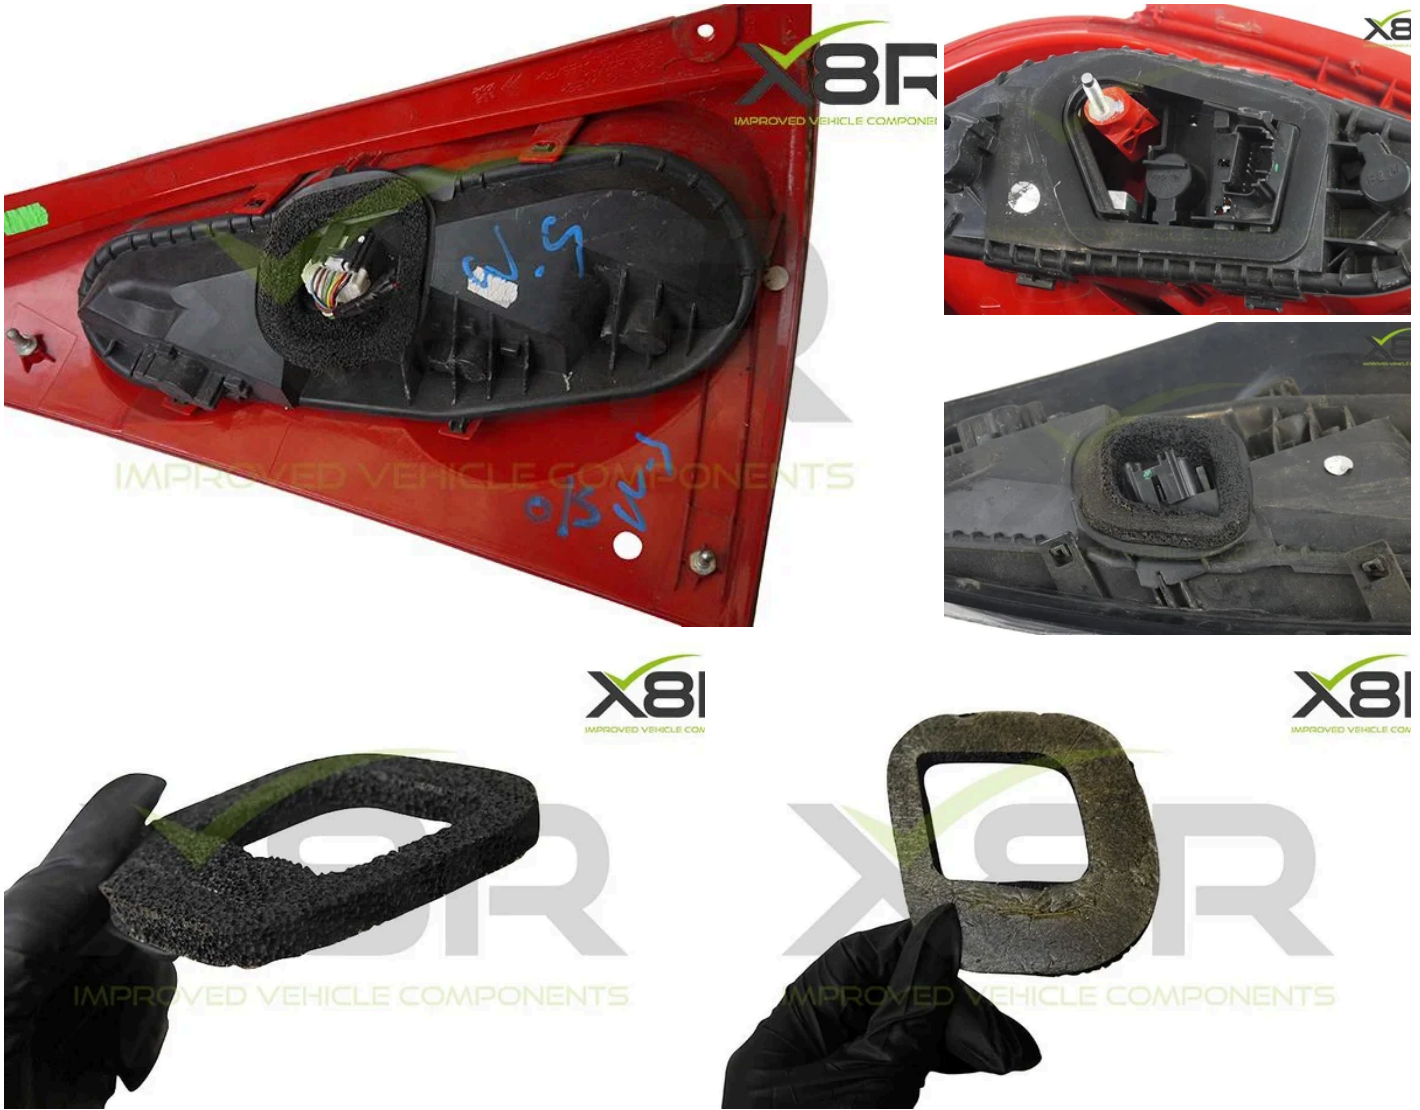
Step 2: Remove the Original Seal

The original seal surrounds the electrical connector. If it does not peel off in one go, we recommend using a sharp flat-headed screwdriver to scrape away the remainder of the seal. If it is still not coming away easily, then use a tar & glue remover and a microfibre cloth.

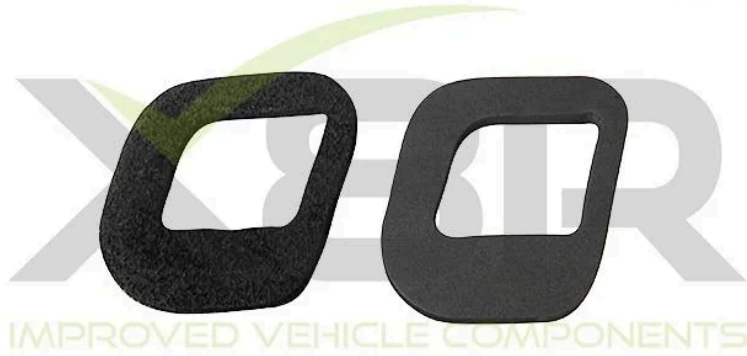
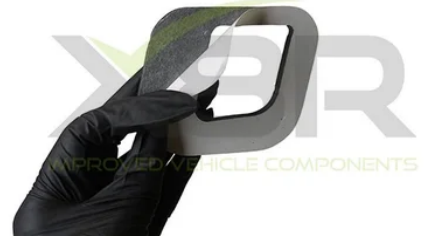
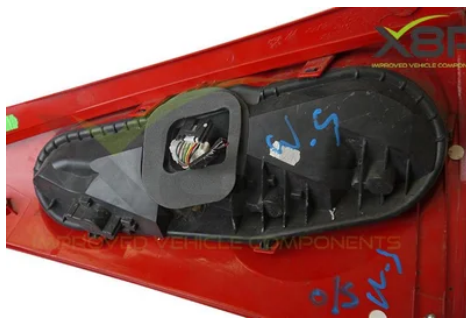
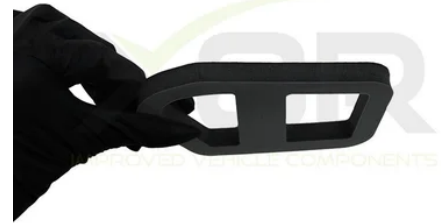
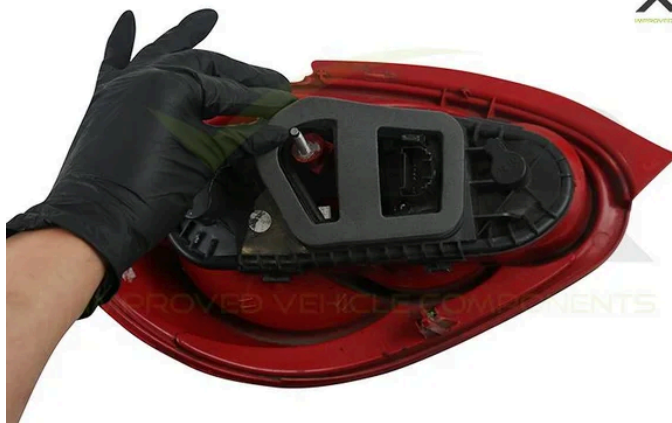
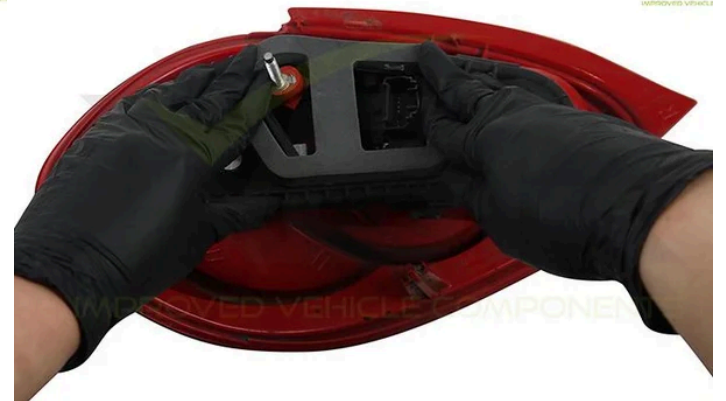
Step 3: Fit New Seal

Once the original seal is completely removed and the area is clean of any old adhesive, apply our new seal.

Peel back the paper from the reverse side, and carefully line up the seal to the light. Once you are confident it matches up, place pressure on the seal to ensure it is stuck down effectively.

When fitting the light back onto the vehicle, please be aware that since the seal is slightly thicker than the original, it may need more pressure to fit the light back into place. This does not affect the light or the fitment. If necessary, you can also place clear RTV sealant around the foam and the screws for the light.
