Jaguar XF 2008-2015 Air Vent Stepper Motor Improved Design Cog

By [x8rltd](#) in [WorkshopCars](#)

Published Oct 22nd, 2024

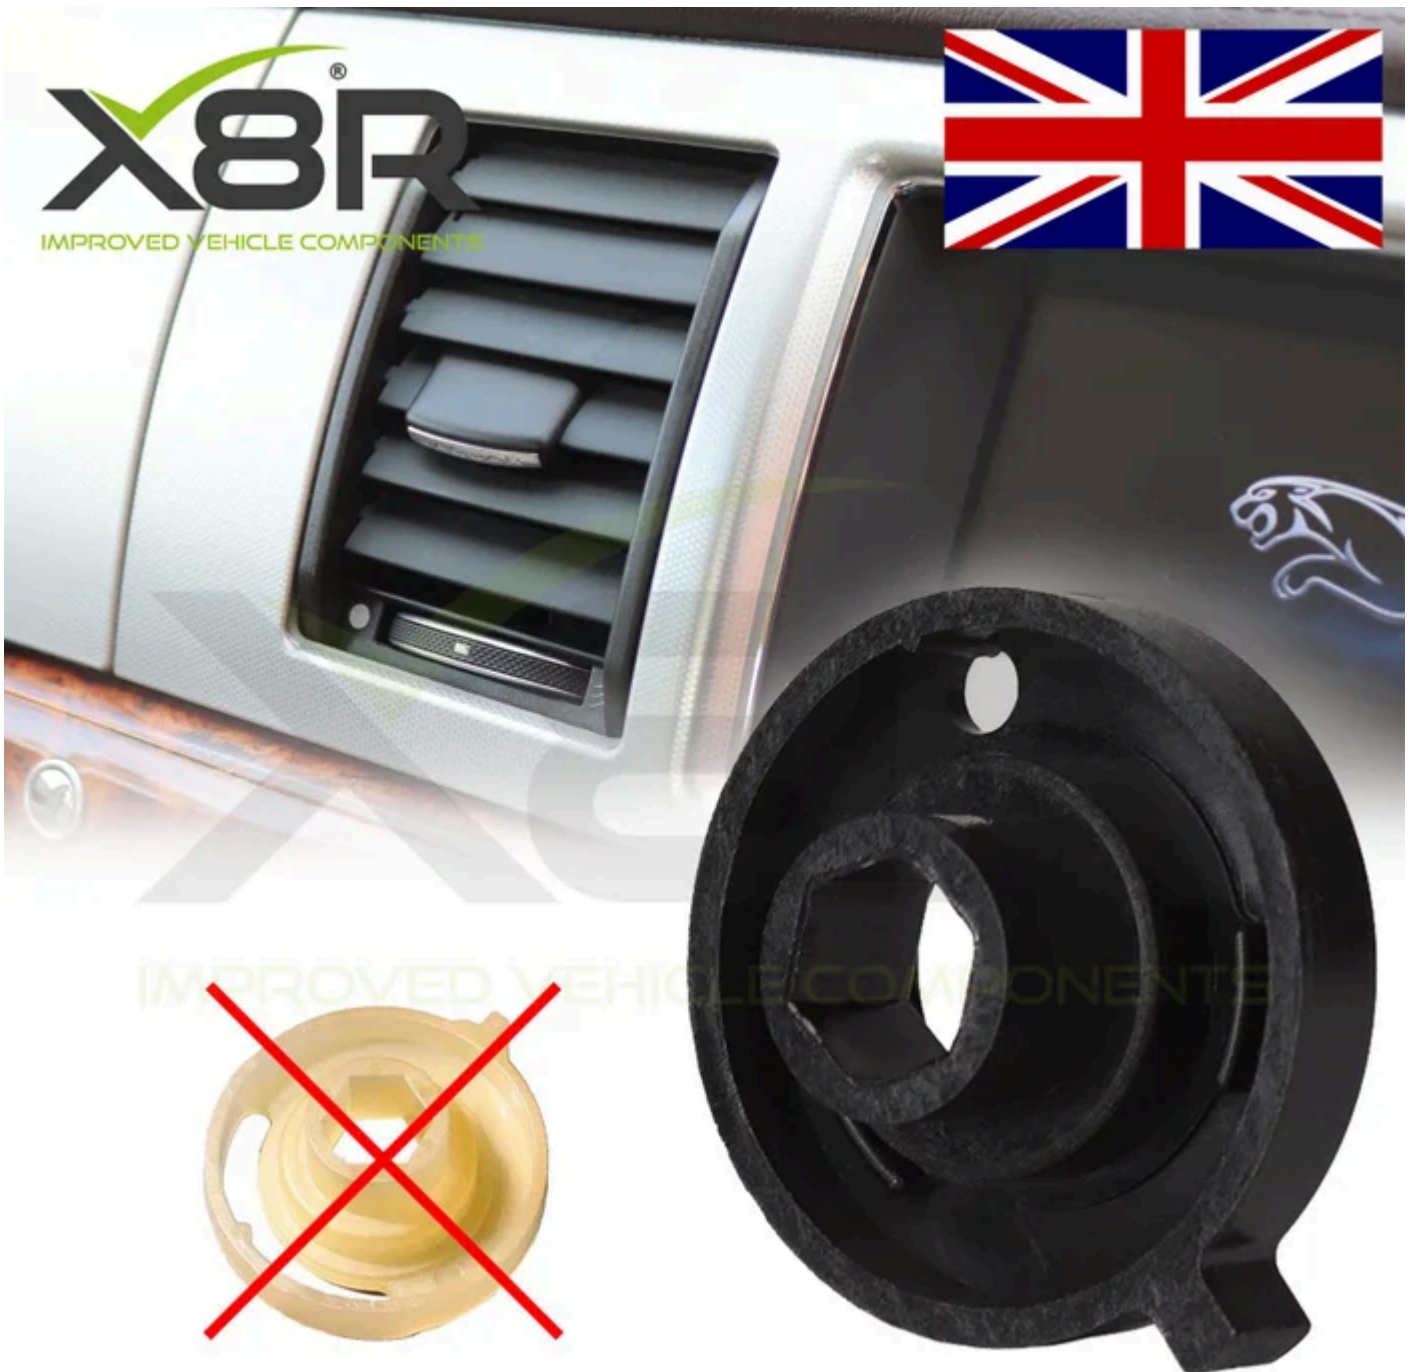
Introduction: Jaguar XF 2008-2015 Air Vent Stepper Motor Improved Design Cog

The Jaguar XF's have a unique feature where the interior air vents rotate upon startup, a great feature when working correctly. Unfortunately the cog which mates the rotating mechanism in the air vents to the motor is made of weak nylon and has a poor structural design, this cog can snap which causes the rotating mechanism to fail.

The cog has a large cut-out, to visually inspect if it is mated correctly. However this cut-out provides structural weakness and often snaps here. The cog also has a thin and weak stopper which breaks and is the most common reason for failure.

Here at X8R Ltd we have designed an improved stepper cog which is guaranteed to fix this issue for the life of the vehicle. Our cog is made from injection moulded carbon fibre reinforced plastic which is a far superior material. Our cog also has two fins incorporated into the design to increase the rotating surface. Not 3D printed. We have seen 3D printed versions of this gear fail prematurely. We have invested in injection moulding this part to make it the most durable gear in the market.

We have dramatically reduced the large cut-out window from a 30mm window to a 3.5mm circular cut-out which is large enough to easily locate into the mating surface and compact enough to not create structural weakness. The X8R cog also has the stopper width increased from 2mm to 2.7mm to prevent damage.

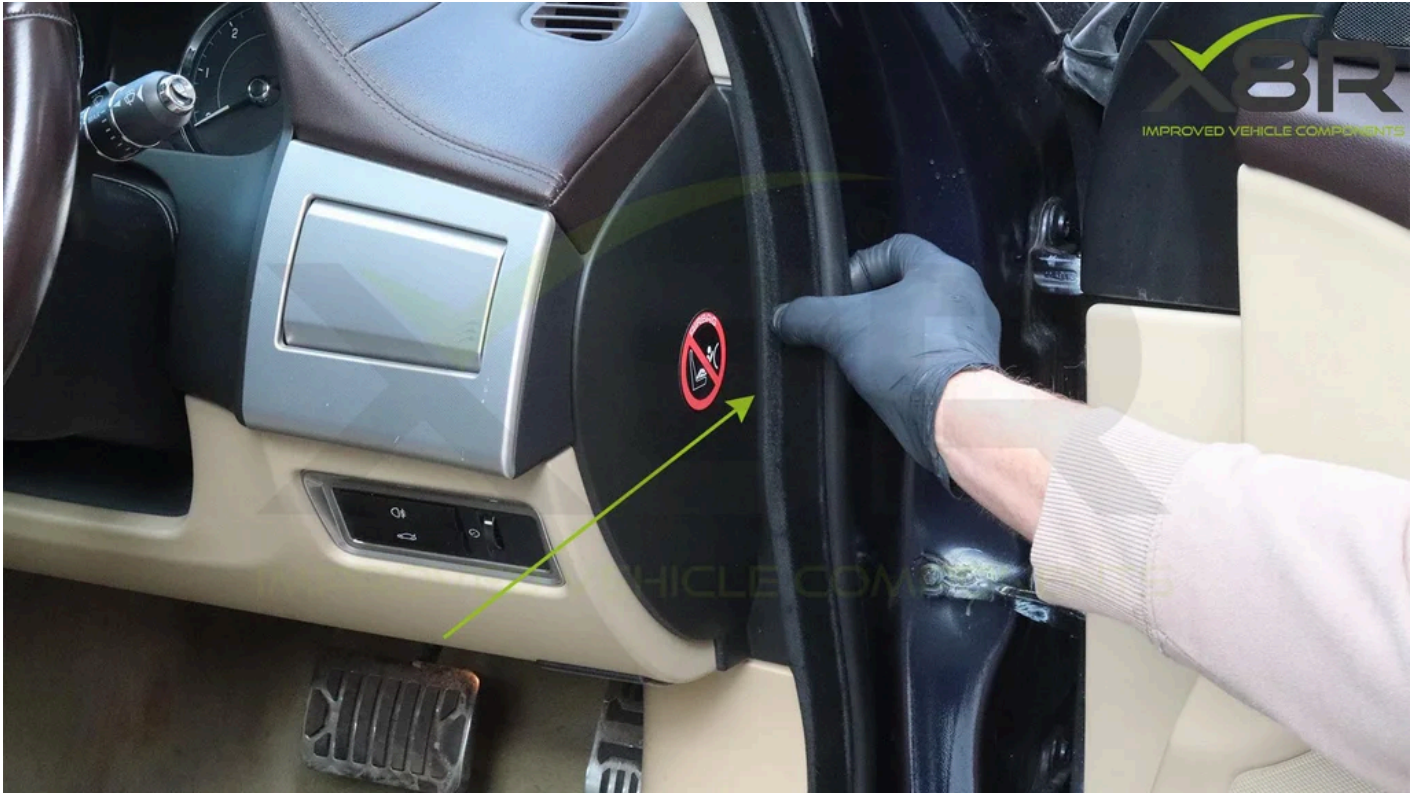
Step 1:

Pull the rubber door seal away from the door frame (only the section next to the air vent)

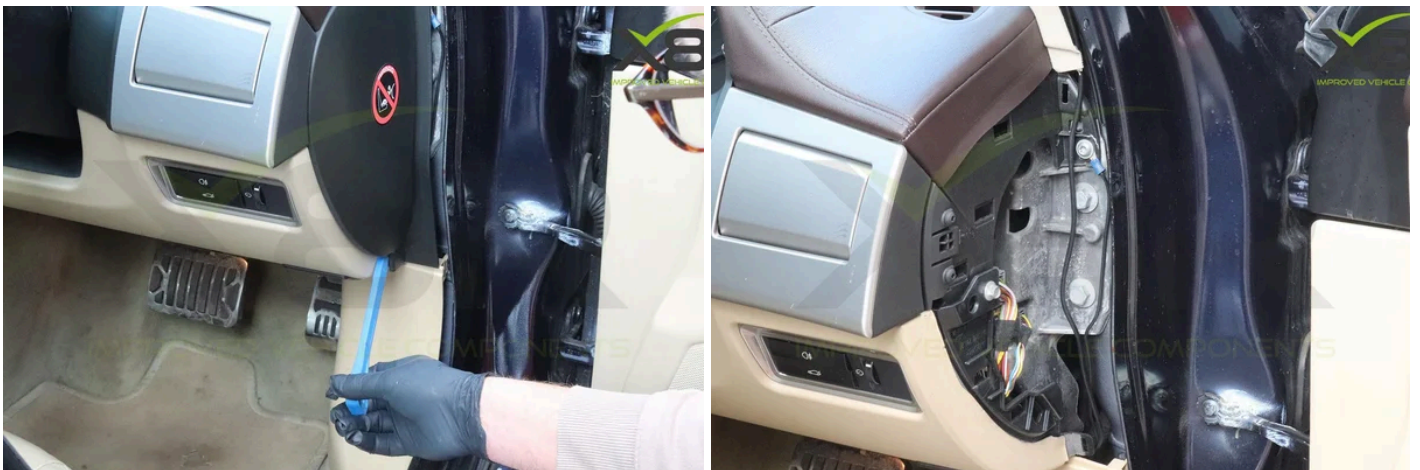
Step 2:

Use a trim removal tool to remove the trim on the side of the dash. Do so gently.

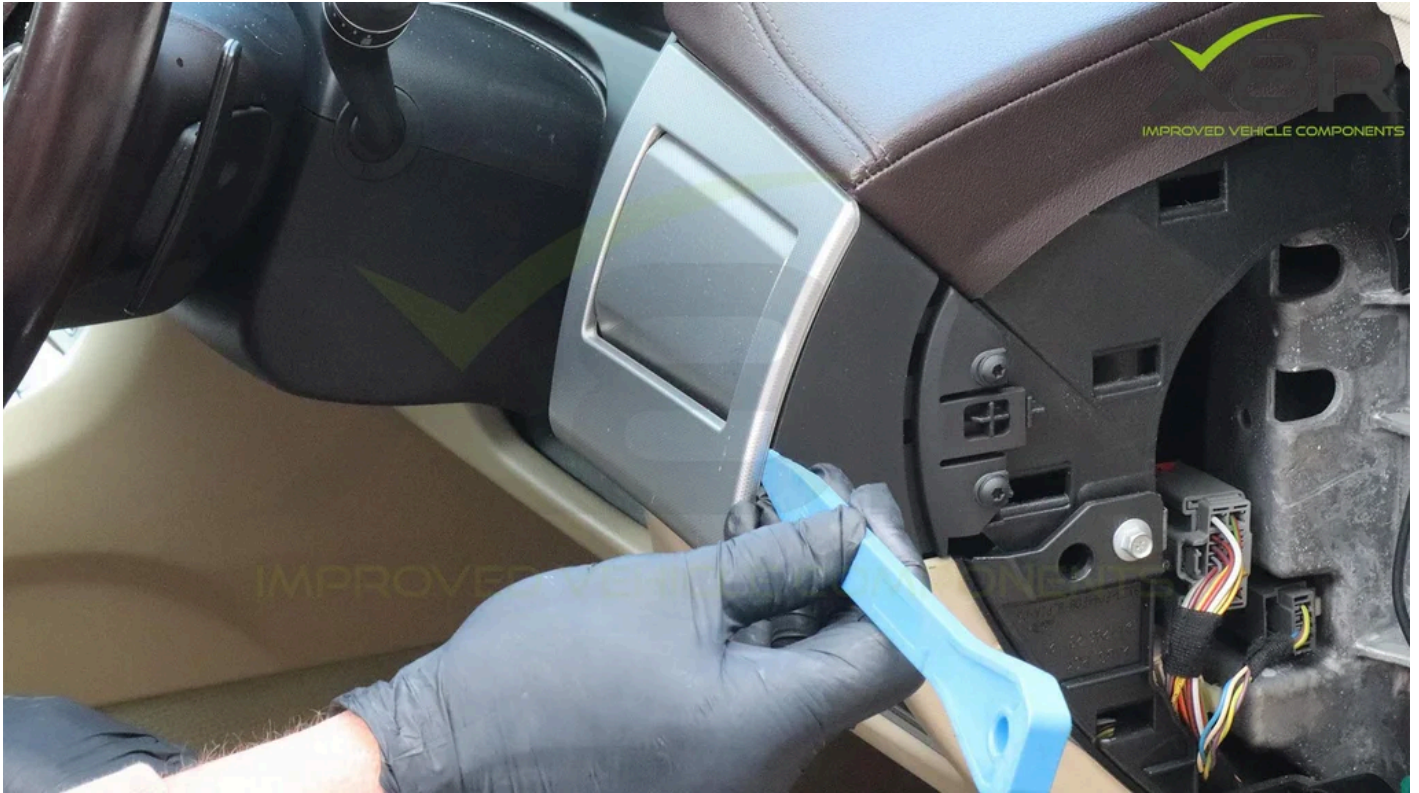
Step 3:

Use a trim removal tool to pry off the front fascia of the air vent.

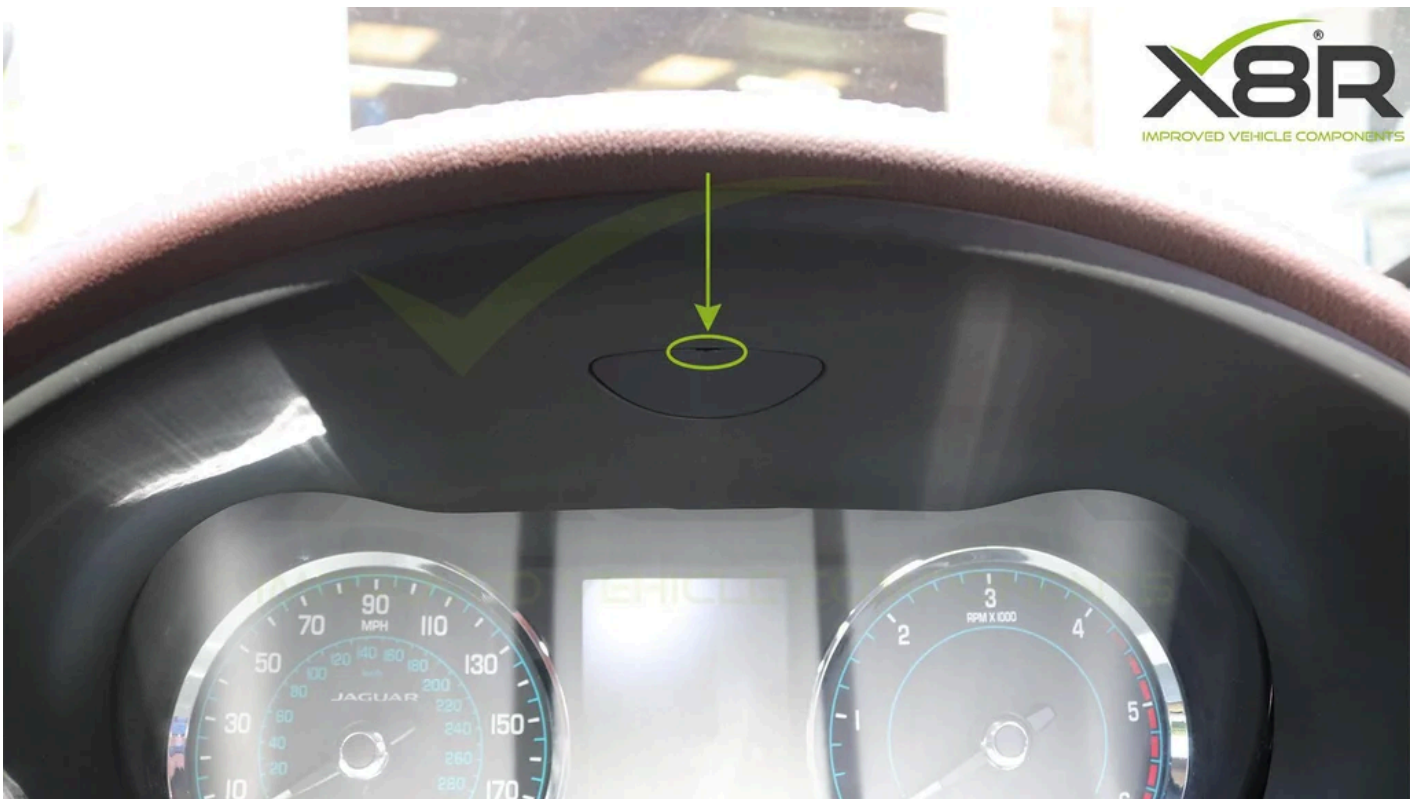
Step 4:

Use a pick or very small flathead screwdriver to pry off the cover at the top of the speed surround. Then use a T20 to remove the screw behind it.

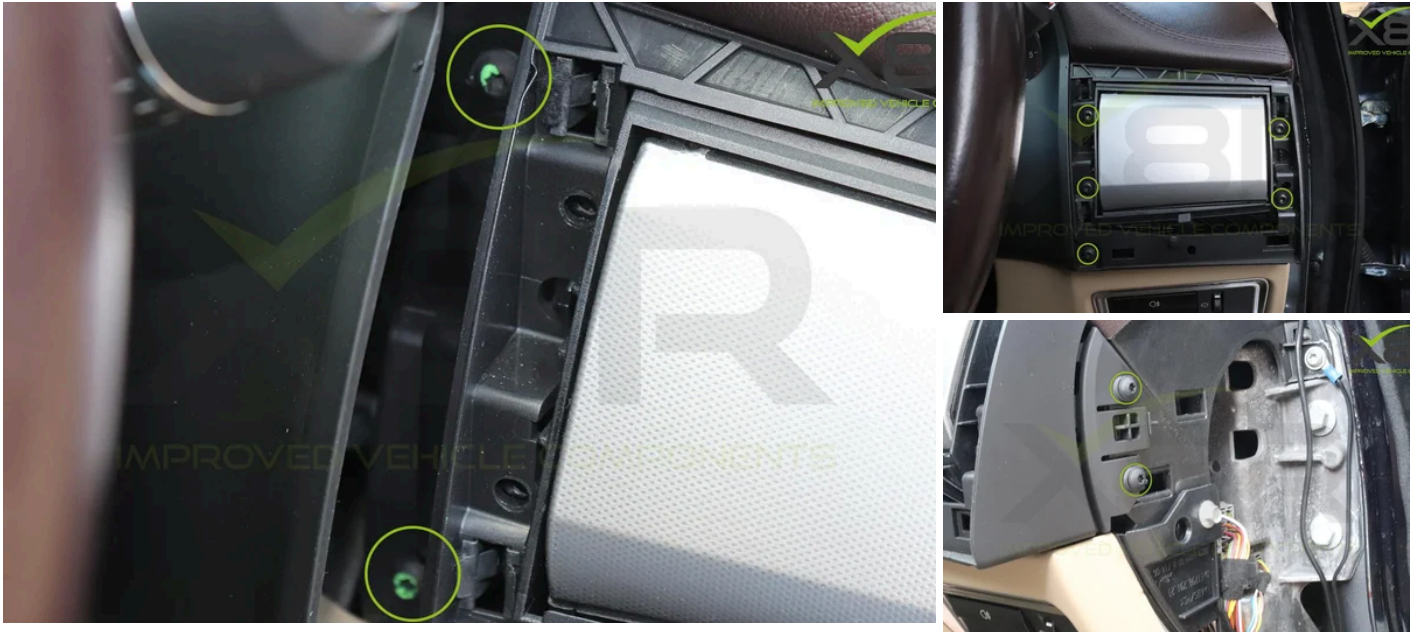
Step 5:

Pull the trim that surrounds the speed dials, the steering wheel and indicator stalks away from the vent. Remove the two screws behind this piece of trim using a T20. Also remove the other screws on the front and side of the air vent.

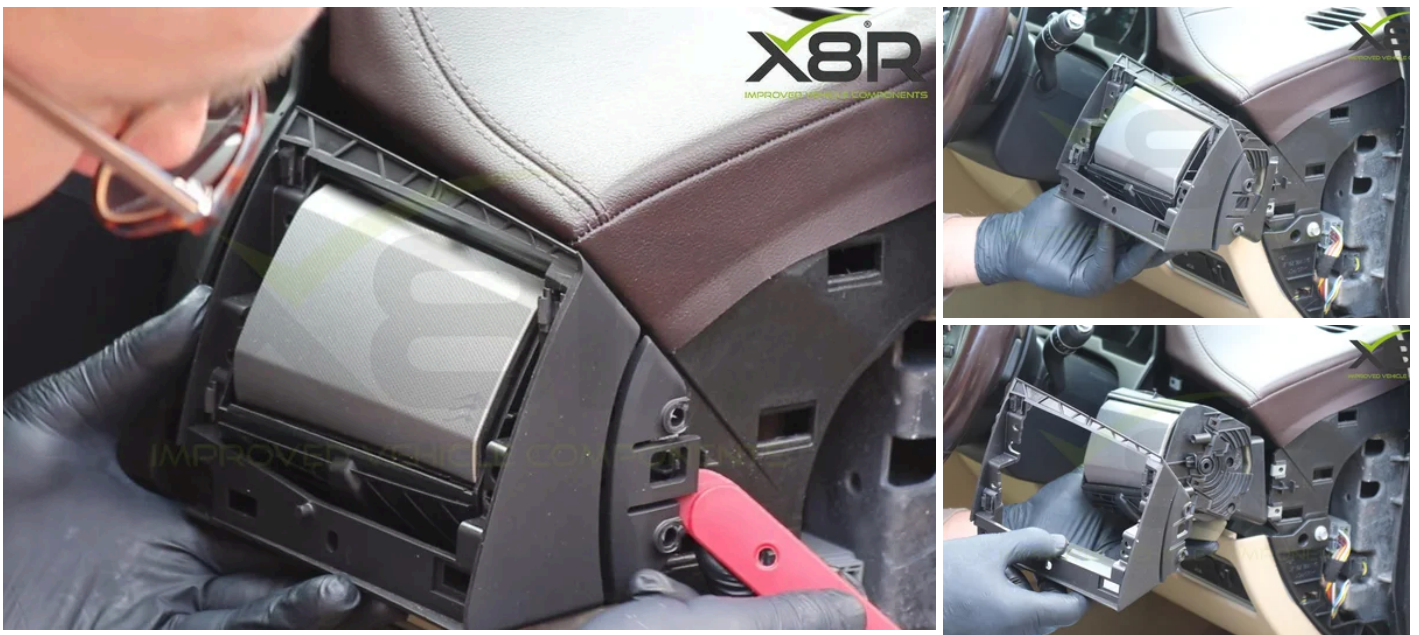
Step 6:

Pull the air vent away from the dashboard. Lever off the inner fascia, do so gently as to not snap it.

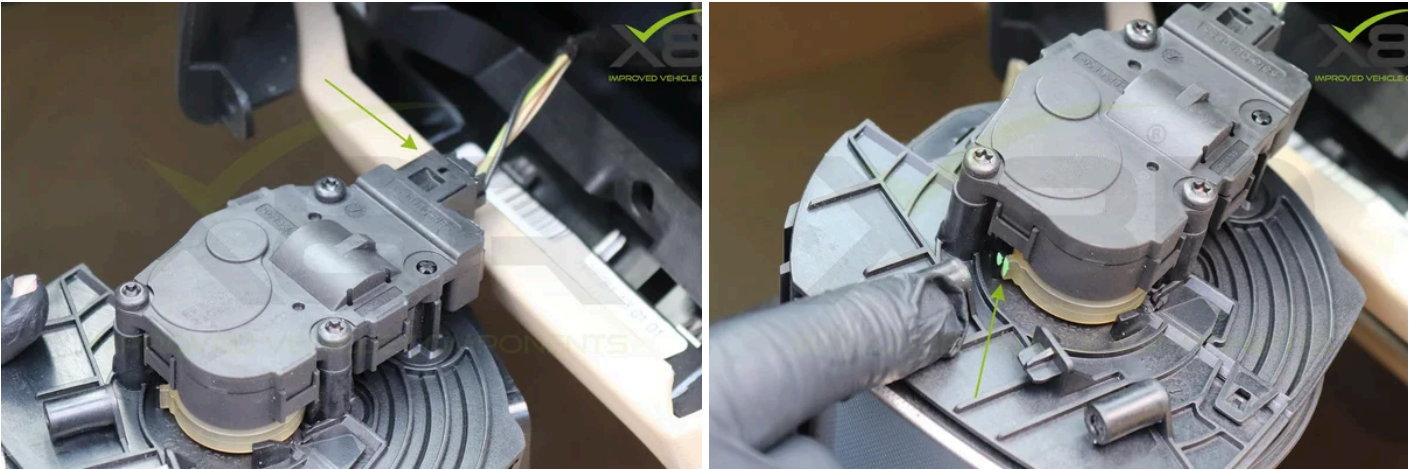
Step 7:

Unplug the electrical connector. Note where the broken cog mates to the air vent, you may want to mark this with a chalk pen.

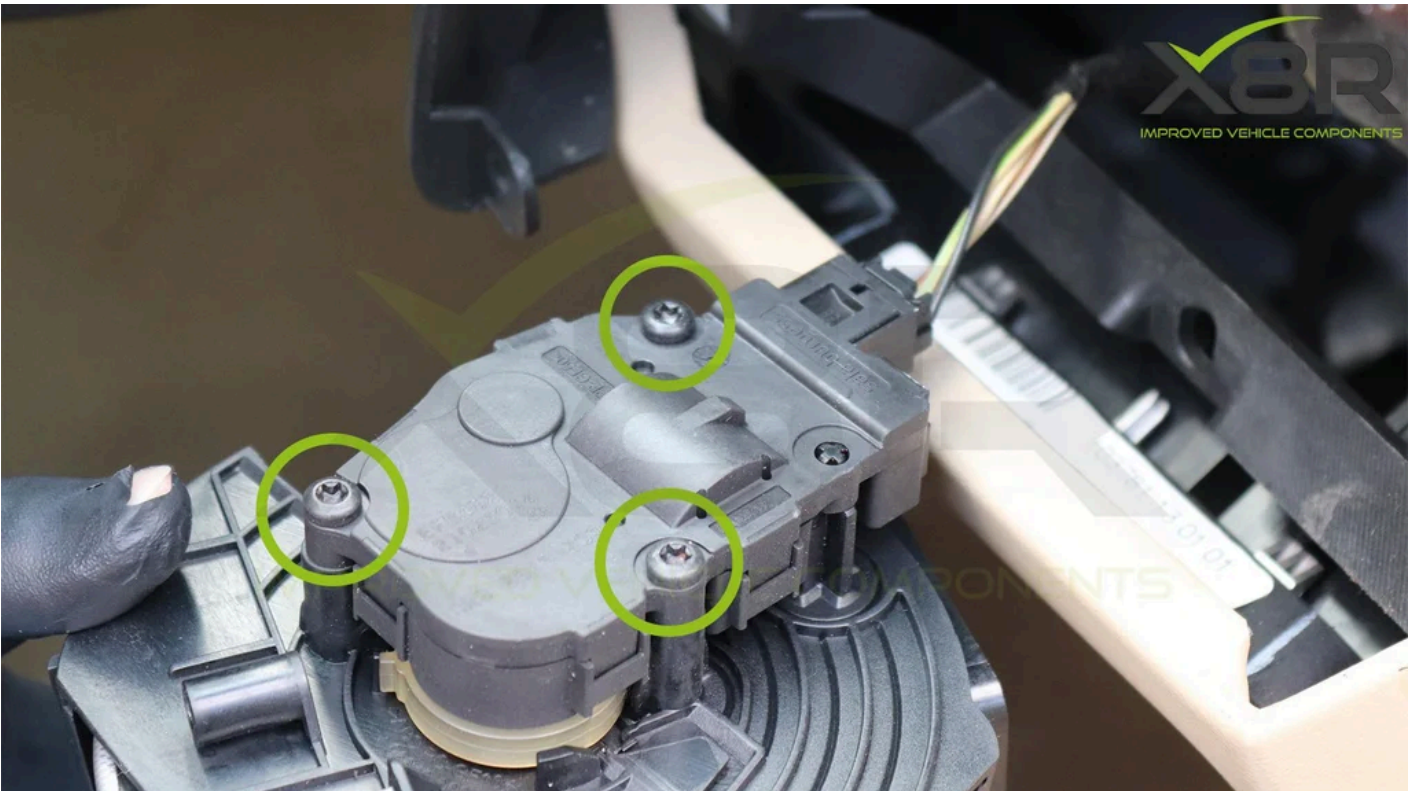
Step 8:

Remove the three T20 screws retaining the motor.

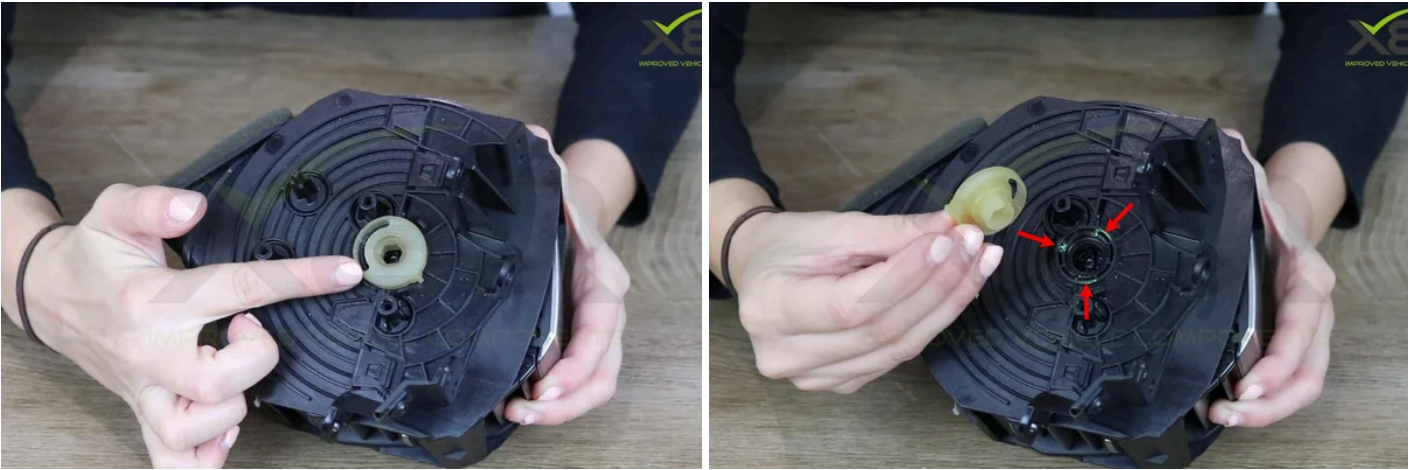
Step 9:

Remove the motor to expose the original cog. Remove the cog. The red arrows show the connecting surfaces.

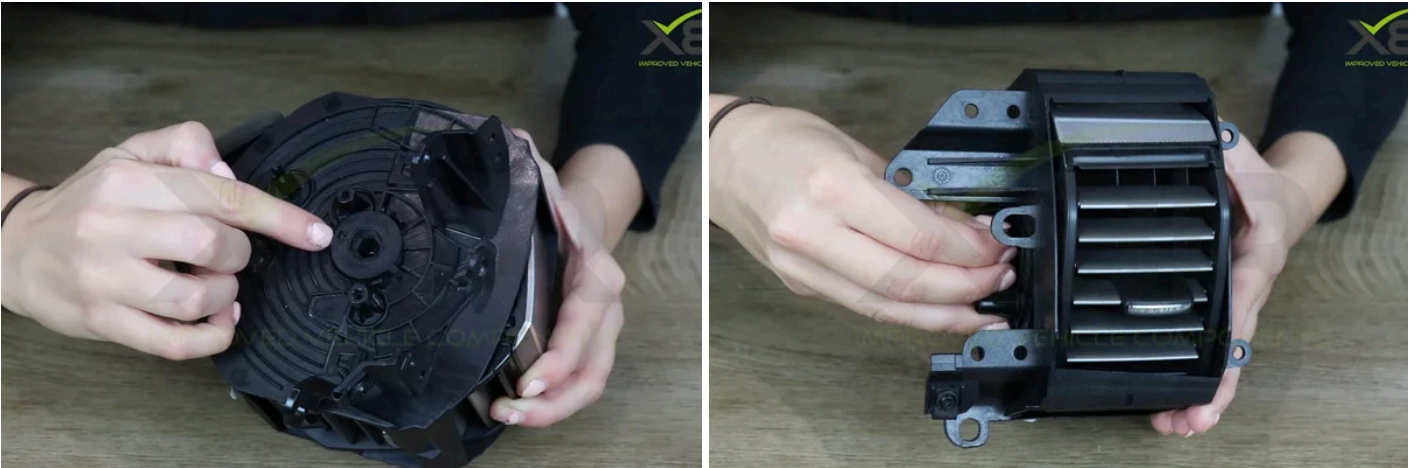
Step 10:

Press in the new X8R cog, ensuring it mates to the connecting surfaces from the previous step. Once fitted, test by rotating and ensuring the vent turns with it.

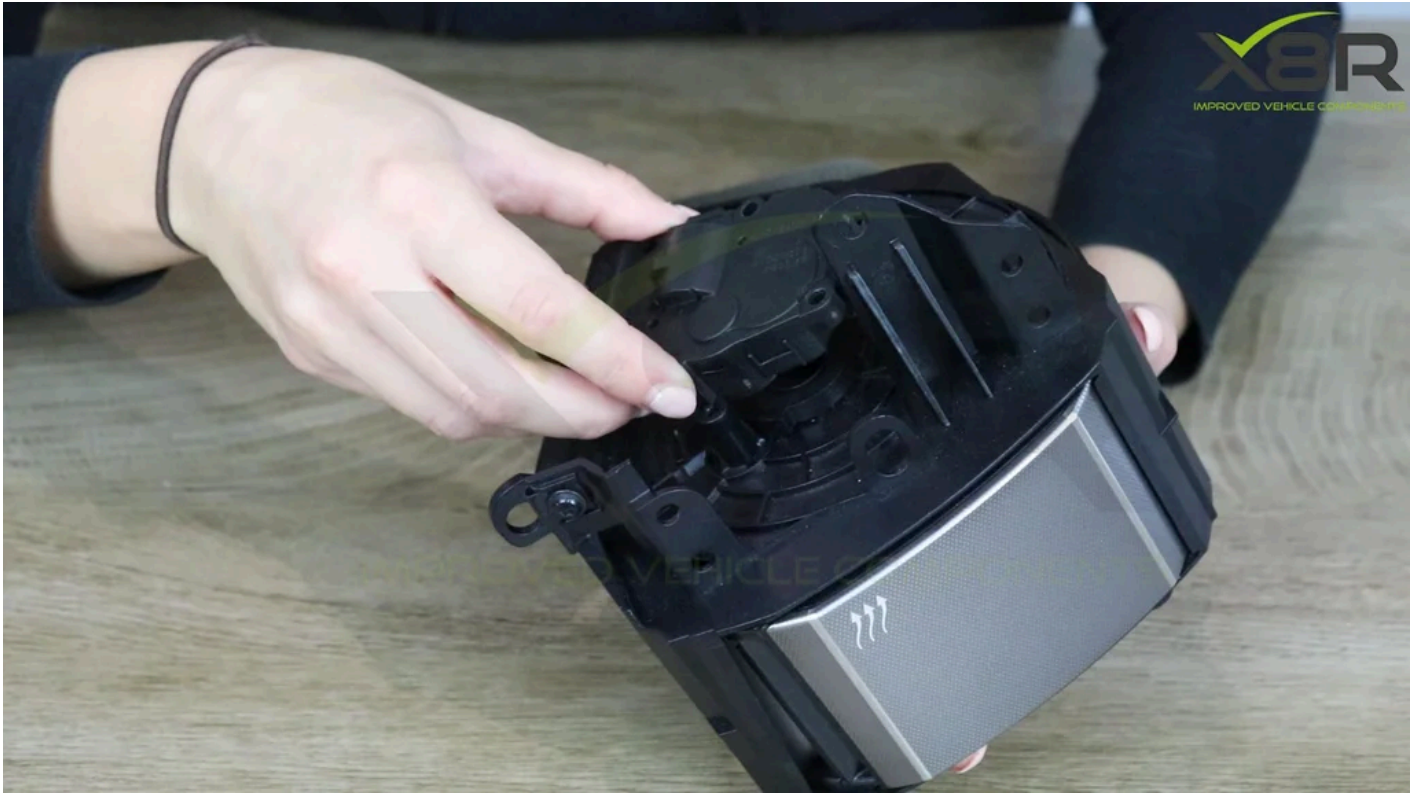
Step 11:

Fit the motor and repeat steps 1-8 in reverse to put the vehicle back together.
