DSG / 0AM Mechatronic Unit 7 Speed Gearbox Hydraulic Accumulator Repair Kit Replacement Overhaul Leaking Crack Repair Fix VW AUDI SKODA SEAT Install Instructions Guide

by x8rltd

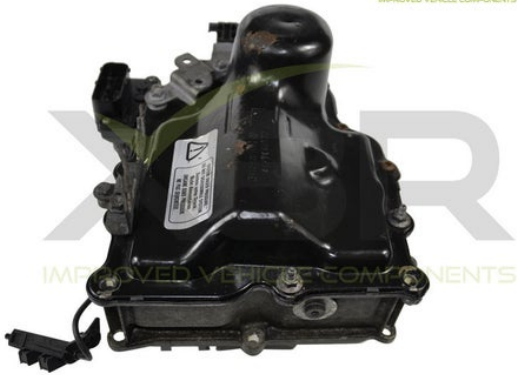
Within the DSG Mechatronic unit, the hydraulic pump pushes oil through the filter towards the pressure accumulator which provides the system with oil pressure when the pump is switched off.

The cast metal part that the accumulator seats in to is too thin for the pressure exerted, this causes this part to crack and for the system to lose pressure causing the mechatronic unit to fail.

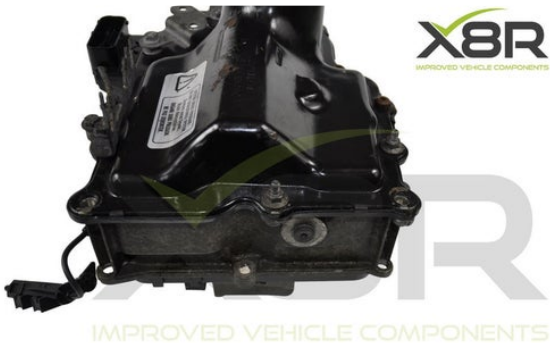
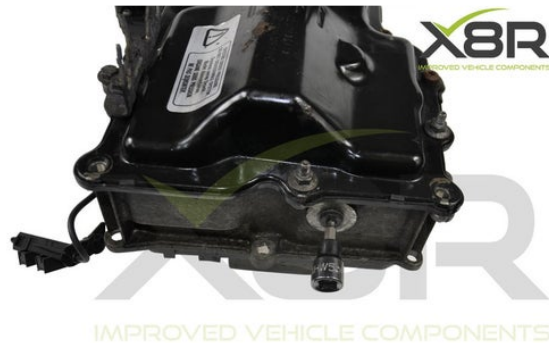
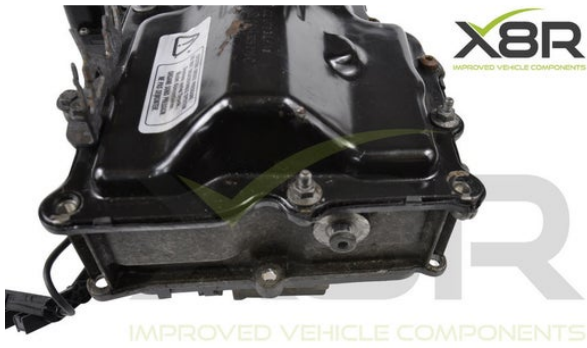
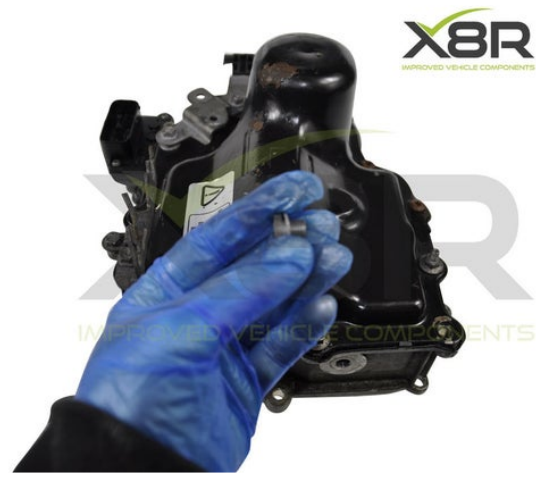
Step 1: Depressurise and Drain Mechatronic Unit

Using a 5mm Allen key socket loosen the screw shown slowly and drain down the Hydraulic fluid from the Mechatronic unit.

The Mechatronic unit is under pressure.

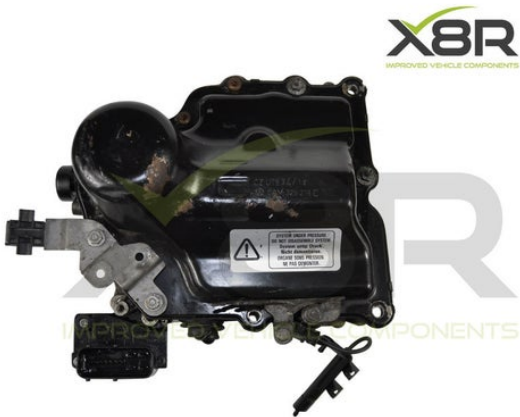
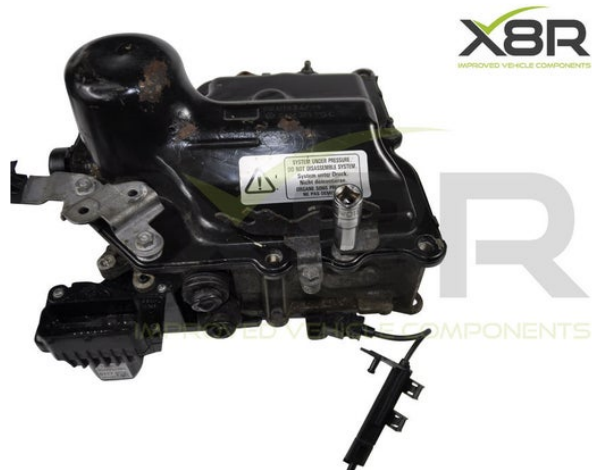
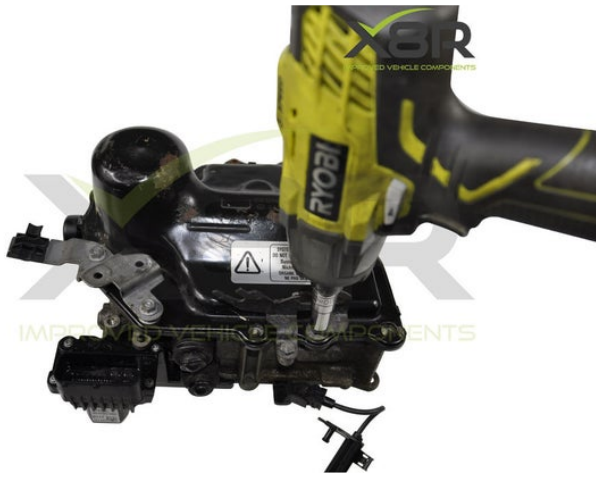
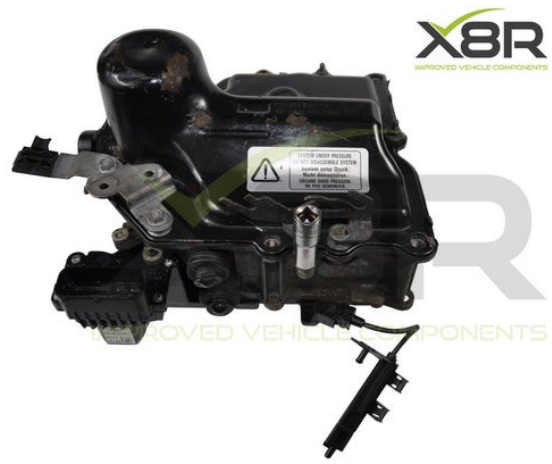
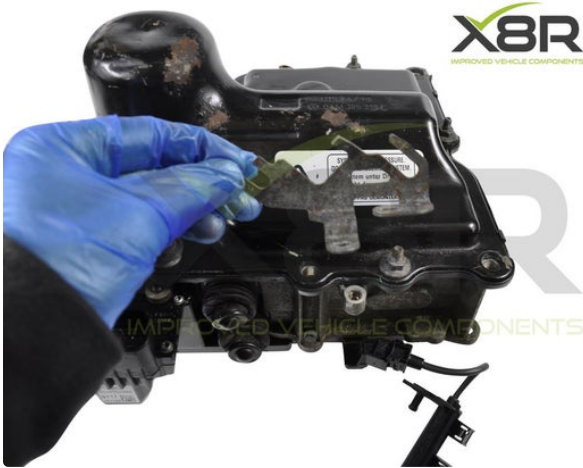
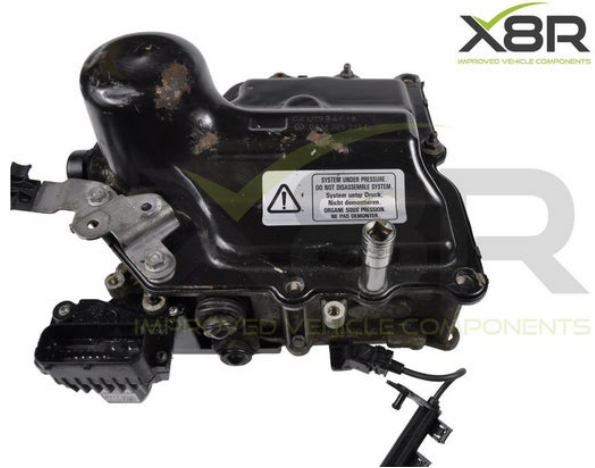
Step 2: Remove Sump Cover

Remove the sump cover fasteners. Take note of the location of each fastener for reinstall. Socket sizes required: 10mm socket, T30 Torx.

Using a flat bladed screw driver lever off the sump cover, taking care not to damage the gasket.

Keep gasket in place on sump cover for reinstall.

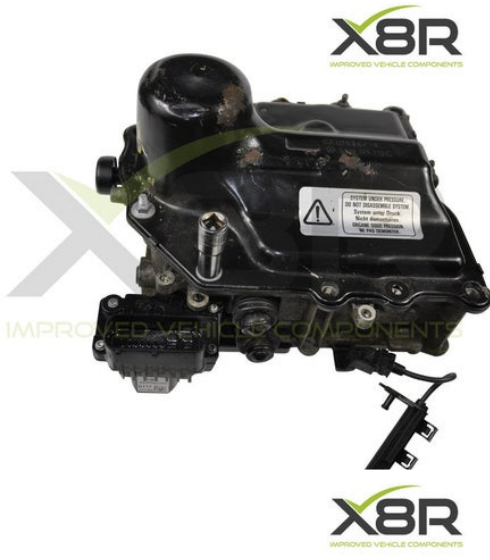
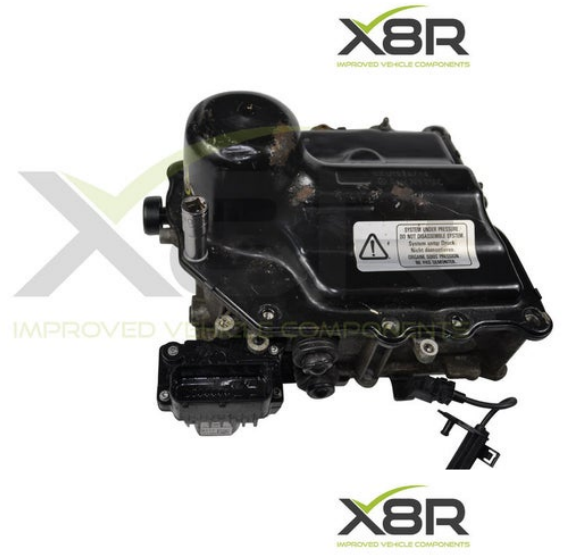
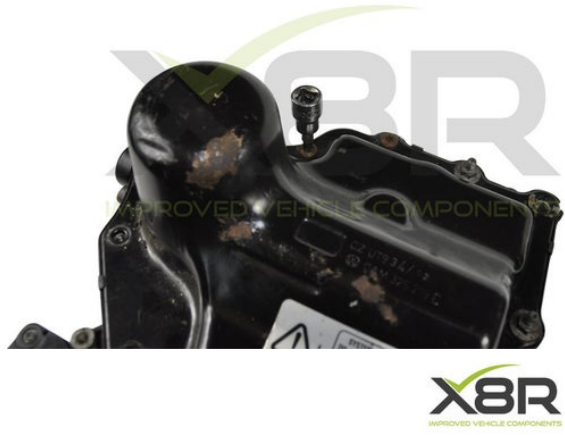
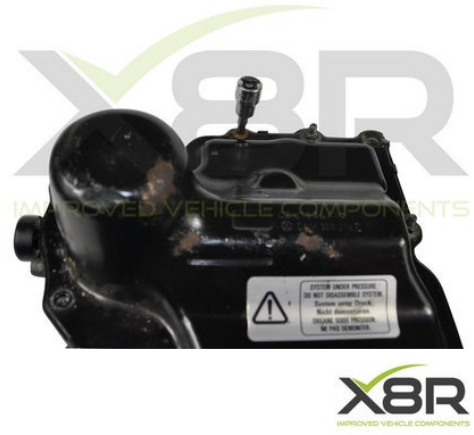
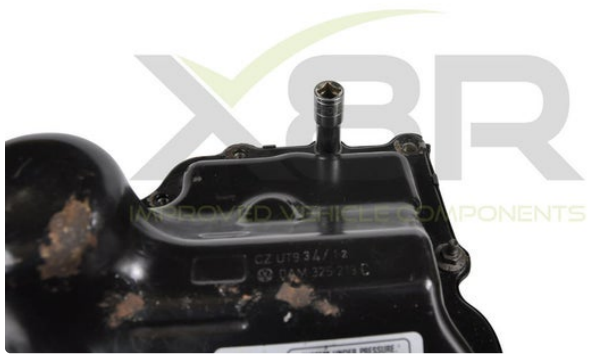
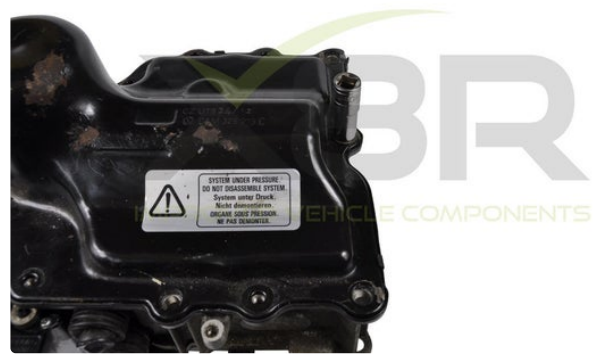
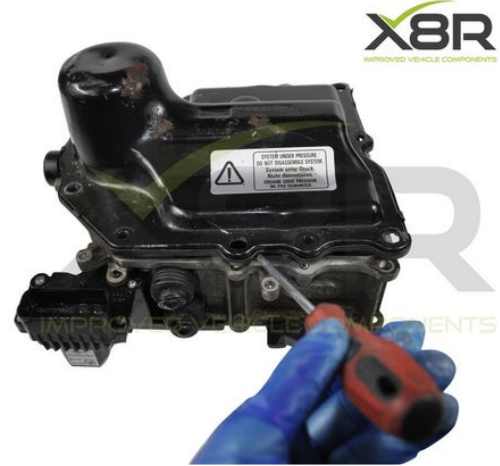
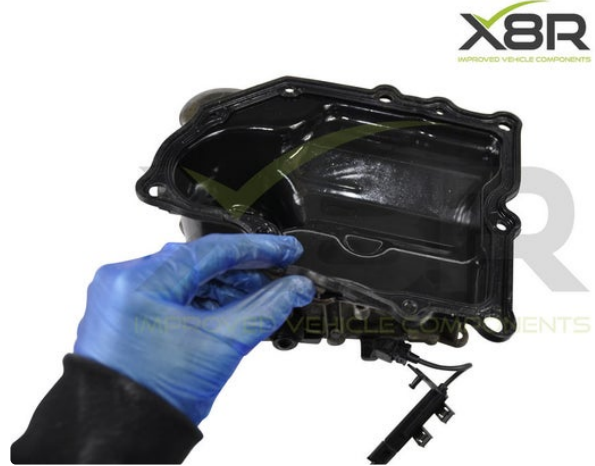
Step 3: Remove Accumulator

Although the Mechatronic hydraulic fluid has been drained down the accumulator could still be under pressure as it is designed to store the fluid under pressure when the unit isn't active. Inspect closely around the base of the accumulator to check for cracks or splits where the accumulator base has failed. If there is no sign of damage the likely hood is that our part won't cure the fault it is also likely the unit

is under pressure and should not be disassembled. Only if damaged is evident and you are confident that the unit is not under pressure should you continue. If you are unsure or not confident; consult a professional.

Using a T70 bit loosen and remove the accumulator.

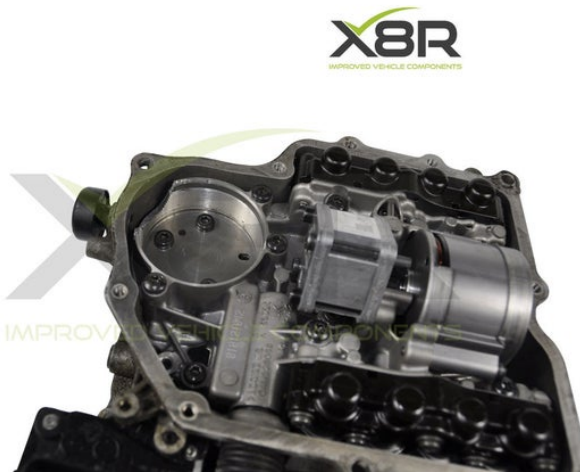
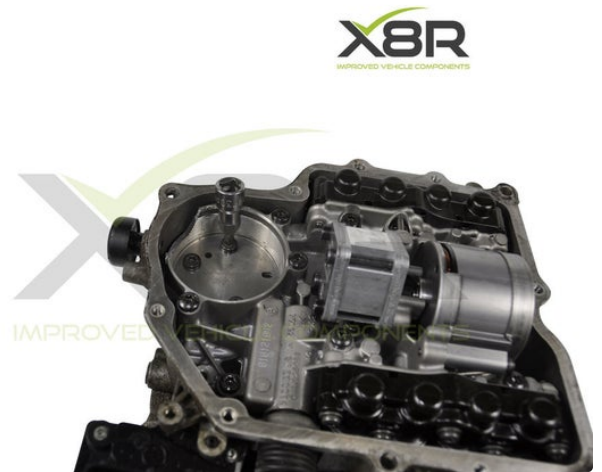
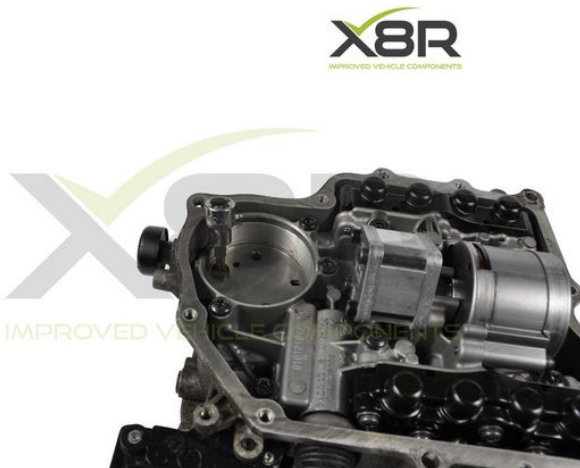
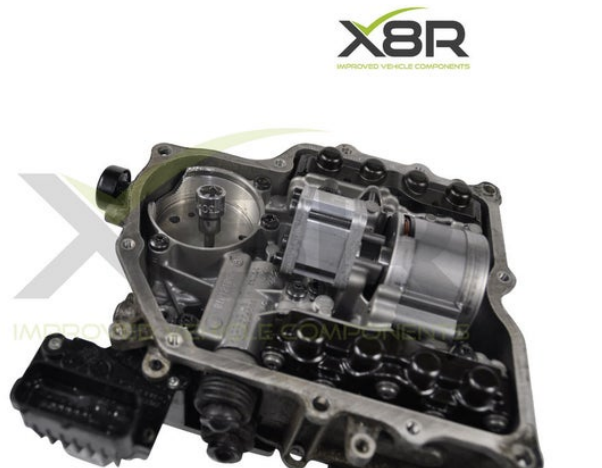
Step 4: Remove Accumulator Base Screws

If the block has fully cracked as shown here; remove all metal parts that have broken away.

Using a T30 bit remove the 3 screws shown.

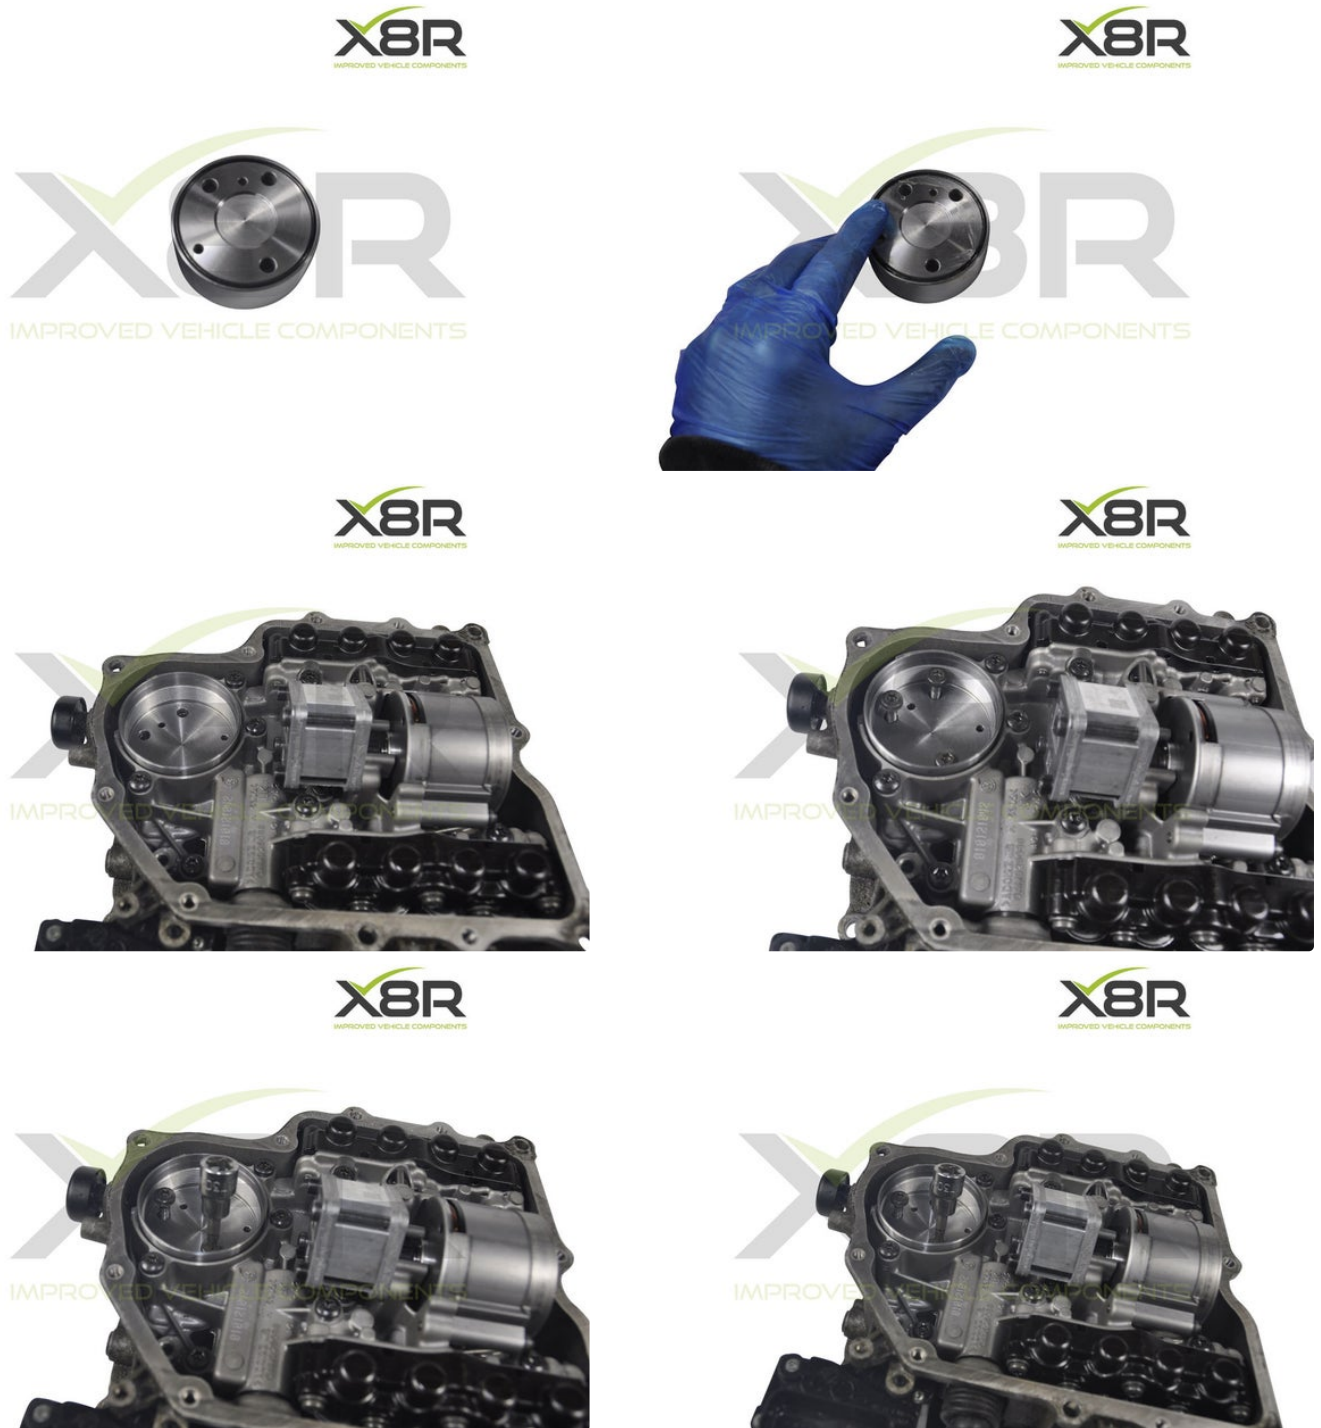
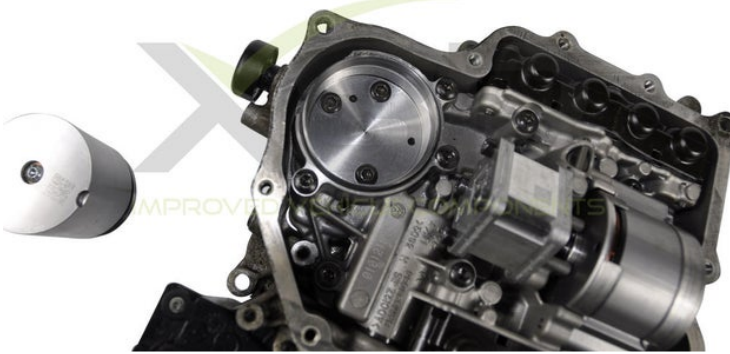
Step 5: Fit Our Accumulator Base

Apply a very small amount of grease to the O-ring seal on the bottom of our Accumulator base. To aid with the initial sealing of this part.

Insert this part in to the cast block as shown, lining up the 3x screw holes with those in the cast block.

Reinstall the 3x OEM screws and tighten using an impact wrench.

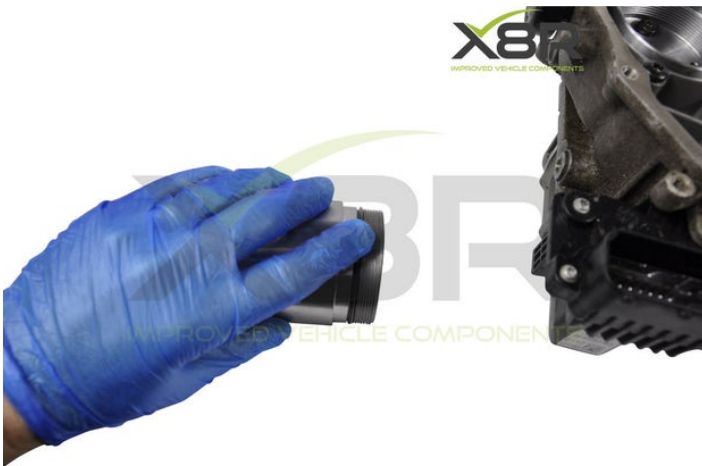
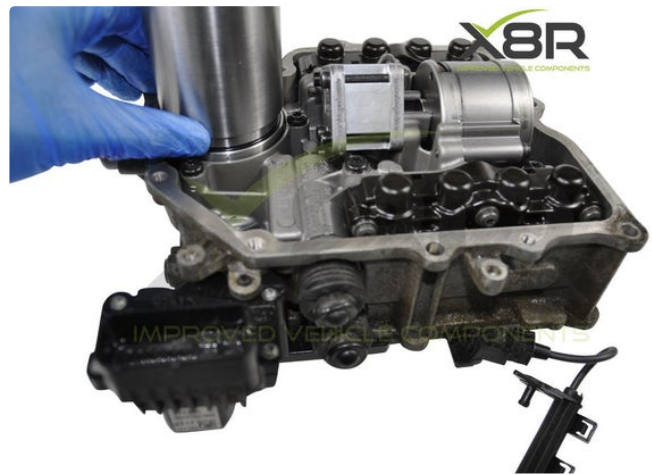
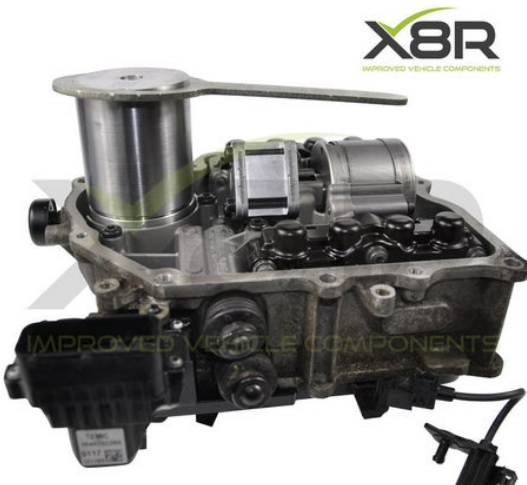
Step 6: Install Our Accumulator

Apply a very small amount of grease to the O-ring seal on the accumulator.

Screw the accumulator in to the accumulator base.

Fully tighten using the spanner included with our kit.

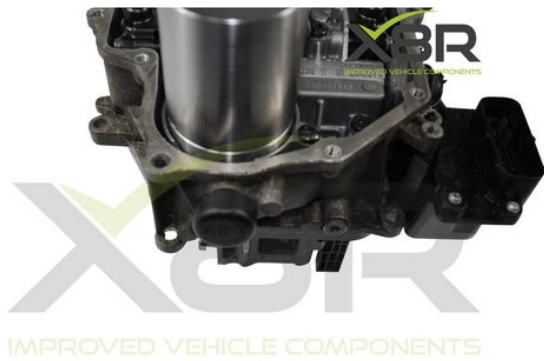
Completing the Repair

The Mechatronic unit can then be refilled with hydraulic fluid (available from us), 1ltr is required. Note the breather shown here in the final image. If refilling on the vehicle this can normally be accessed from the engine bay. Pull the cap off of the breather and using a syringe push in 1ltr of fluid and refit cap.
