## Peugeot 3008 5008 Rear Footwell Storage Compartment Lid

**1 X REAR GLOVEBOX LID**  
**PEUGEOT 3008 (07-16)**  
**PEUGEOT 5008 (09-16)**

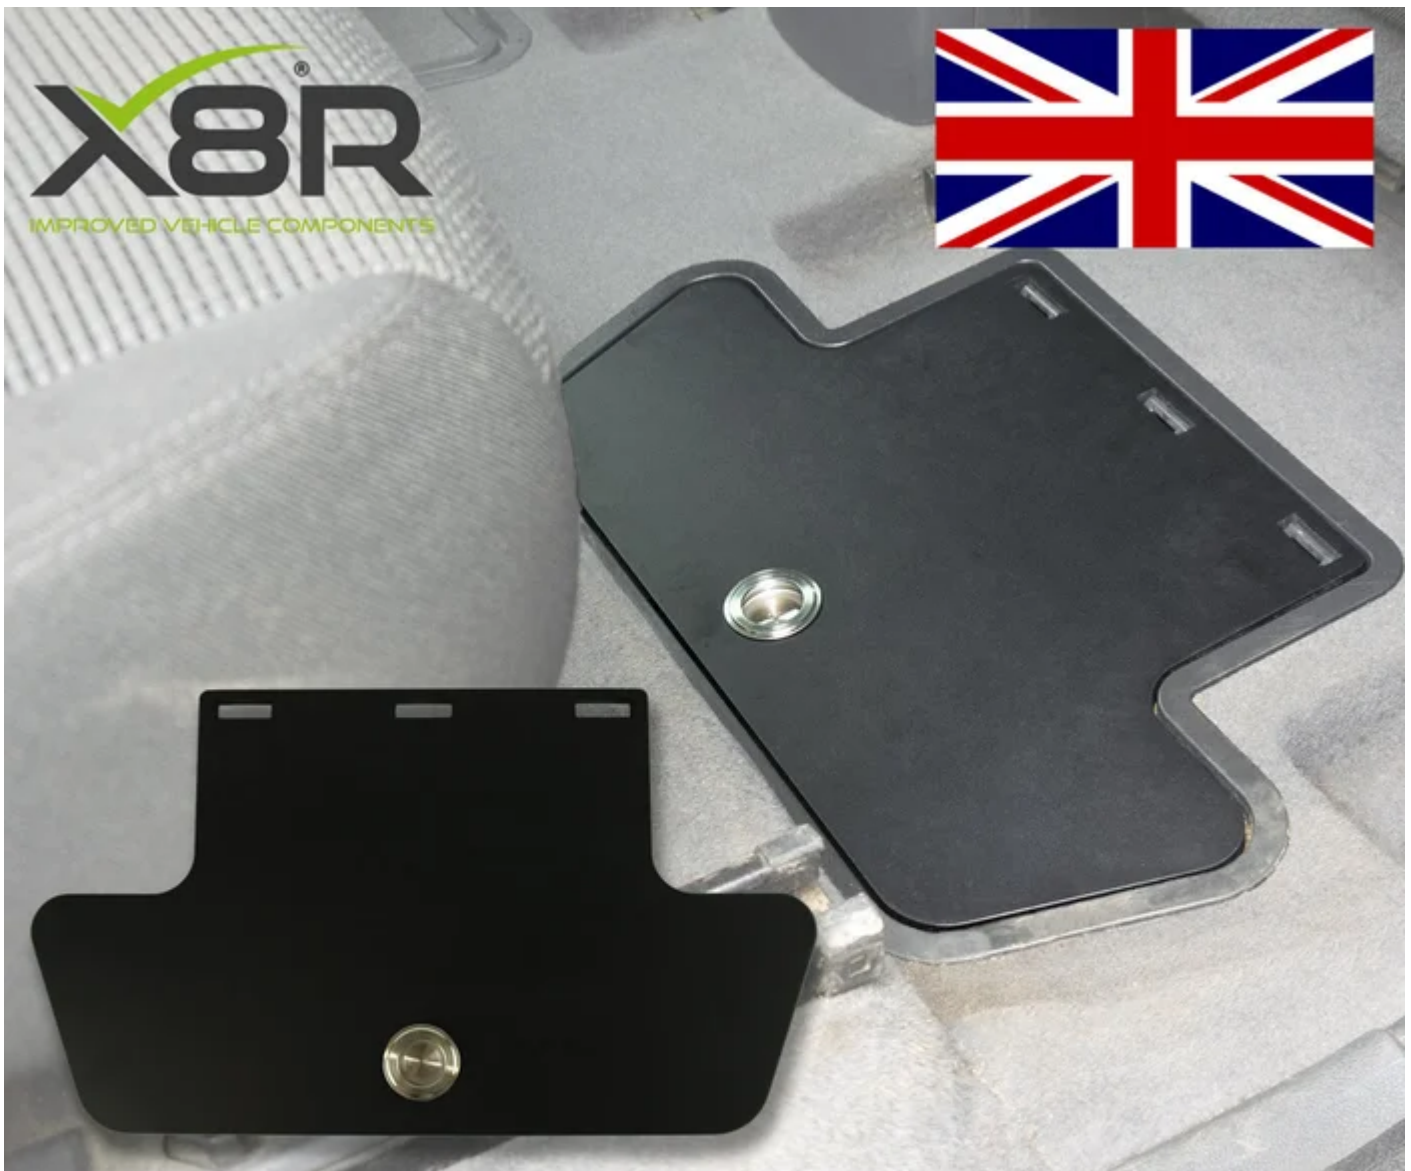
Snapped, broken, collapsed storage lid. Frame of lid come away from carpet. Difficulty opening original lid due to poor design.

The OEM storage lid is a poor design which is easily broken.

The original design of storage lids for the footwell glovebox are made from flimsy plastic, foam, fiberglass and carpet and easily snap, break or buckle when stood on.

X8R's improved design storage lid for the rear footwell storage compartment looks the part and is made from MDF wood, it certainly improves the aesthetics of your vehicle's interior. The MDF is far stronger than the OEM mix of plastic, foam, fiberglass and carpet. It can easily withstand the weight of an adult.

The design also features a stainless steel handle so you can access the storage compartment far more easily than before.

Install the X8R storage lid to save money and restore the look of your interior.

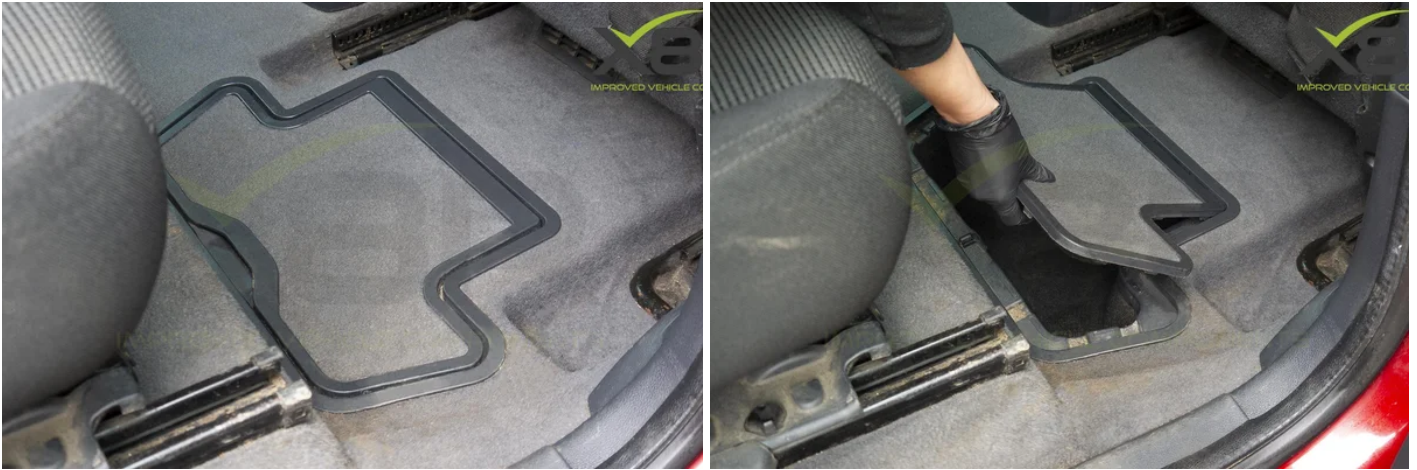
## Step 1: Remove Old Lid

Remove the old lid from your storage compartment.

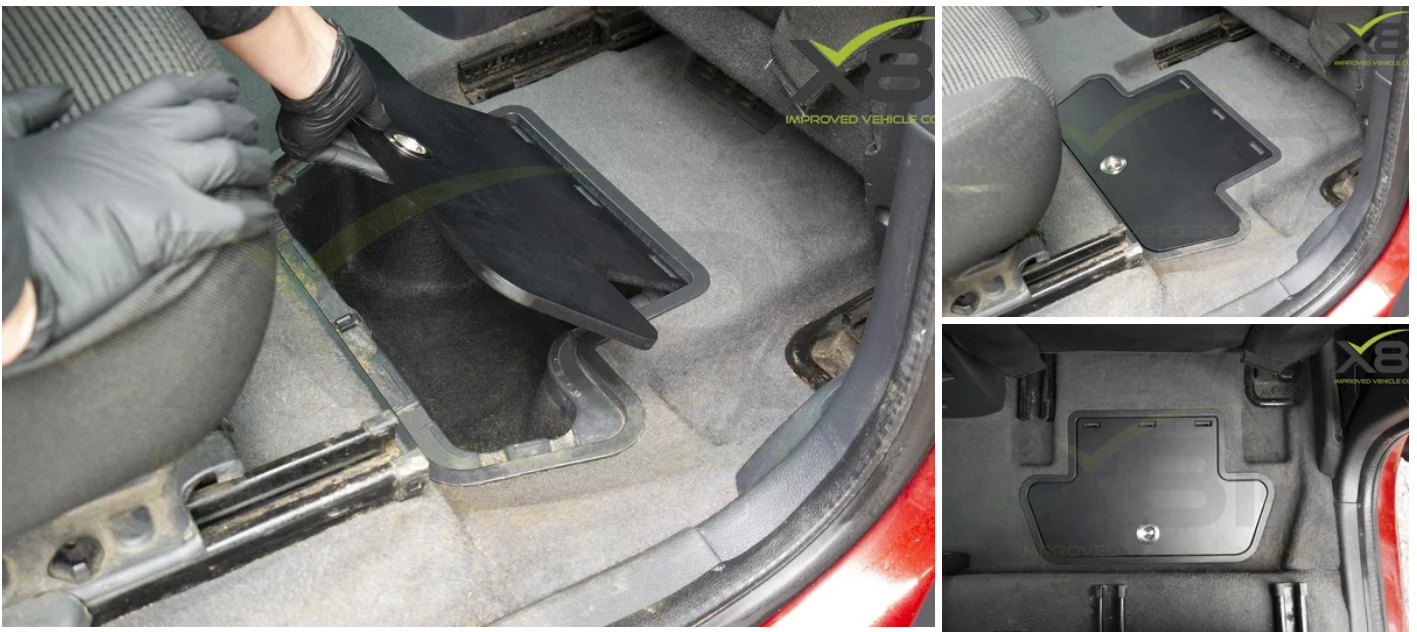
## Step 3: Install the New Lid

Install the new lid by pressing it at an angle into the clips on the compartment.
